# **APPRAISAL OF REAL PROPERTY**

# HAZARDOUS MATERIALS ASSESSMENT REPORT

225 4 St Lehigh

E3030-A

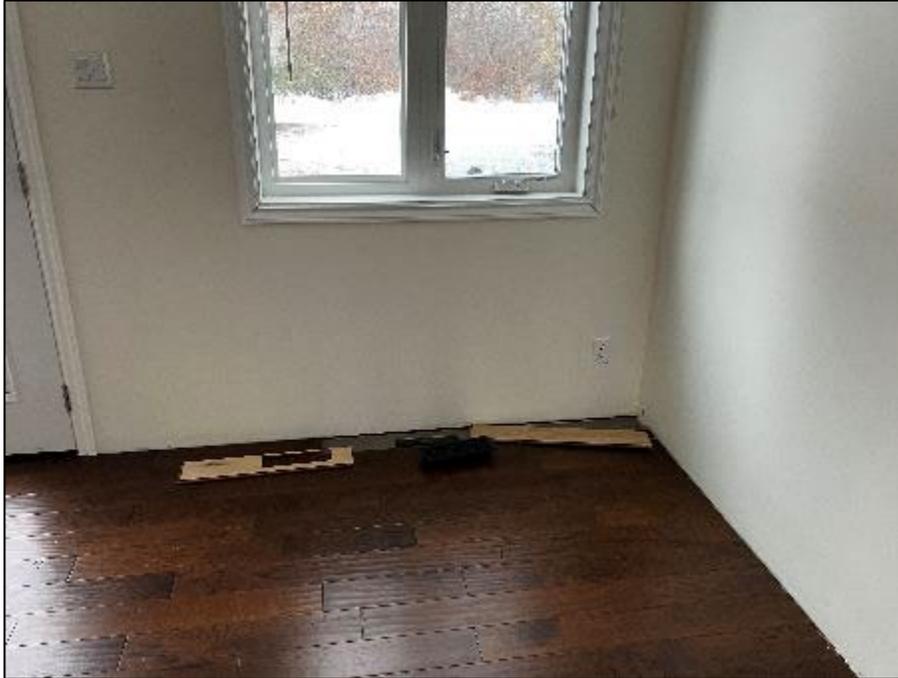
**PHOTOGRAPH #1:** Drywall Joint Compound - Level 1 Dining Room Exterior (None Detected)

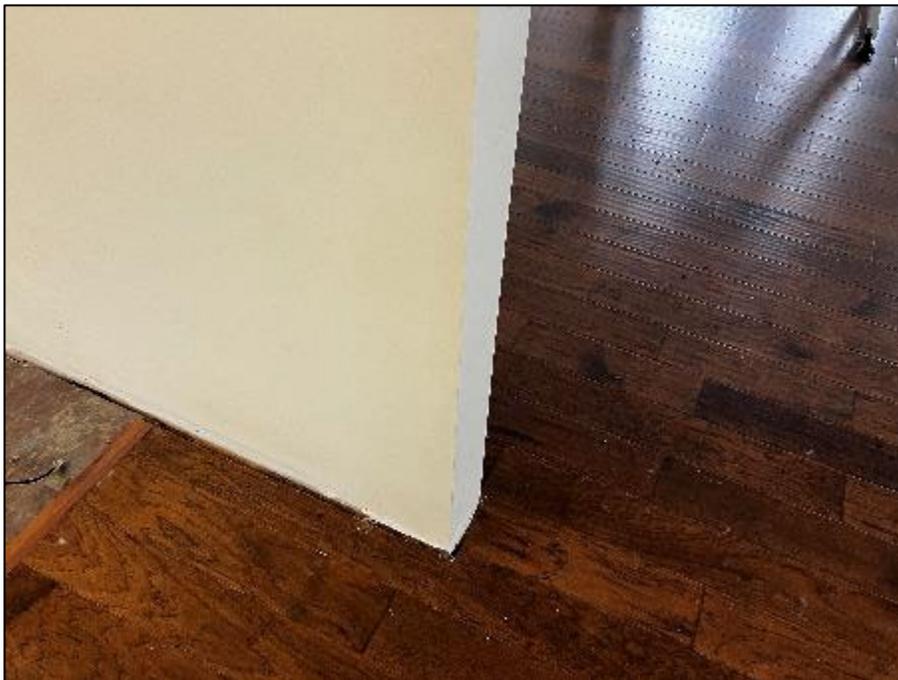
**PHOTOGRAPH #2:** Drywall Joint Compound - Level 1 Dining Room Interior (None Detected)

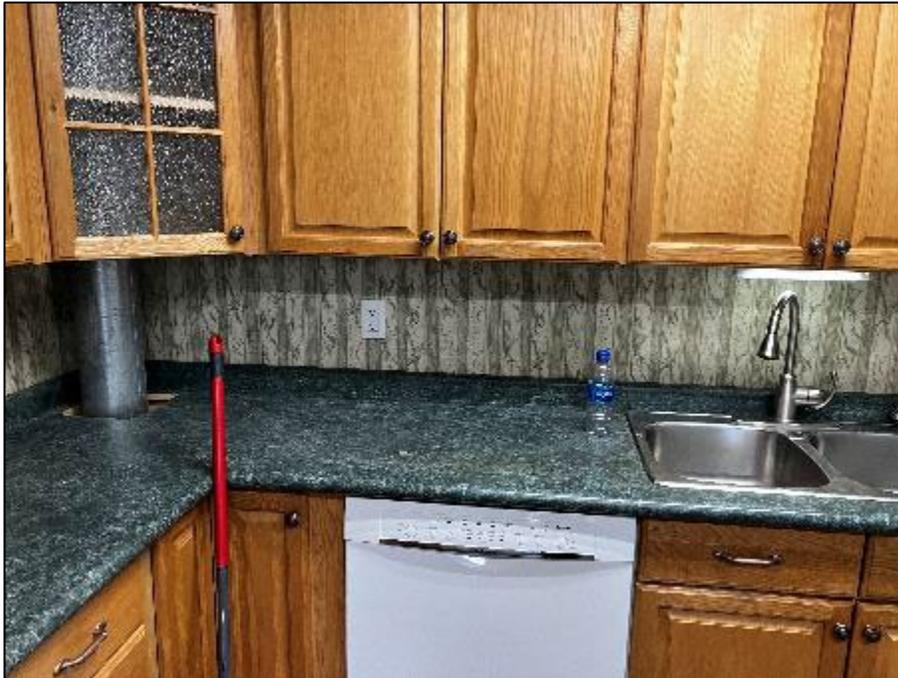
**PHOTOGRAPH #3:** Drywall Joint Compound - Level 1 Kitchen Interior (None Detected)

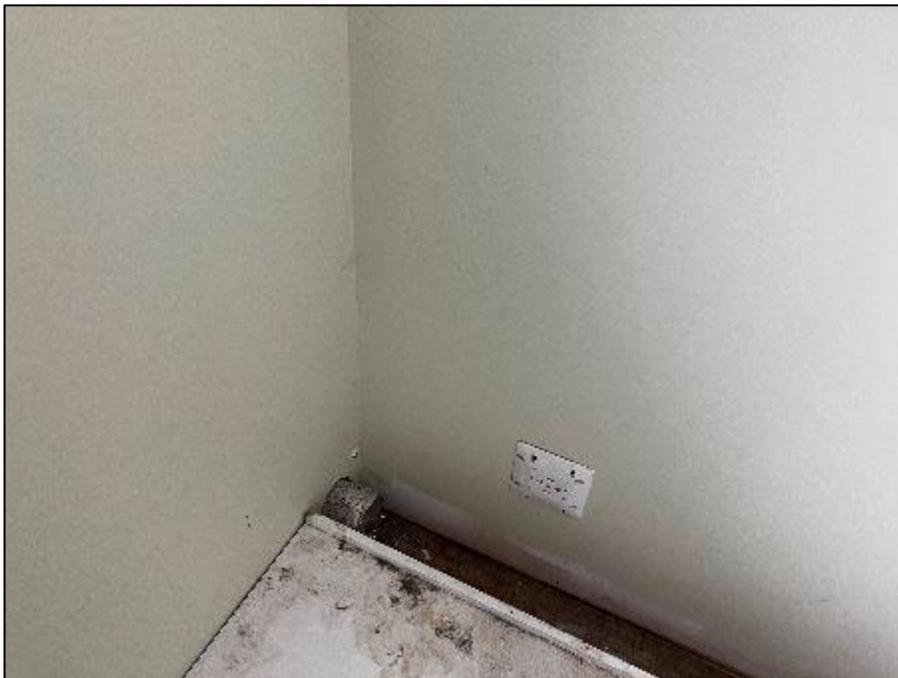
**PHOTOGRAPH #4:** Drywall Joint Compound - Level 1 Laundry Room Exterior (None Detected)

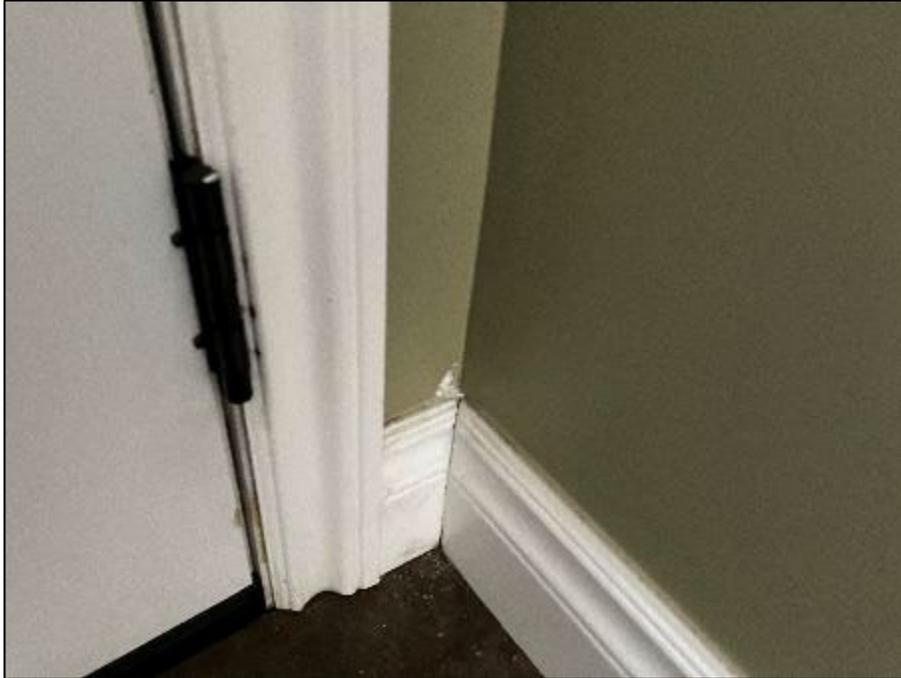
**PHOTOGRAPH #5:** Drywall Joint Compound - Level 1 Foyer Exterior (None Detected)

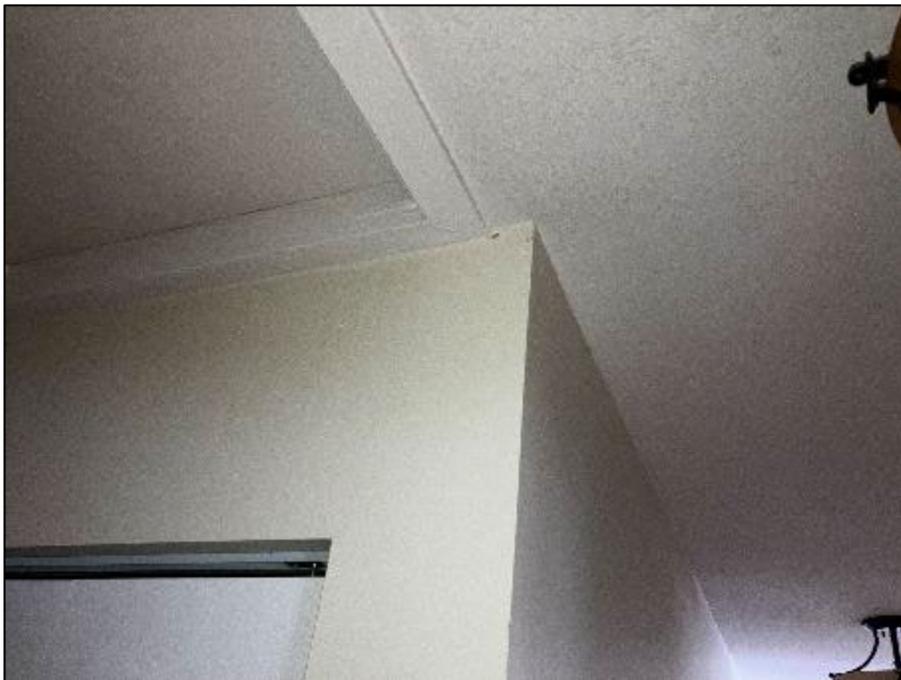
**PHOTOGRAPH #6:** Drywall Joint Compound - Level 1 Hallway Interior (None Detected)

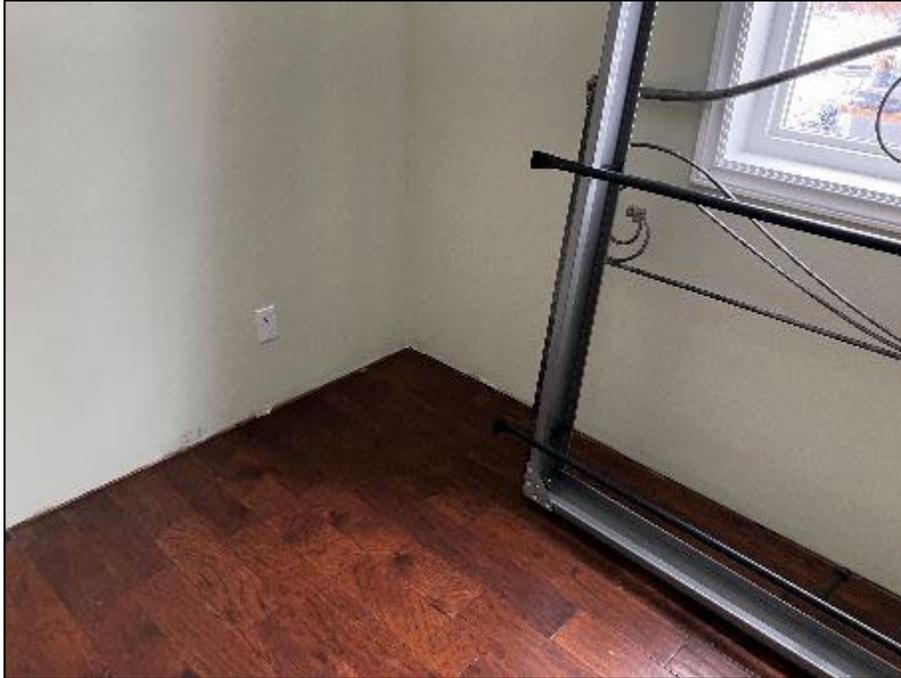
**PHOTOGRAPH #7:** Drywall Joint Compound - Level 1 SE Bedroom Exterior (None Detected)

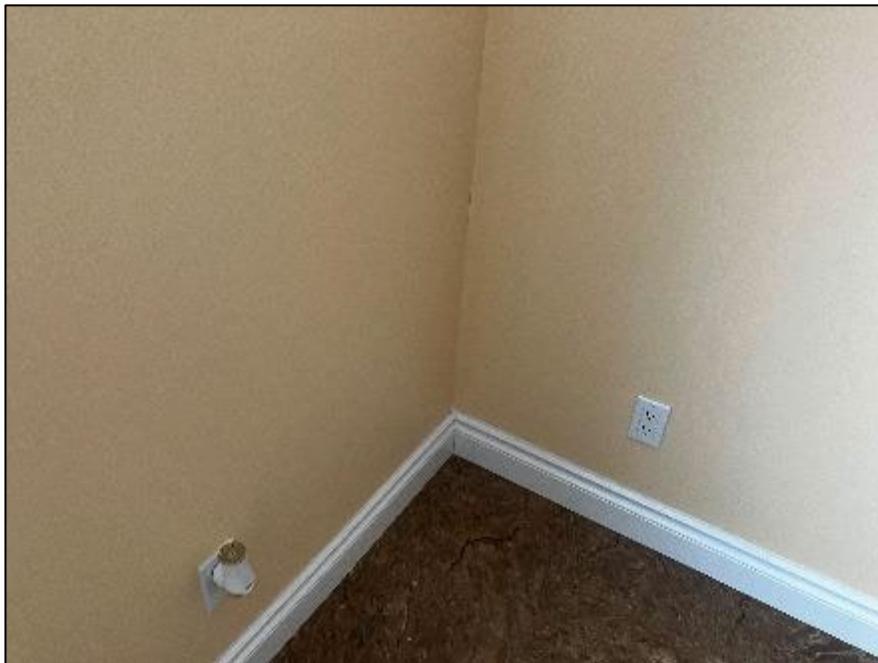
**PHOTOGRAPH #8:** Drywall Joint Compound - Level 1 SW Bedroom Exterior (None Detected)

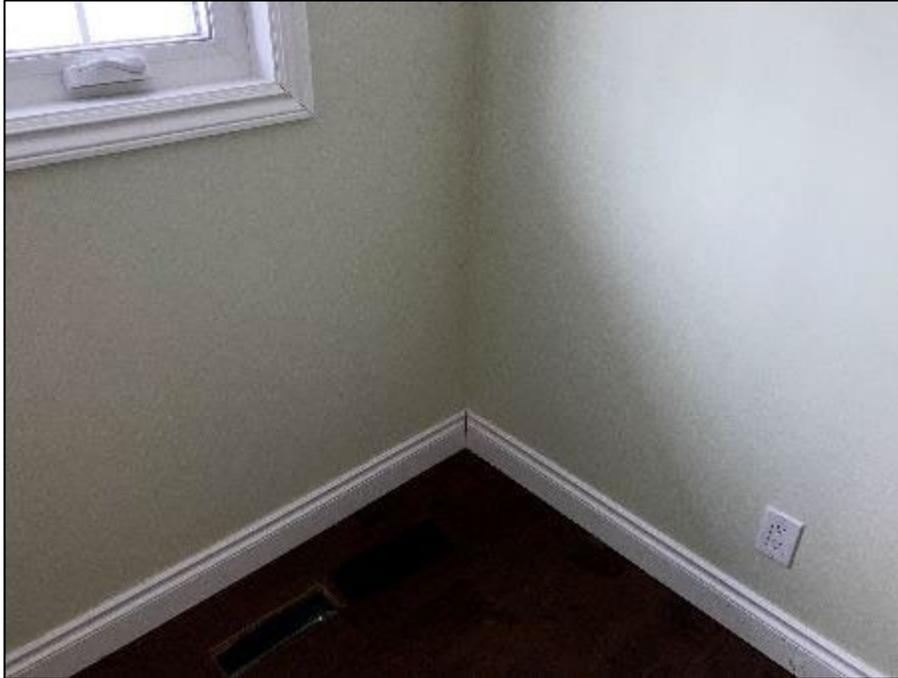
**PHOTOGRAPH #9:** Drywall Joint Compound - Level 1 N Bedroom Exterior (None Detected)

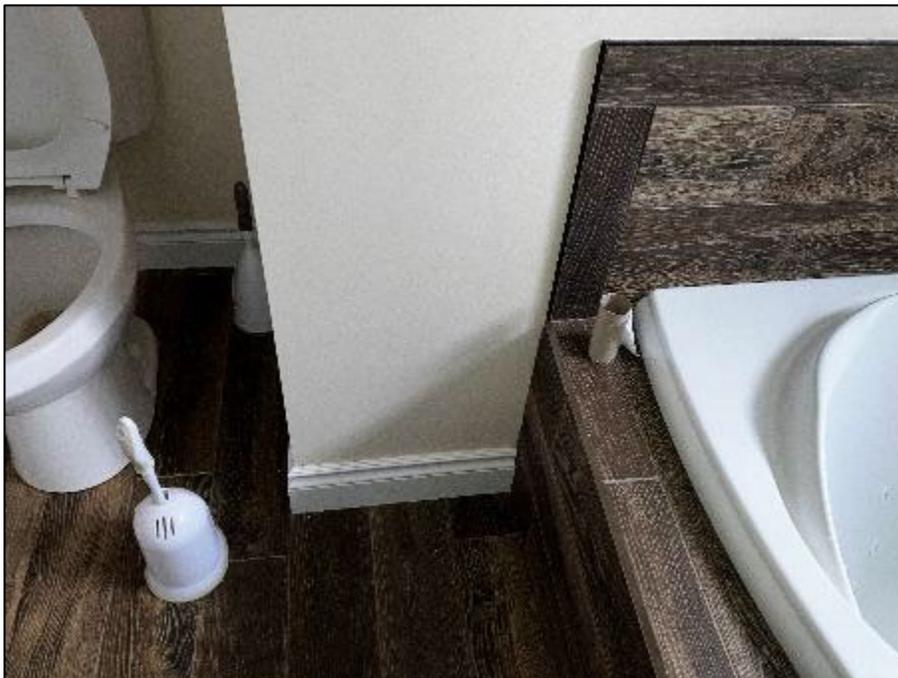
**PHOTOGRAPH #10:** Drywall Joint Compound - Level 1 Bathroom Interior (None Detected)

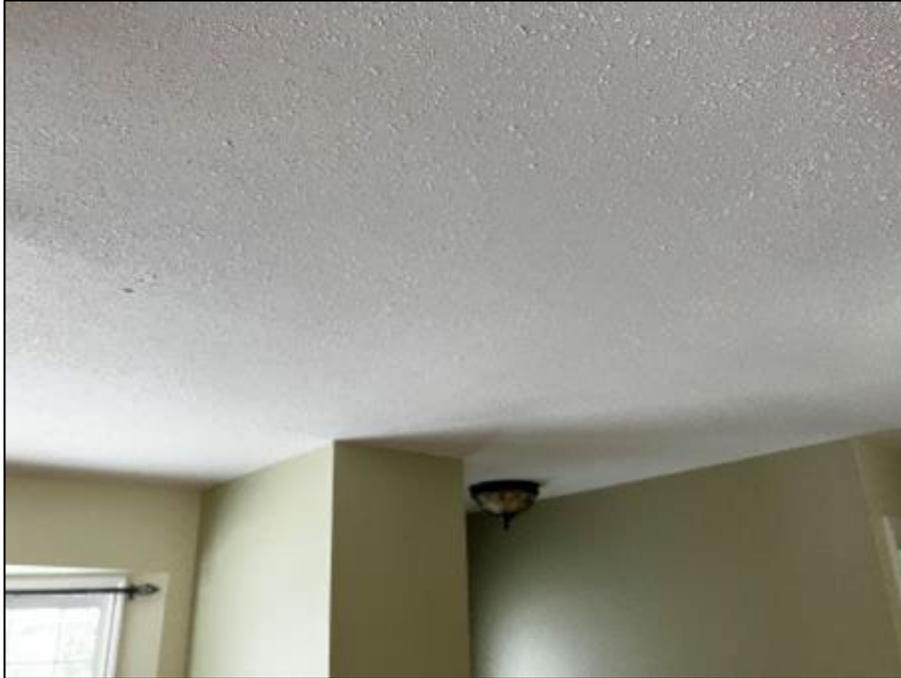
**PHOTOGRAPH #11:** Ceiling Texture - Level 1 Foyer Popcorn (None Detected)

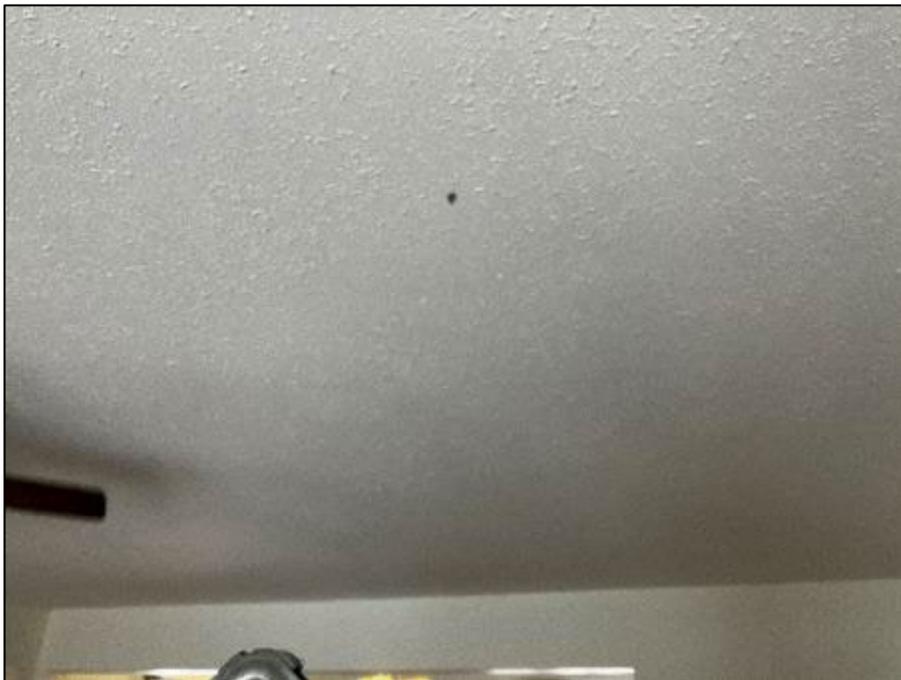
**PHOTOGRAPH #12:** Ceiling Texture - Level 1 Dining Room Popcorn (None Detected)

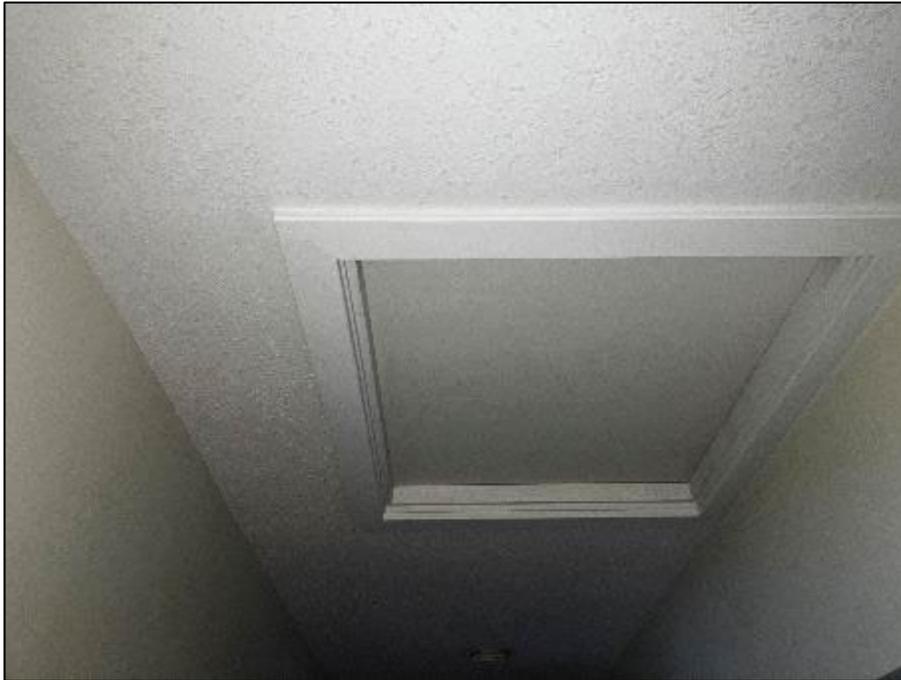
**PHOTOGRAPH #13:** Ceiling Texture - Level 1 Hallway Popcorn (None Detected)

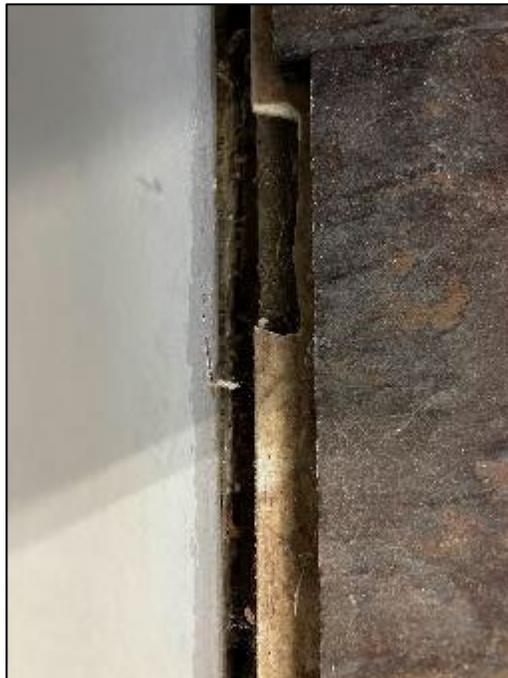
**PHOTOGRAPH #14:** Sheet Flooring - Level 1 Kitchen (None Detected)

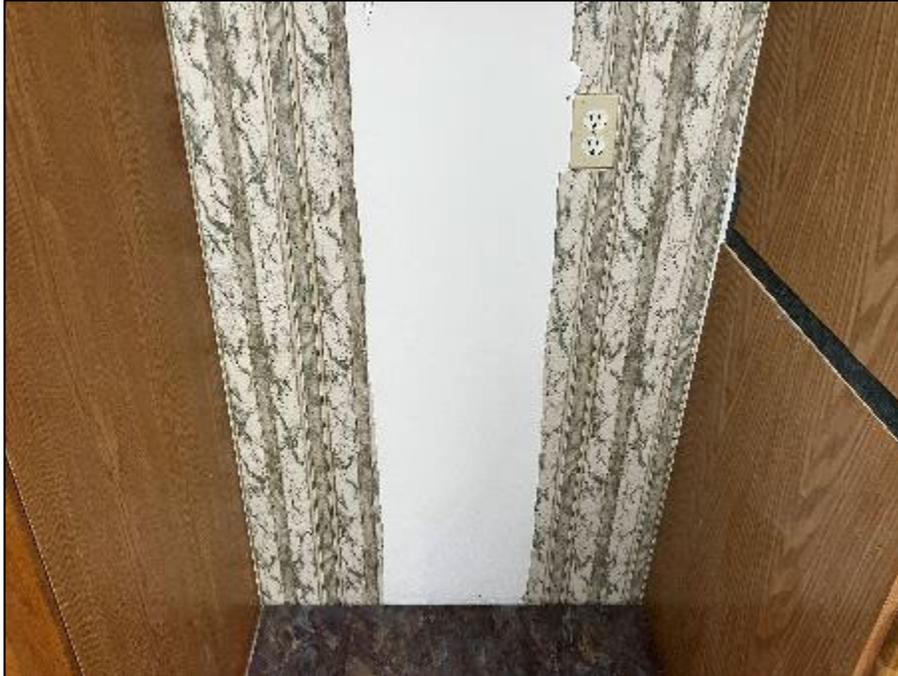
**PHOTOGRAPH #15:** Wall Paper - Level 1 Kitchen (None Detected)

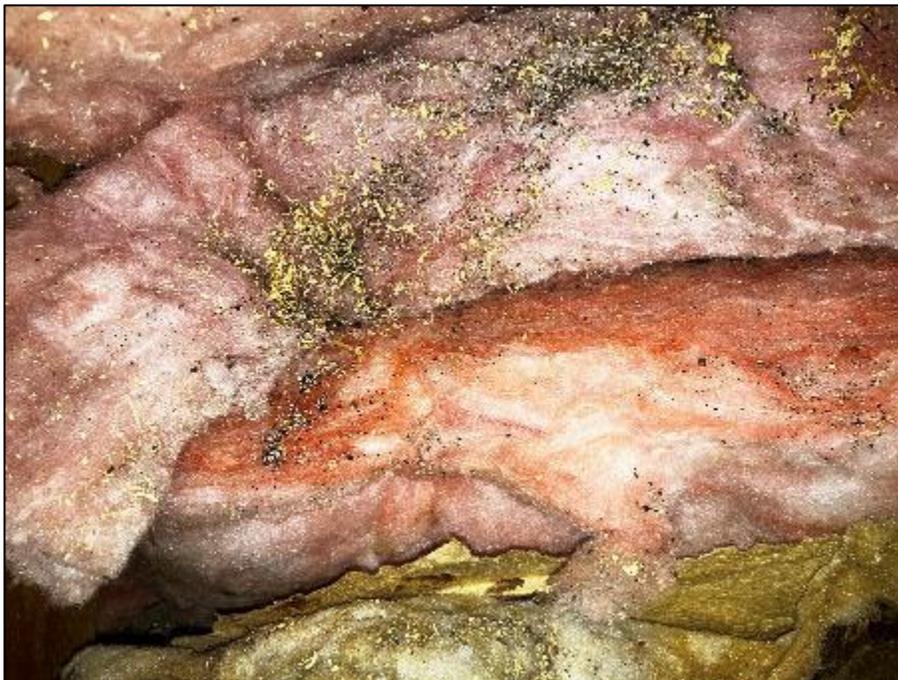
**PHOTOGRAPH #16:** Attic Insulation (None Detected)

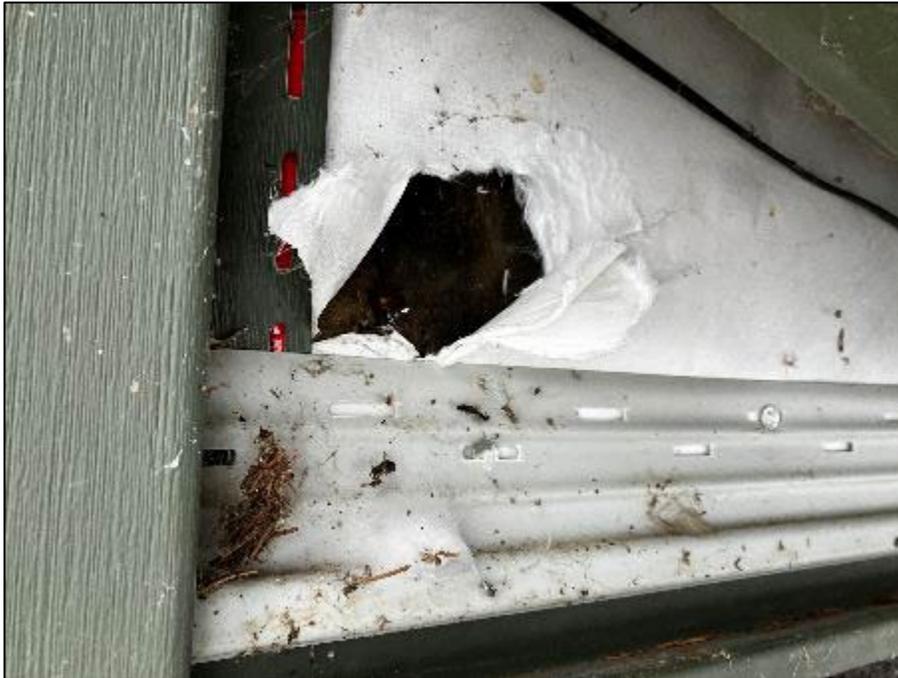
**PHOTOGRAPH #17:** Siding Paper (None Detected)

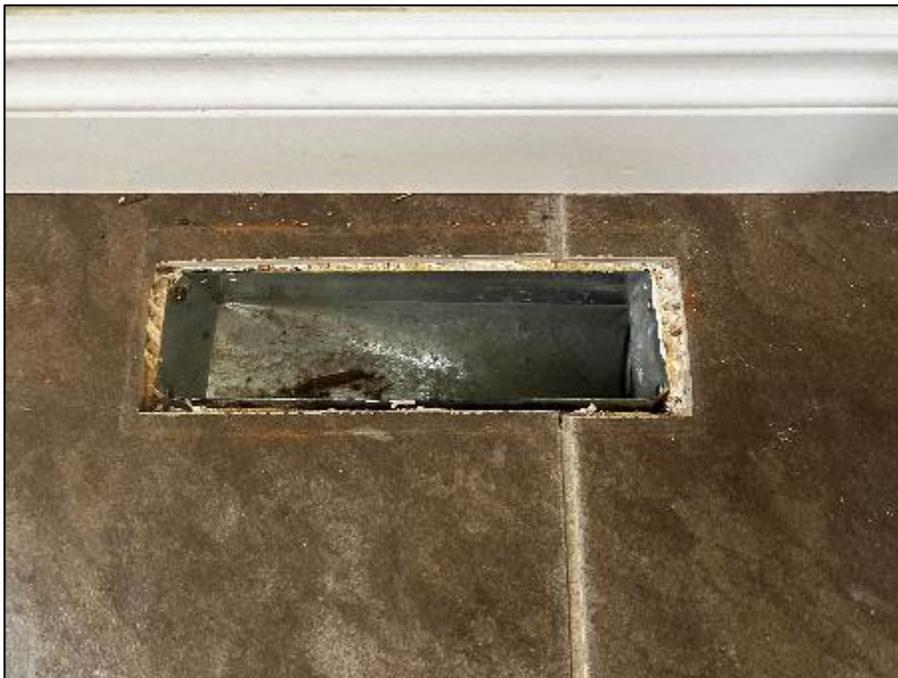
**PHOTOGRAPH #18:** Flooring - Level 1 Foyer (None Detected)

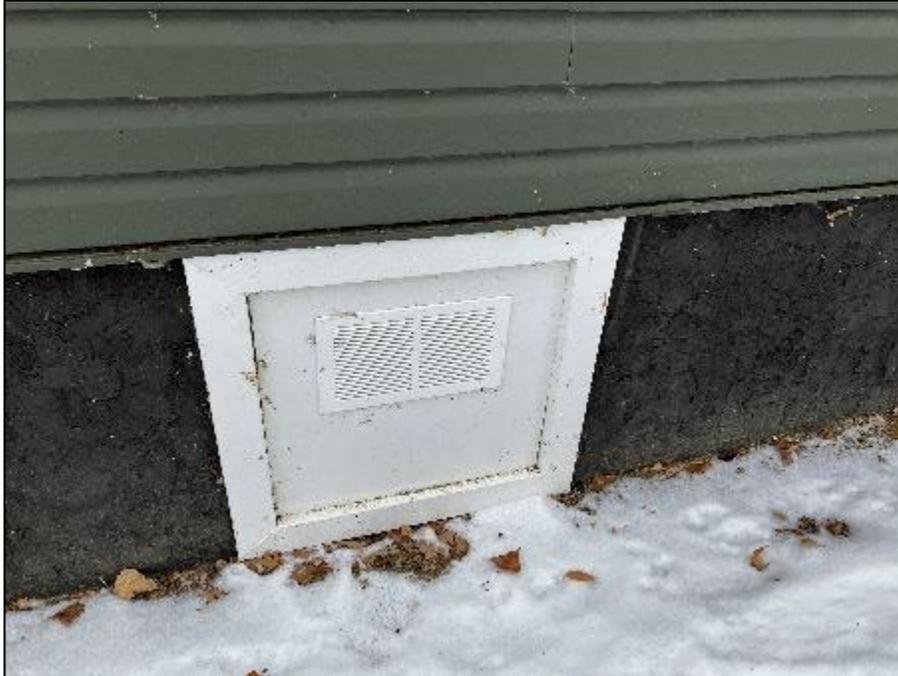
**PHOTOGRAPH #19:** Parging - Back Exterior (None Detected)

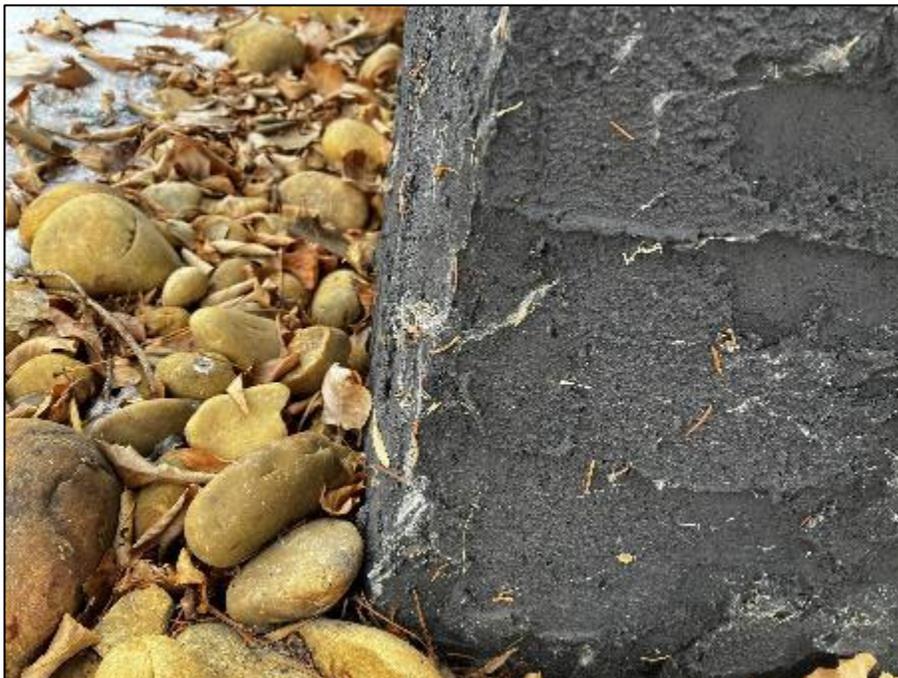
**PHOTOGRAPH #20:** Parging - Front Exterior (None Detected)

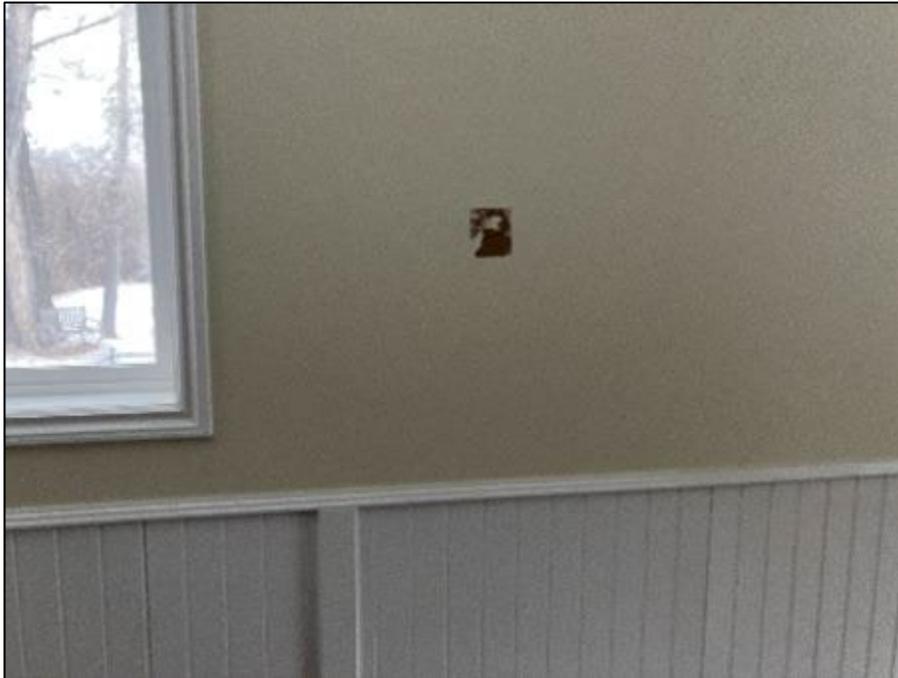
**PHOTOGRAPH #21:** Paint - Level 1 Dining Room Yellow (<80 ppm Lead)

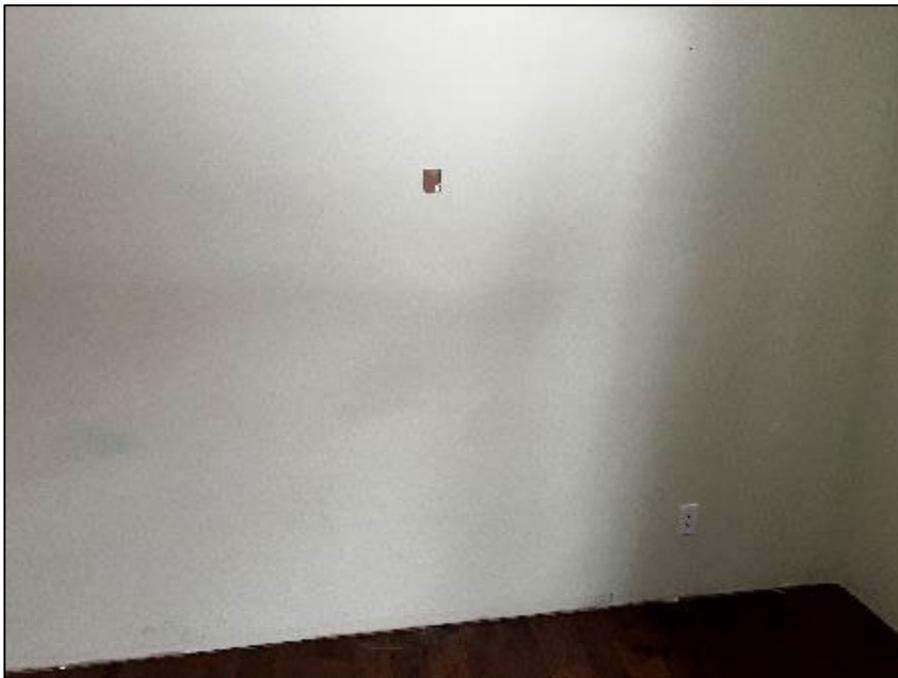
**PHOTOGRAPH #22:** Paint - Level 1 SE Bedroom Pale Green (<80 ppm Lead)

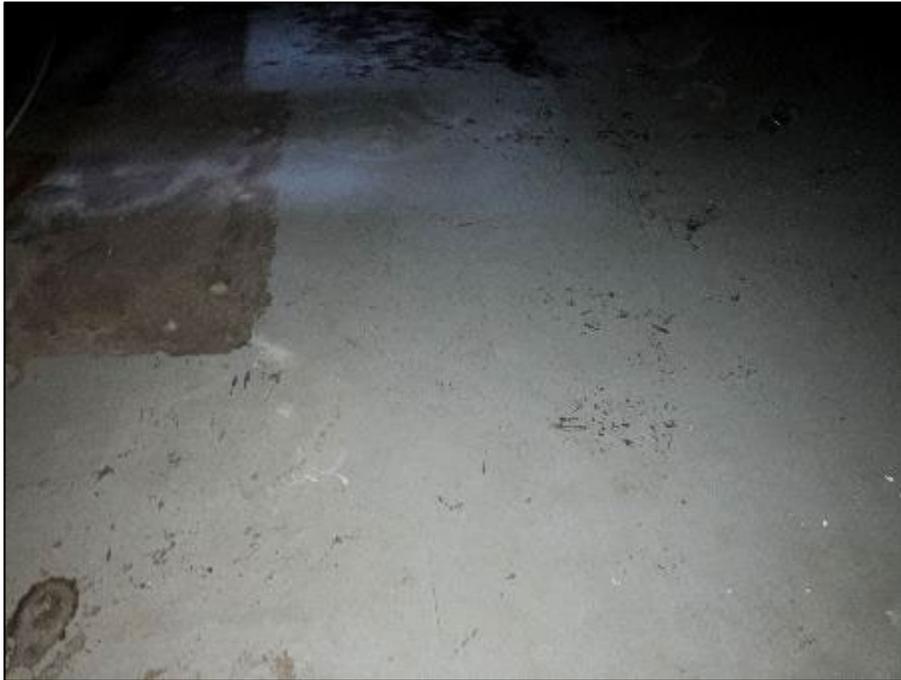
**PHOTOGRAPH #23:** Paint - Basement Floor Grey (<80 ppm Lead)

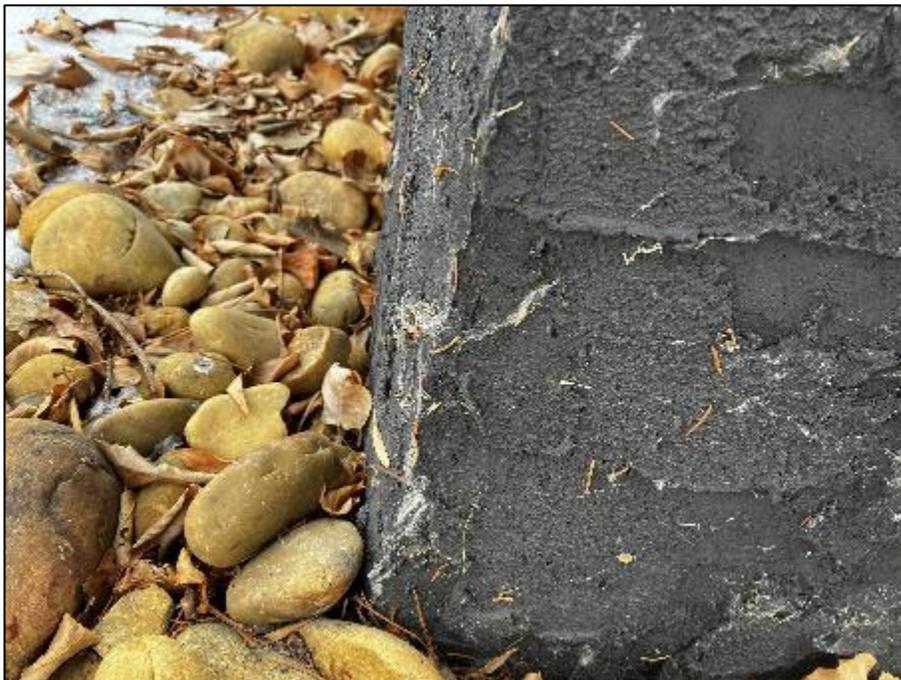
**PHOTOGRAPH #24:** Paint - Parging Exterior (<80 ppm Lead)

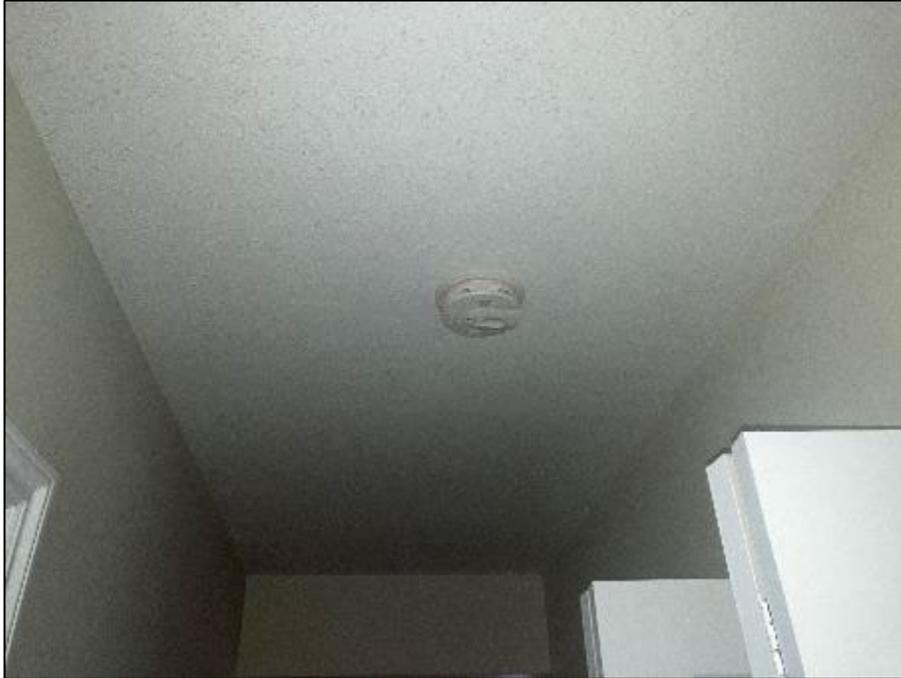
**PHOTOGRAPH #27:** Smoke Detector in Hallway

1. Hazardous components were identified on site and will require appropriate disposal prior to demolition, including: radioactive materials in smoke detectors, ozone depleting substances in air conditioning unit, biological growth and miscellaneous chemicals .
2. Should any new materials be identified throughout the process, work should stop until the materials can be assessed by a qualified health and safety professional.

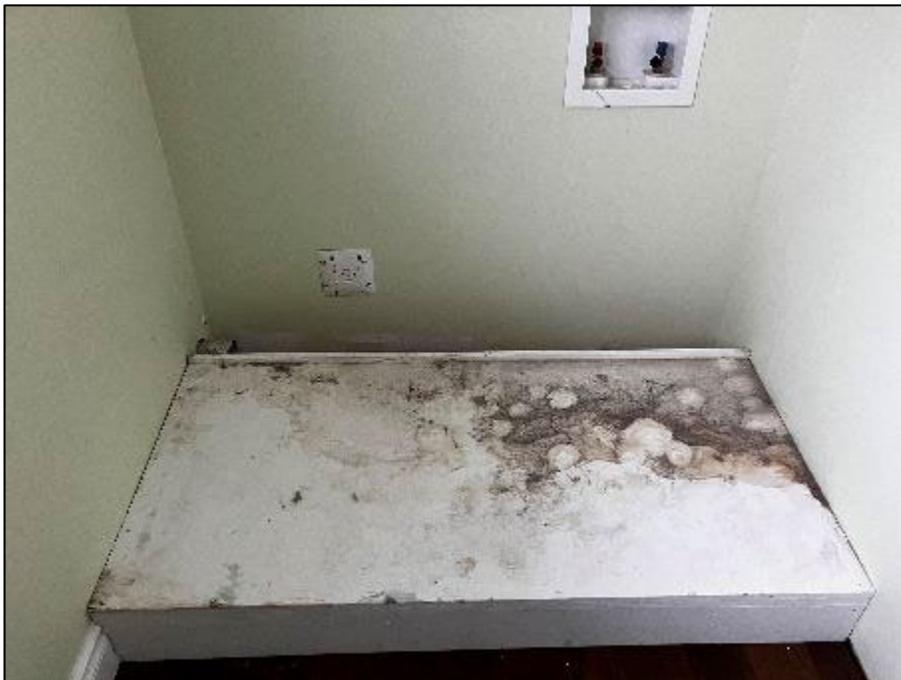
**PHOTOGRAPH #28:** Organic Growth Observed in Laundry Room
