EXPRESSION OF INTEREST #2022-04-05

PROPOSAL: [Flood Mitigation – House Relocation]

3084 Riverview Drive - West Rosedale

3088 Riverview Drive - West Rosedale

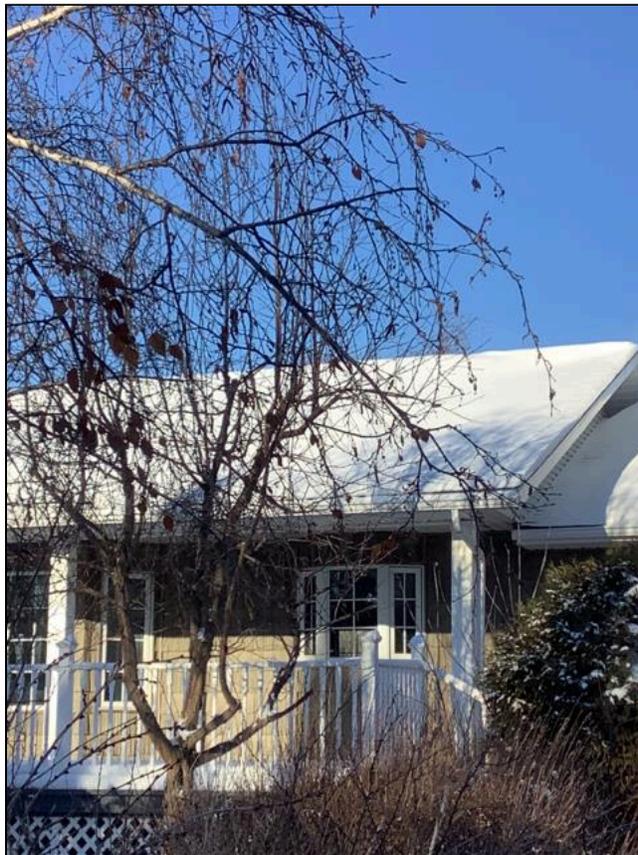
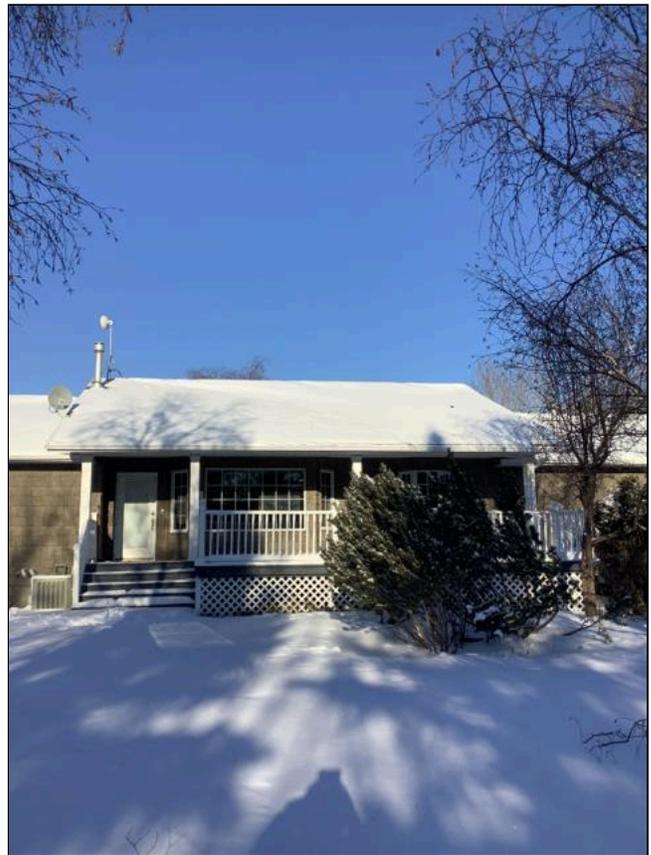
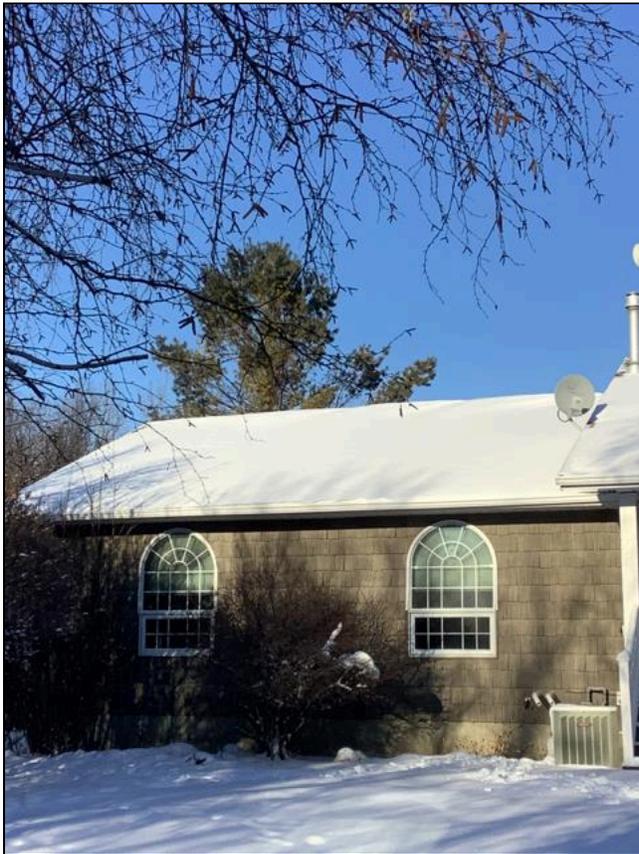
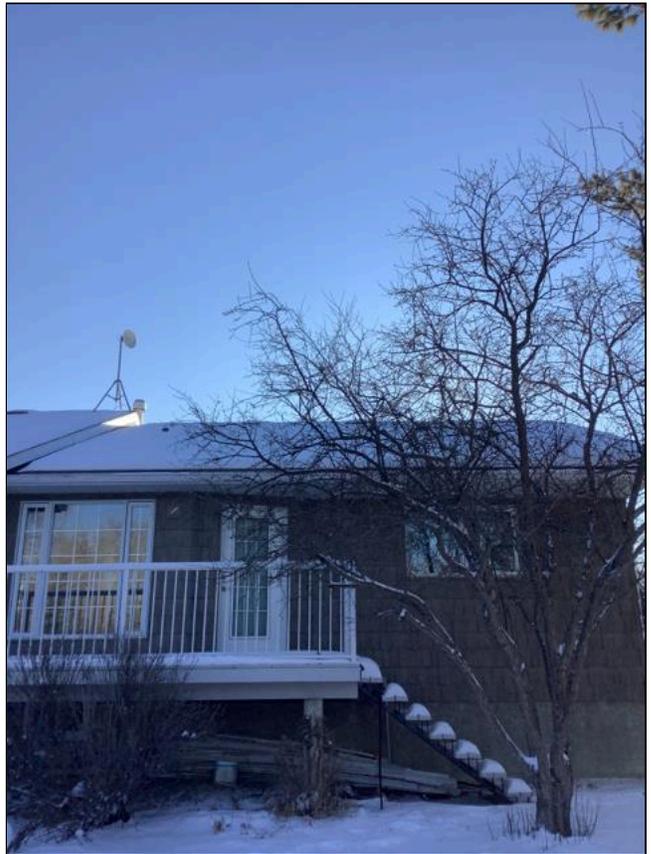
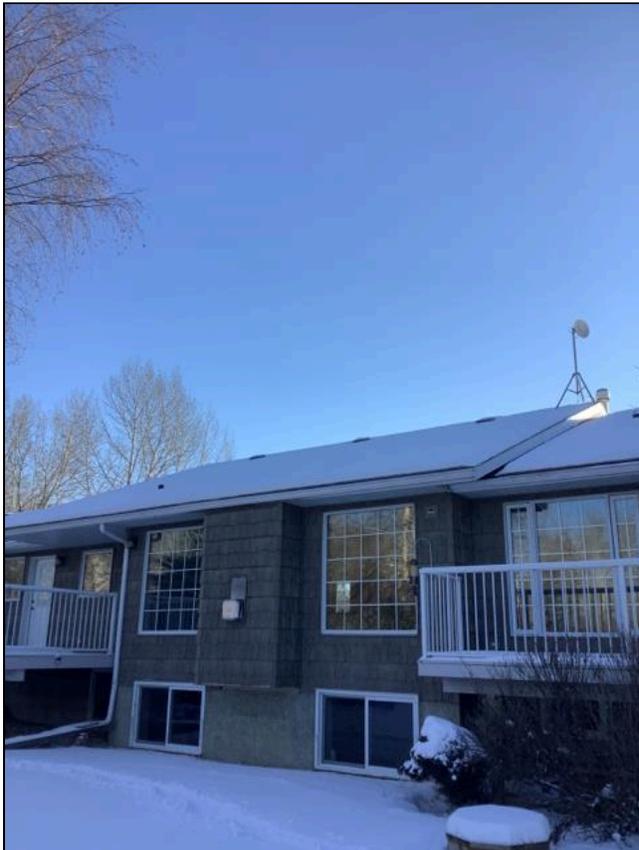
Roof was limited to a visual inspection with the use of binoculars as it was covered in snow, no issues to report from what was seen.

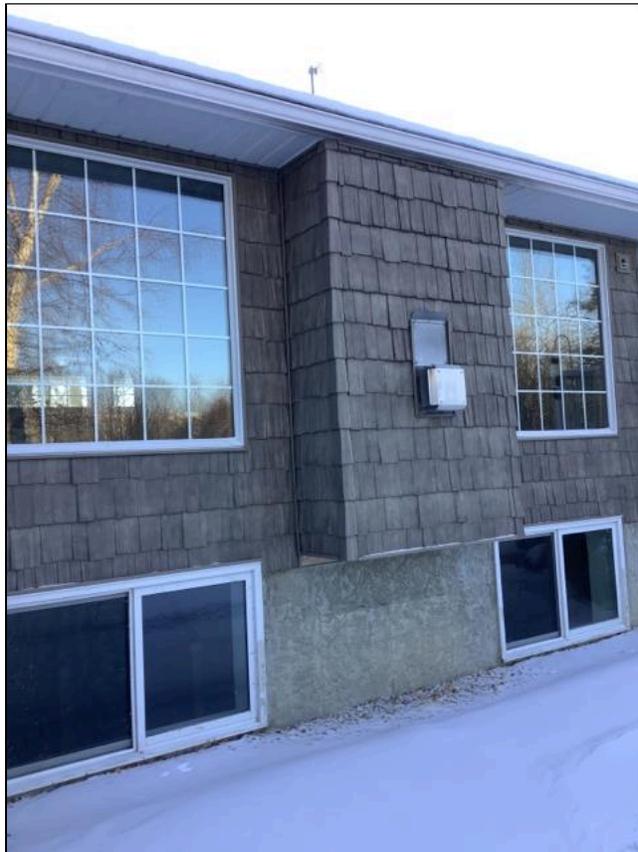
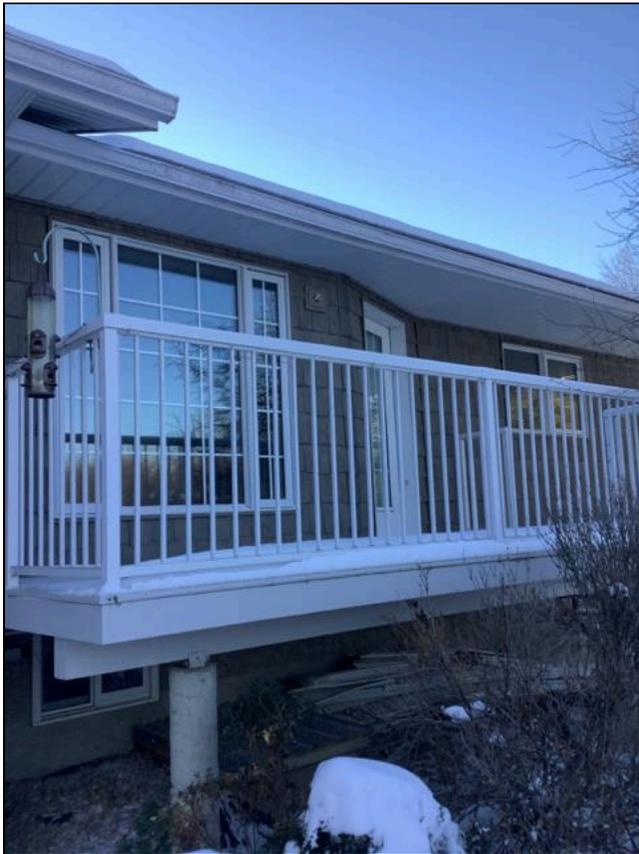
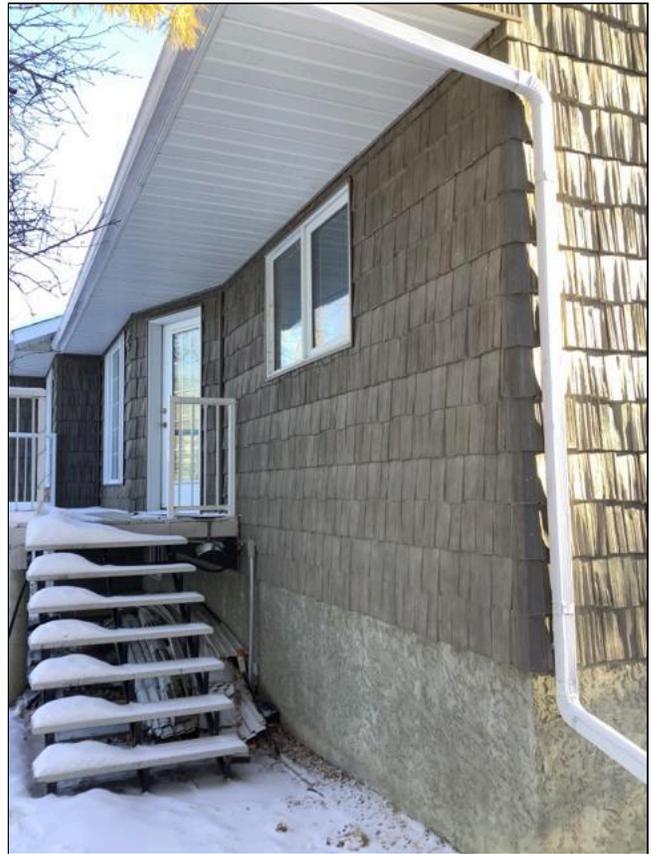
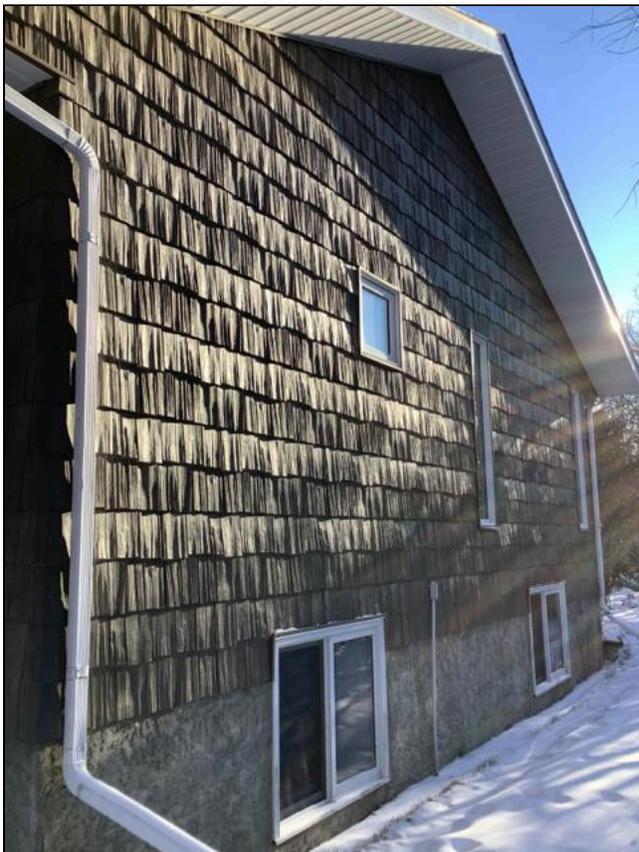
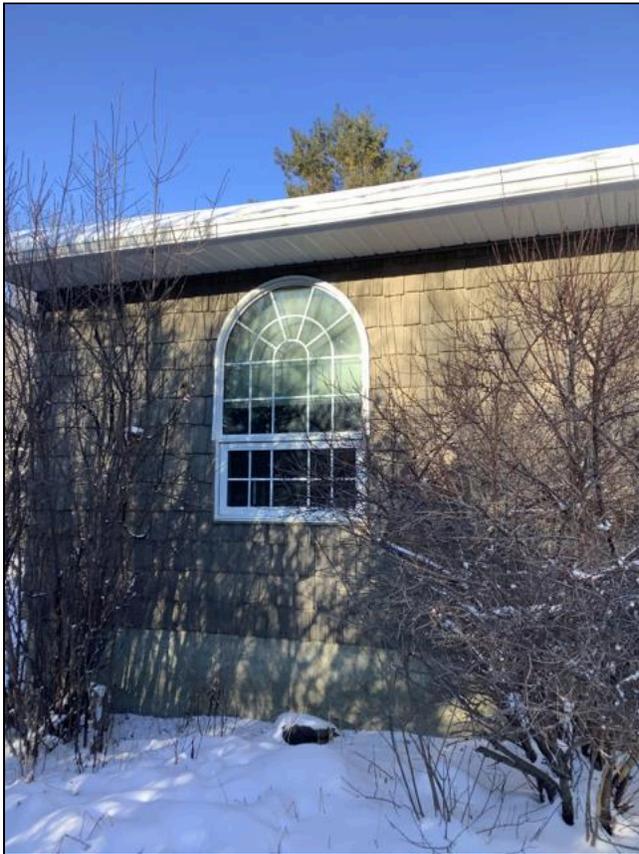
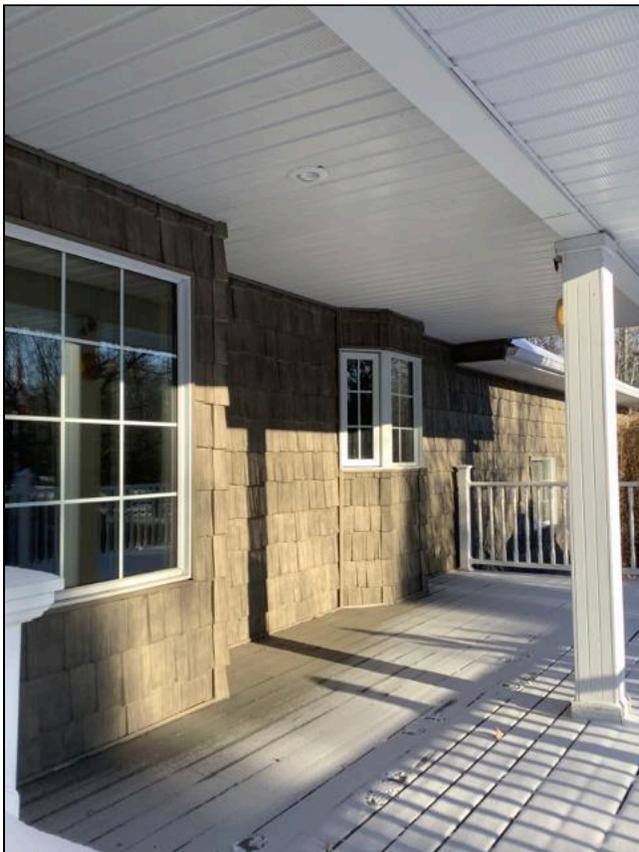
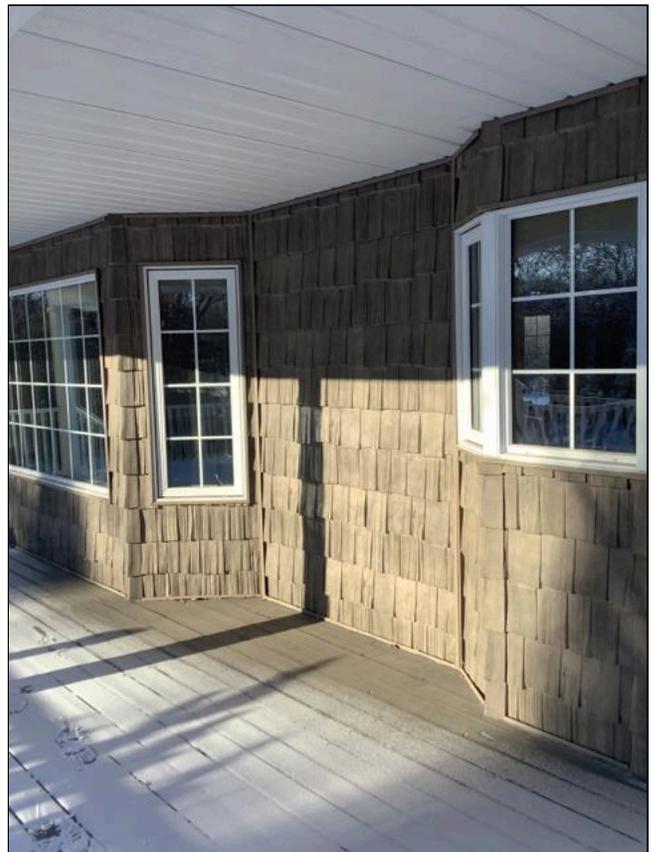
Higher levels of wall clad around the home are only visually inspected from the ground level. No signs of any major concerns.

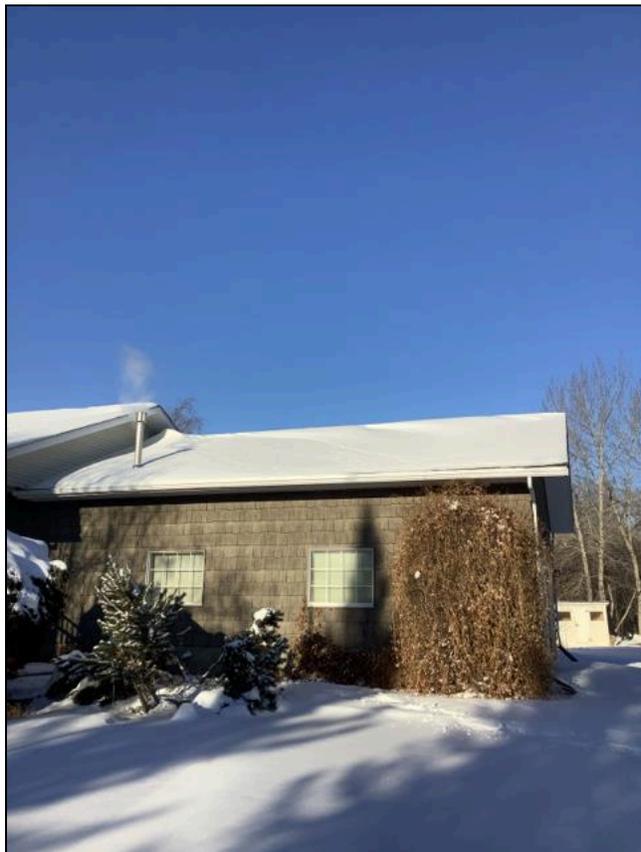
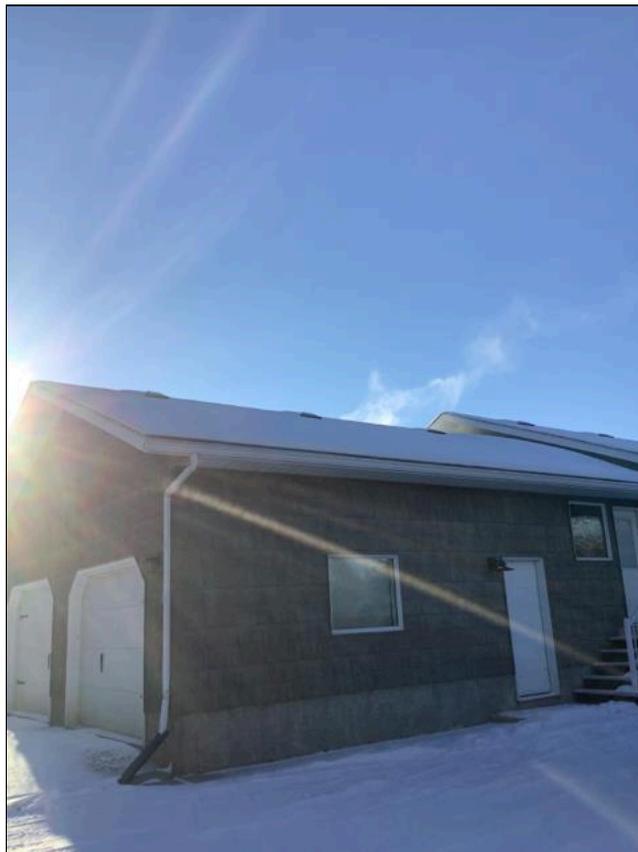
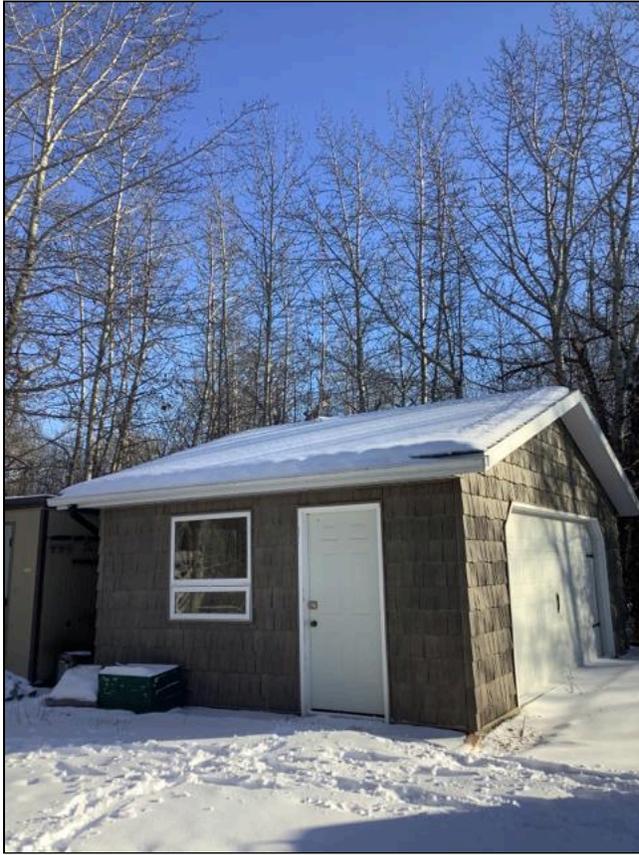
Roof was limited to a visual inspection with the use of binoculars as it was covered in snow, no issues to report from what was seen.

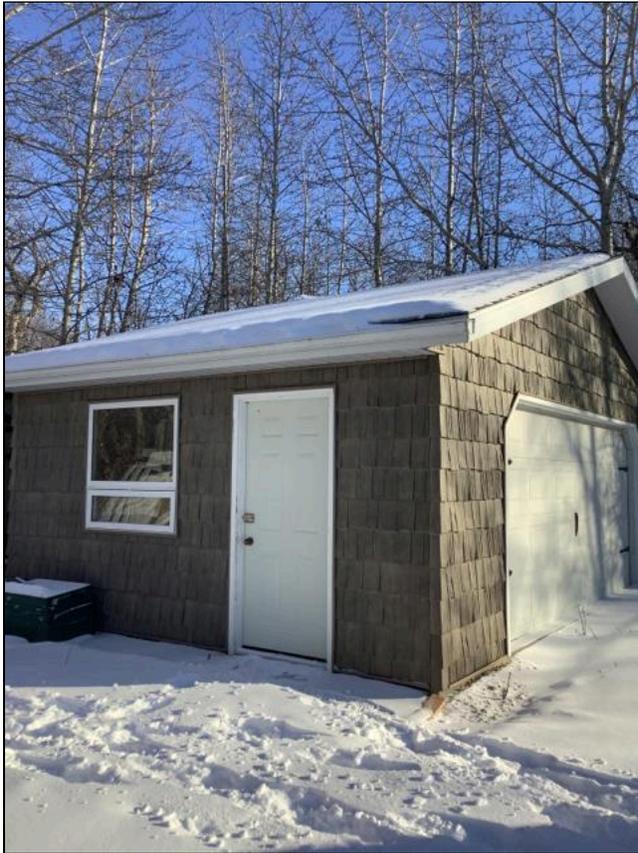
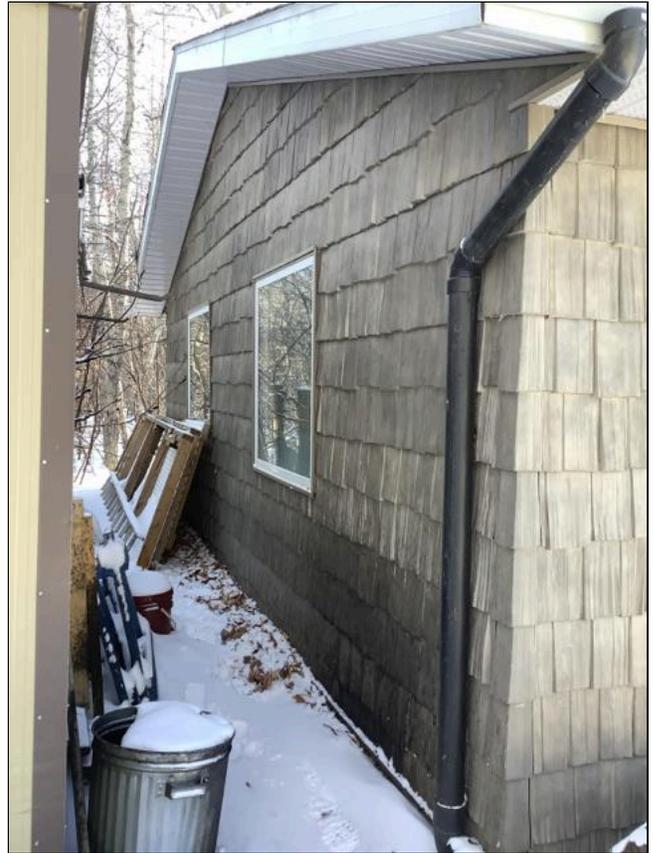
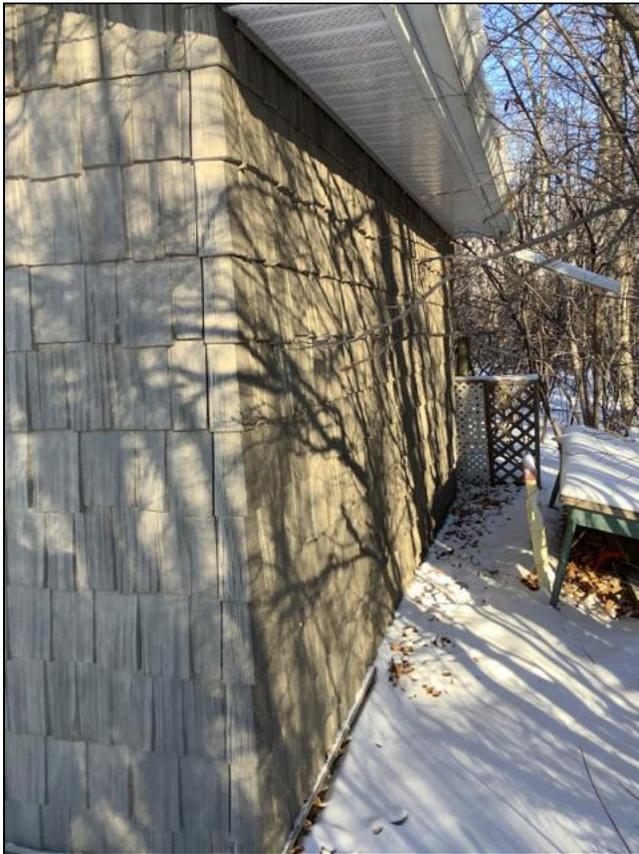
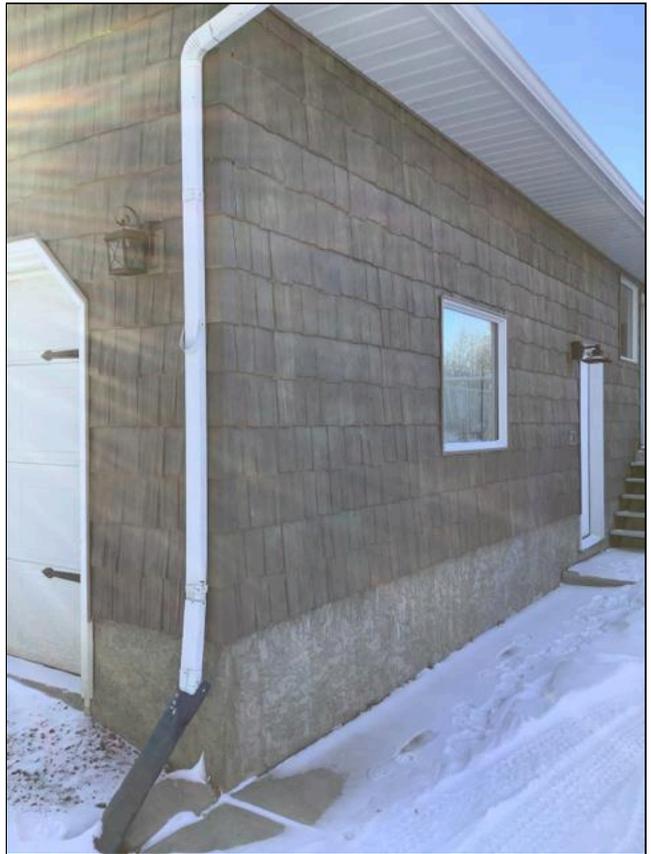
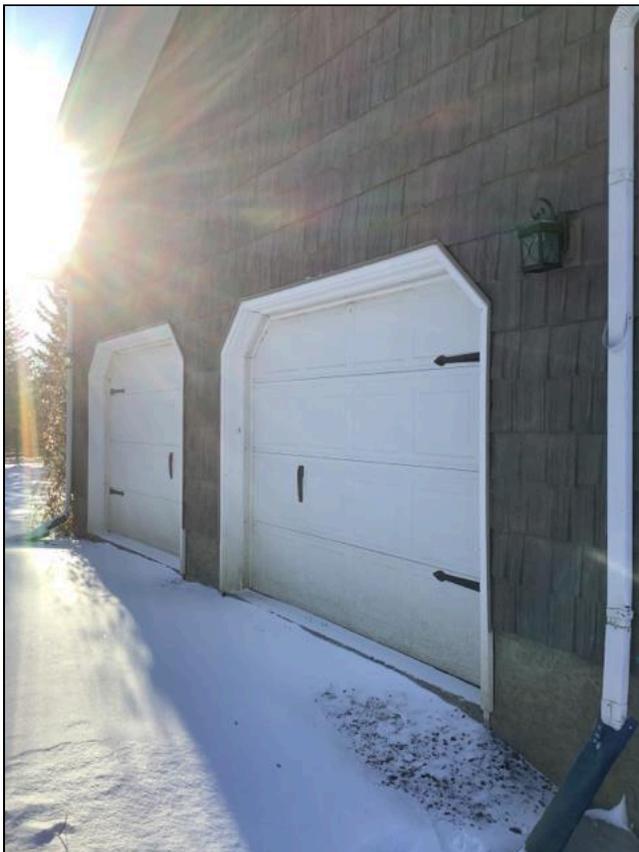
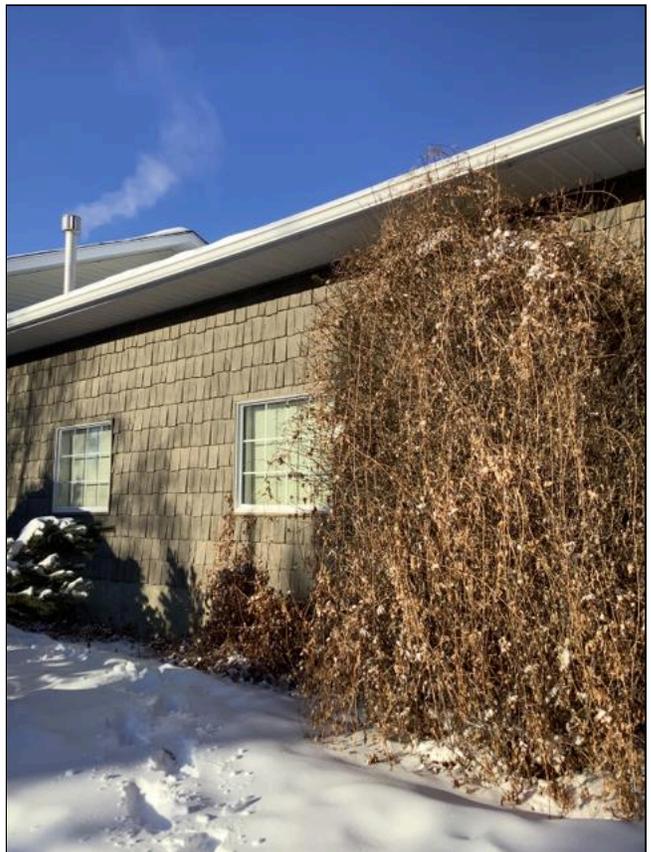
Higher levels of wall clad around the home are only visually inspected from the ground level. No signs of any major concerns.

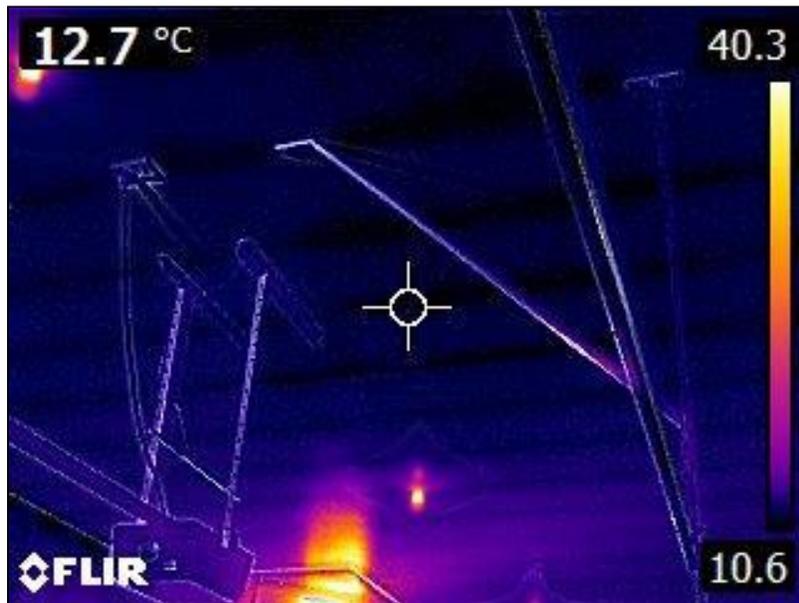
4.5 Item 1(Picture) Garage Ceiling

Dry at time of the inspection, in good shape and condition.

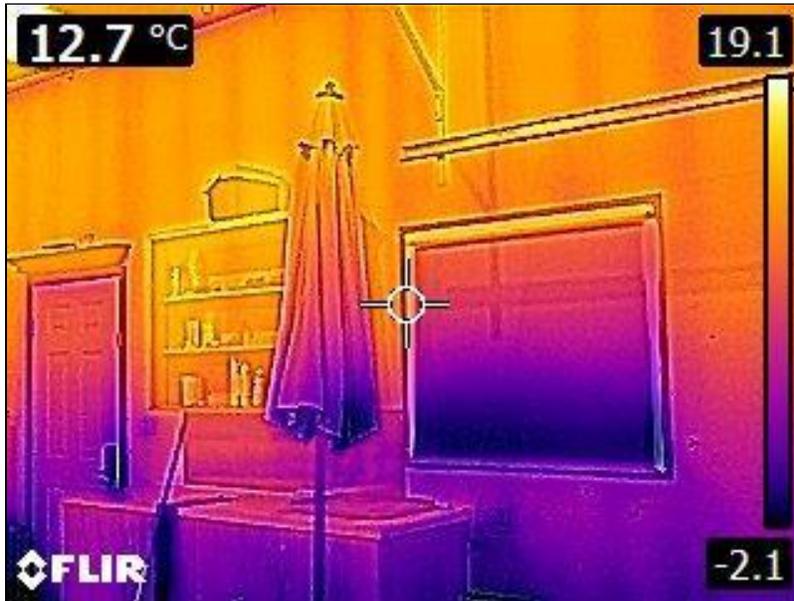
4.6 Item 1(Picture) Garage Firewall

Firewall in good condition- found to be dry, with no holes or damage of note at time of inspection. If damage occurs in the future, repair to maintain the fire rating.

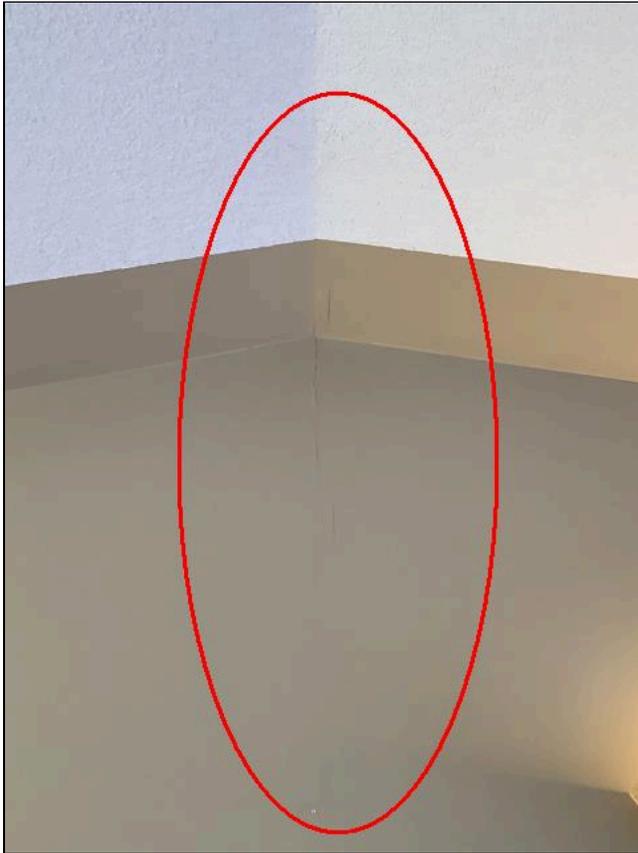
All walls were in good condition and dry at the time of inspection. There was one common stress crack that can be patched at any time and is not a concern.

5.1 Item 1(Picture) Common stress crack

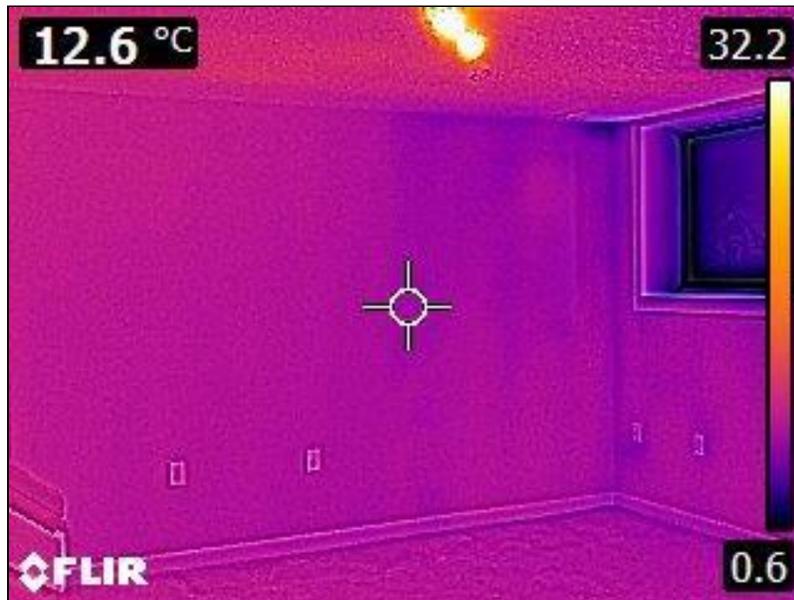
7.1 Item 1(Picture) Basement Walls

Most of the walls and ceilings in the finished basement are covered and structural members are not visible. No obvious problems discovered. I could not see behind these coverings. All accessible walls were in good condition and dry at the time of the inspection. (Cosmetic issues are not part of the inspection.)

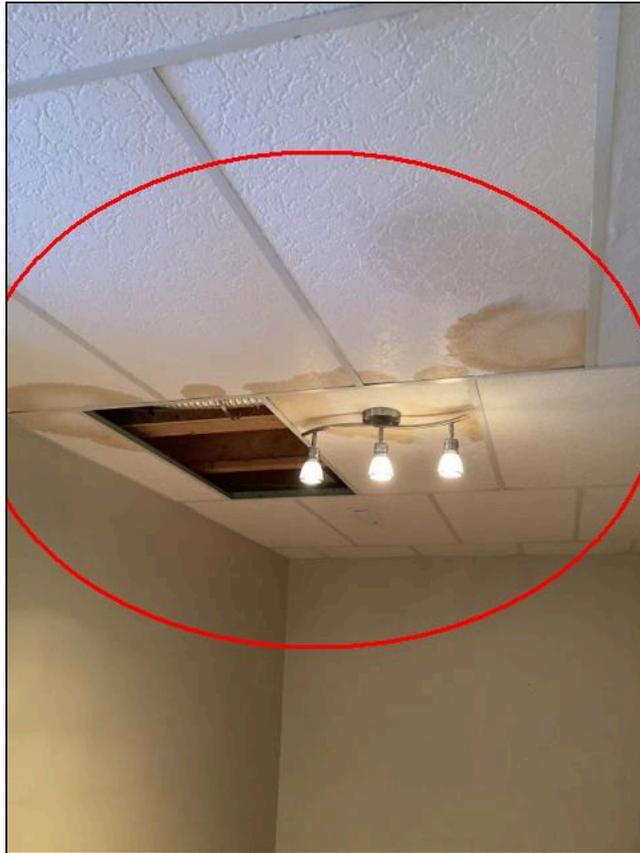
There was a moisture stain on the ceiling in the basement rec room, it was dry at the time of the inspection. No other major concerns.

7.4 Item 1(Picture) Basement Rec Room Ceiling - moisture stain

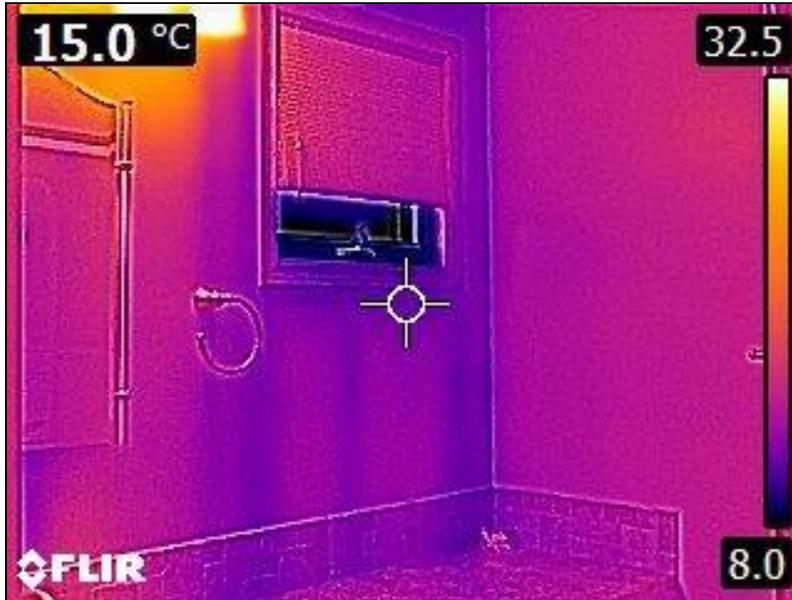
9.0 Item 1(Picture) Bathroom Walls

All bathroom walls and ceiling were in good condition and dry at time of inspection. (Cosmetic issues are not part of the inspection.)

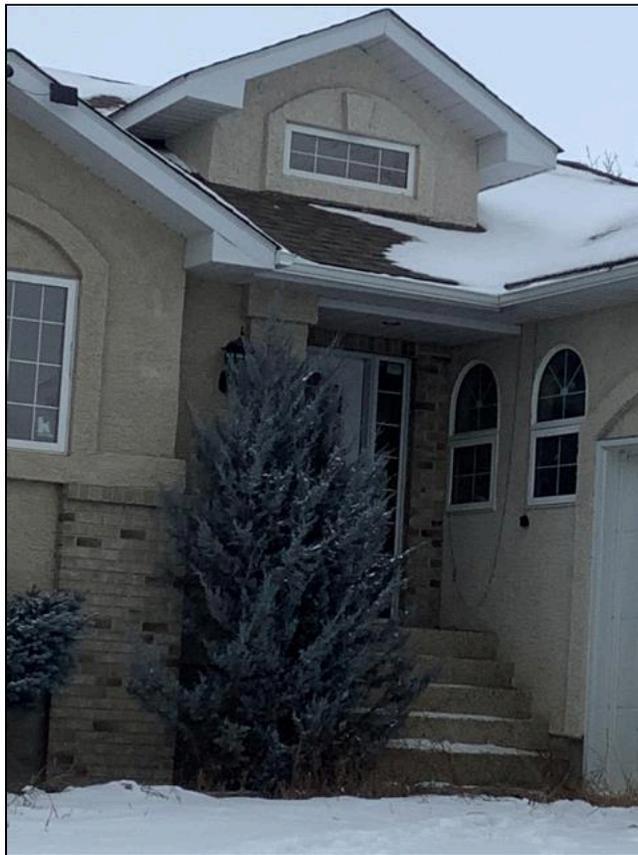
1.0 Item 1(Picture) Roof

Roof was limited to a visual inspection with the use of binoculars as it was covered in snow, no issues to report from what was seen.

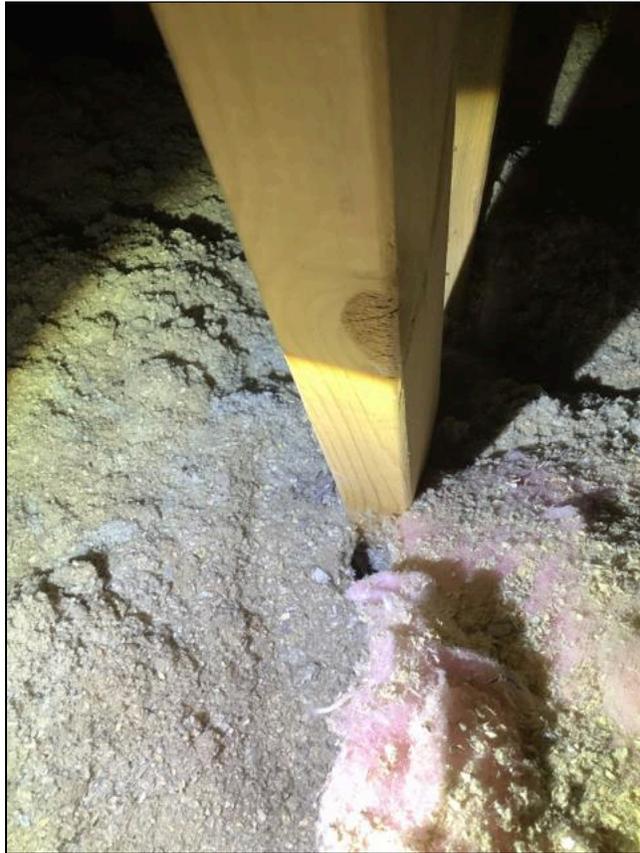
Good amount of insulation in the attic during the inspection but had signs of tunneling from rodents, recommend that a pest specialist further review and remove as required.

2.4 Item 1(Picture) Attic Insulation - signs of tunneling from rodents

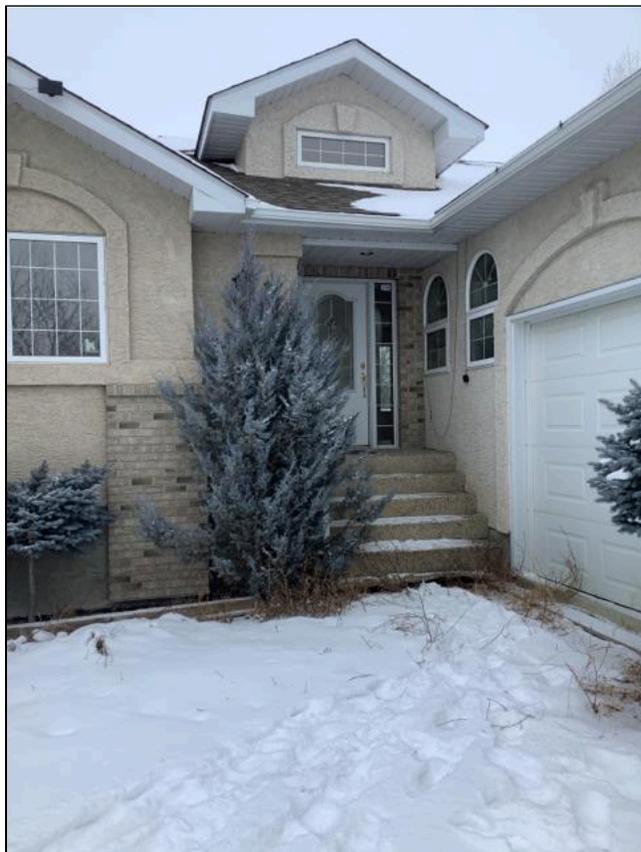
3.1 Item 1(Picture) Exterior

Cracks in stucco - It is the nature of stucco to experience some cracking. Small stucco cracks are normal and do not require any maintenance or repair. If a crack exceeds 1/8 inch in width then the crack should be repaired. Repairing of stucco cracks is made by adding a small amount of stucco to the crack. Do not put caulking into cracks. If you experience cracks that are over 1/8 inch in width, you should contact a contractor so that the proper resolution can be determined, in order to protect the structure.

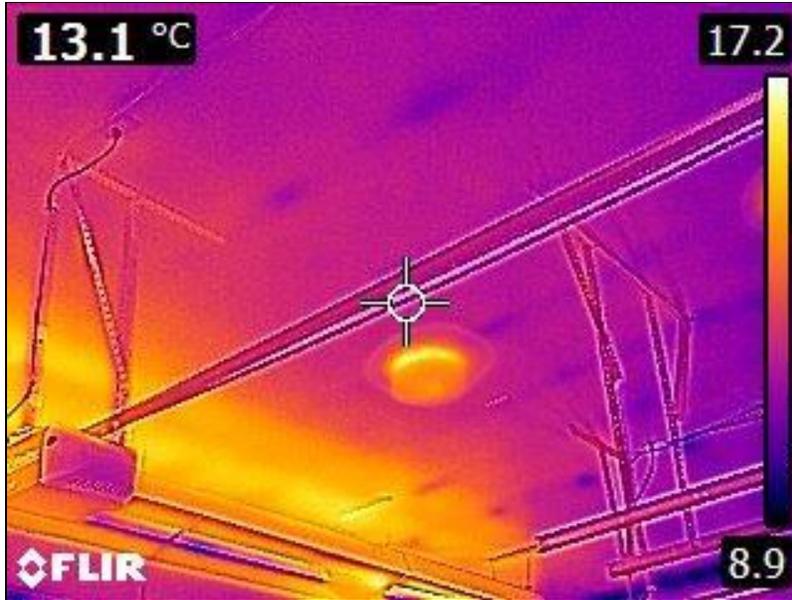
4.5 Item 1(Picture) Garage Ceiling

Dry at time of the inspection, in good shape and condition.

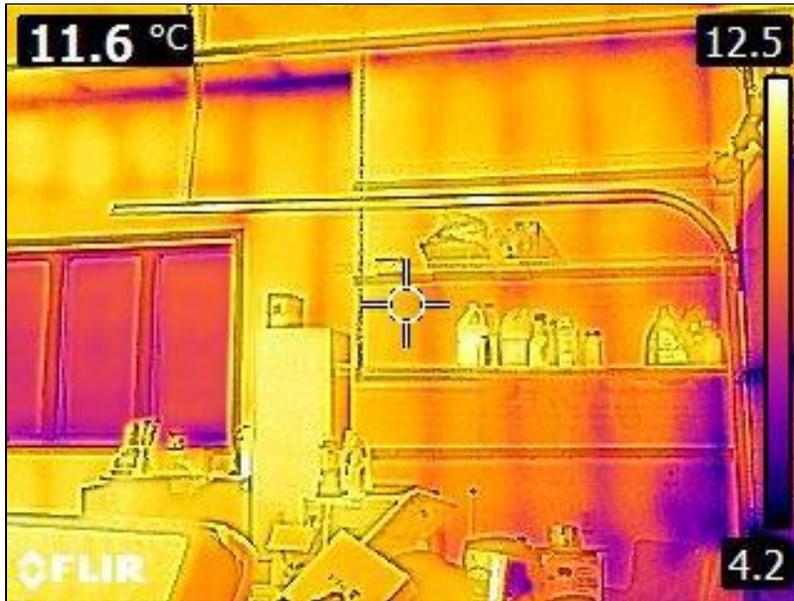
4.6 Item 1(Picture) Garage Firewall

Firewall in good condition- found to be dry, with no holes or damage of note at time of inspection. If damage occurs in the future, repair to maintain the fire rating.

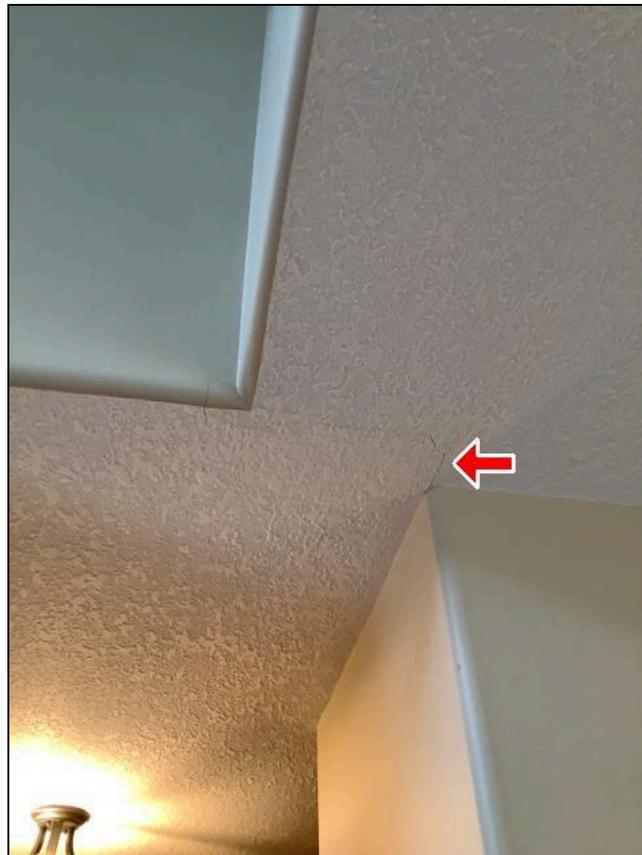
All ceilings were in good condition and dry at time of inspection. There was one settlement crack that is not a concern.

5.0 Item 1(Picture) Ceiling - settlement crack

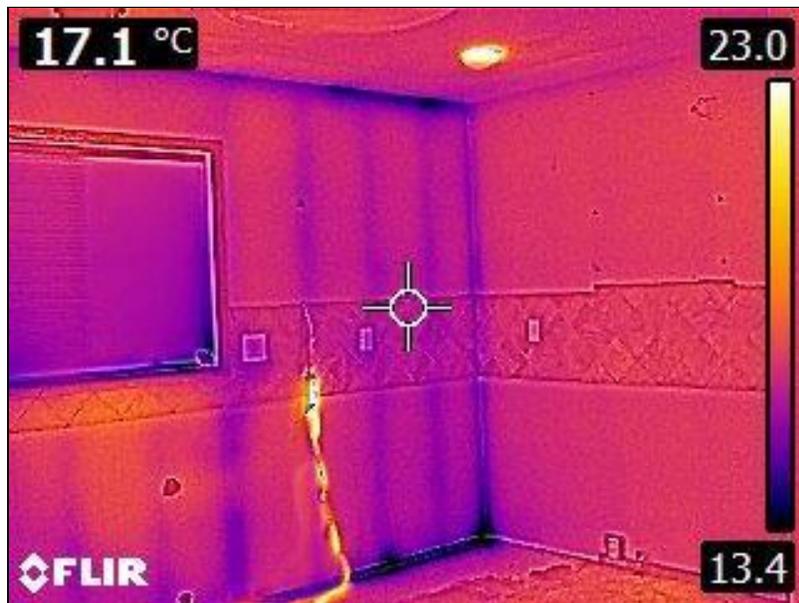
5.1 Item 1(Picture) Interior Walls

All walls were in good condition and dry at the time of inspection.

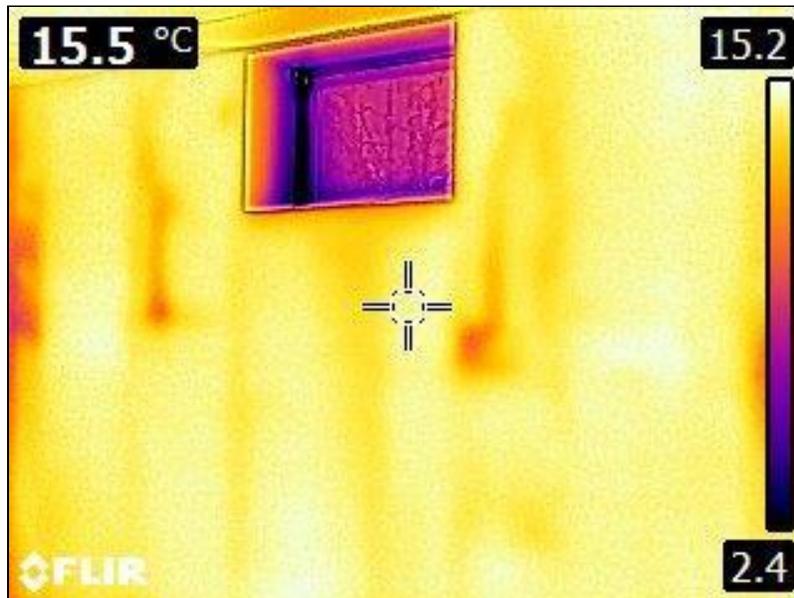
7.1 Item 1(Picture) Basement Walls

Most of the walls and ceilings in the finished basement are covered and structural members are not visible. No obvious problems discovered. I could not see behind these coverings. All accessible walls were in good condition and dry at the time of the inspection. (Cosmetic issues are not part of the inspection.)

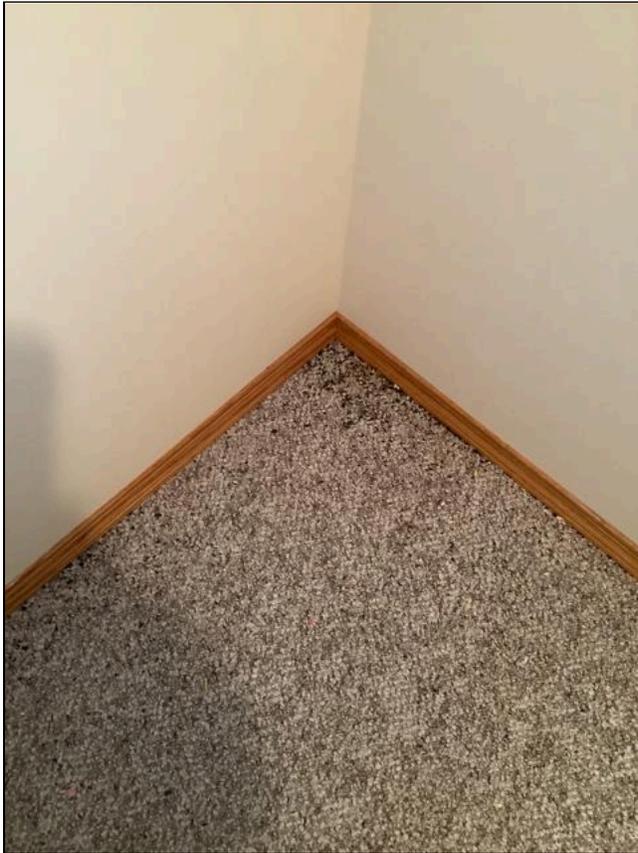
The basement had lots of signs of rodent droppings throughout, recommend that a pest specialist further review and remove as required.

7.3 Item 1(Picture) Basement - signs of rodent droppings

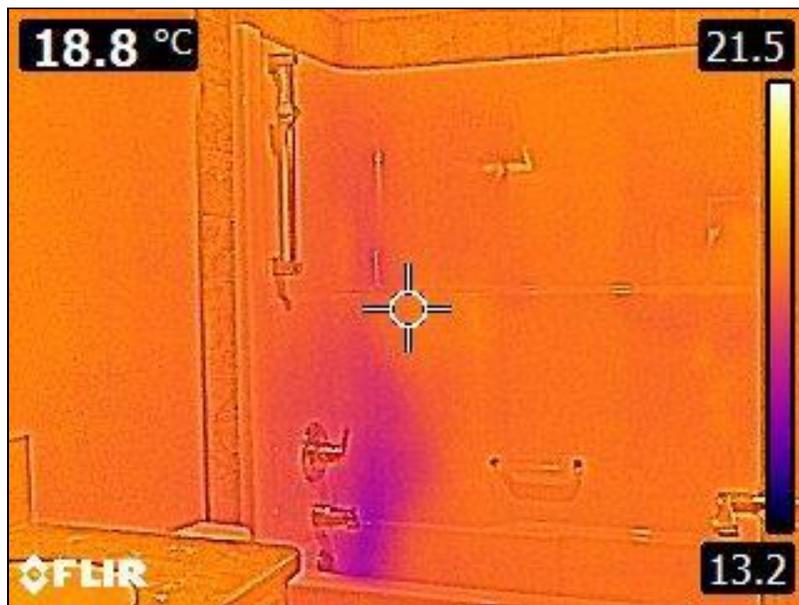
9.0 Item 1(Picture) Bathroom Walls

All bathroom walls and ceiling were in good condition and dry at time of inspection.

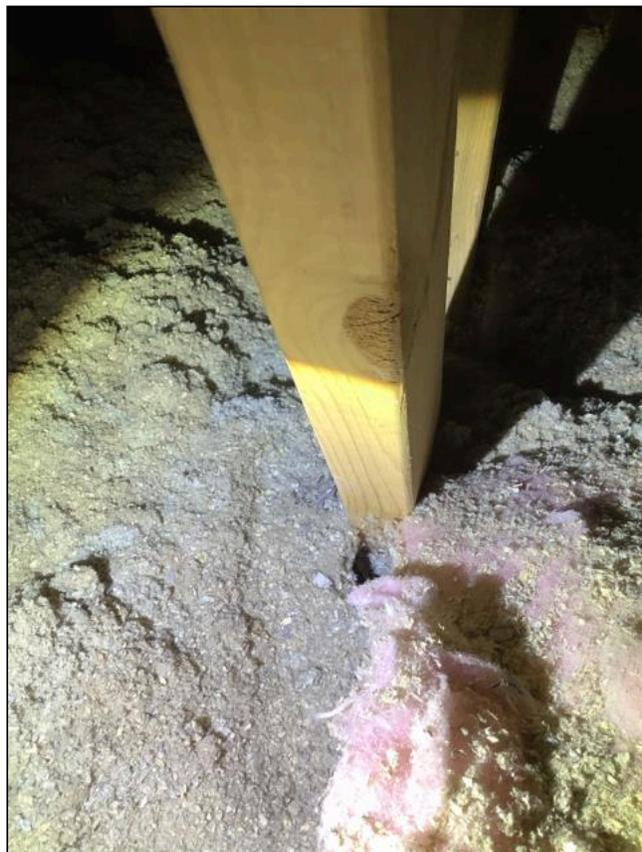
Good amount of insulation in the attic during the inspection but had signs of tunneling from rodents, recommend that a pest specialist further review and remove as required.

2.4 Item 1(Picture) Attic Insulation - signs of tunneling from rodents

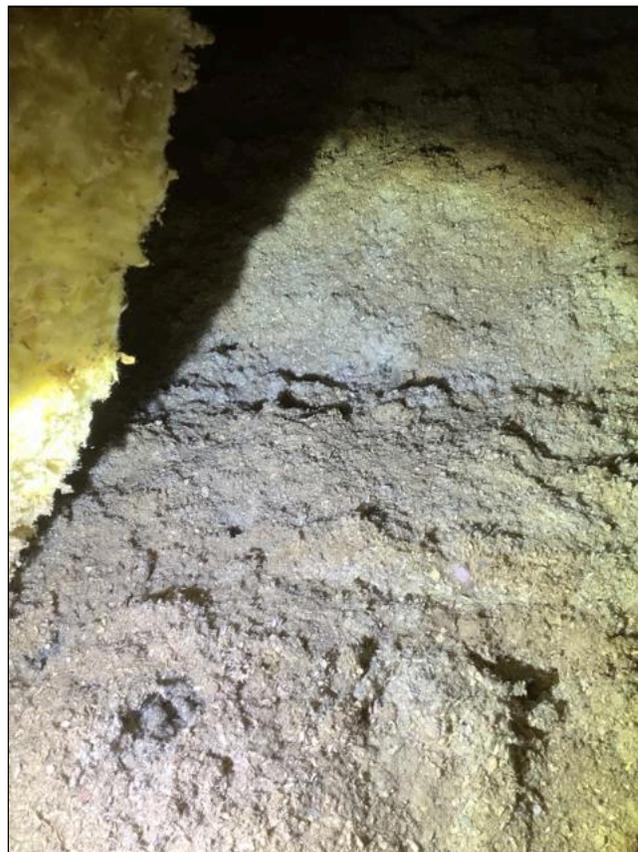
2.4 Item 2(Picture) Attic Insulation - signs of tunneling from rodents

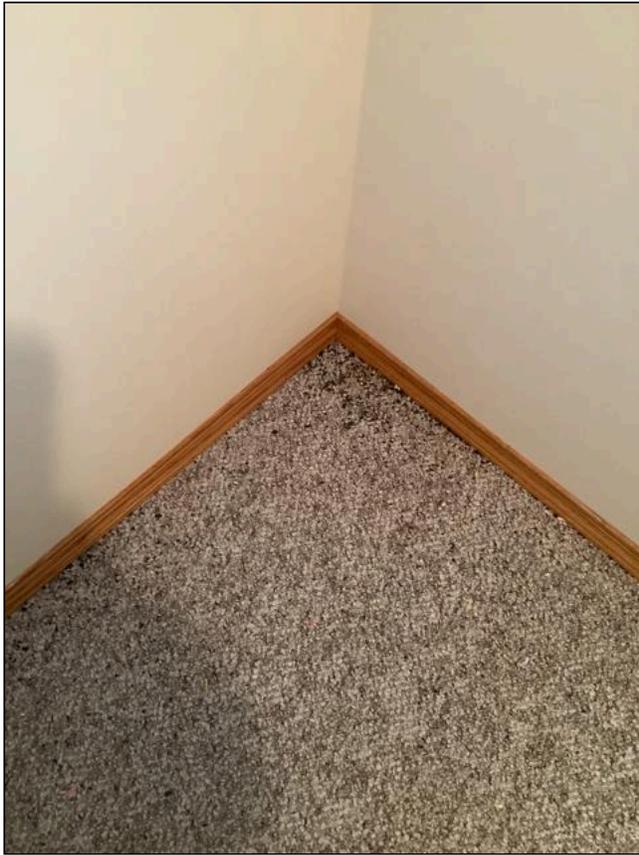
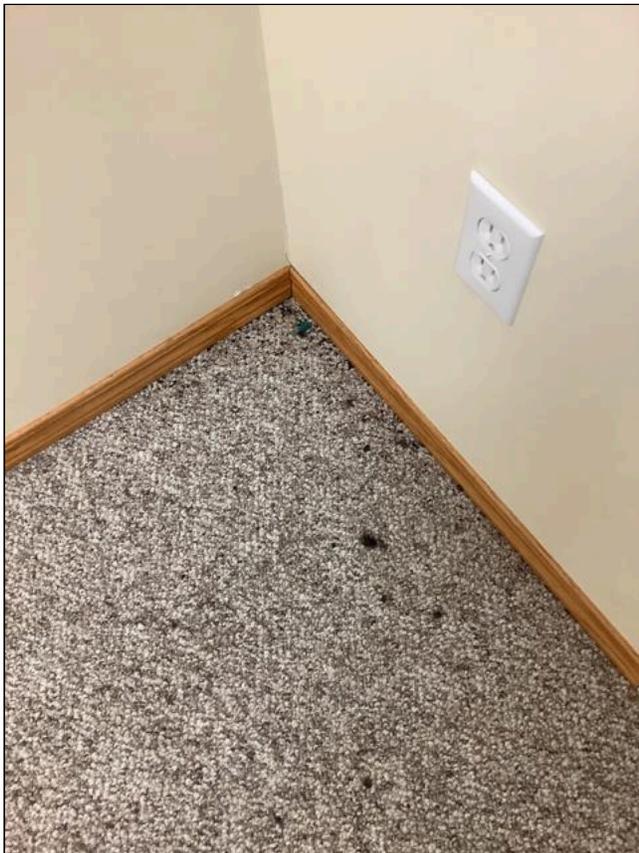
The basement had lots of signs of rodent droppings throughout, recommend that a pest specialist further review and remove as required.

7.3 Item 1(Picture) Basement - signs of rodent droppings

7.3 Item 3(Picture) Basement - signs of rodent droppings
