EXPRESSION OF INTEREST #2022-04-05

PROPOSAL: [Flood Mitigation – House Relocation]

3084 Riverview Drive - West Rosedale

3088 Riverview Drive - West Rosedale

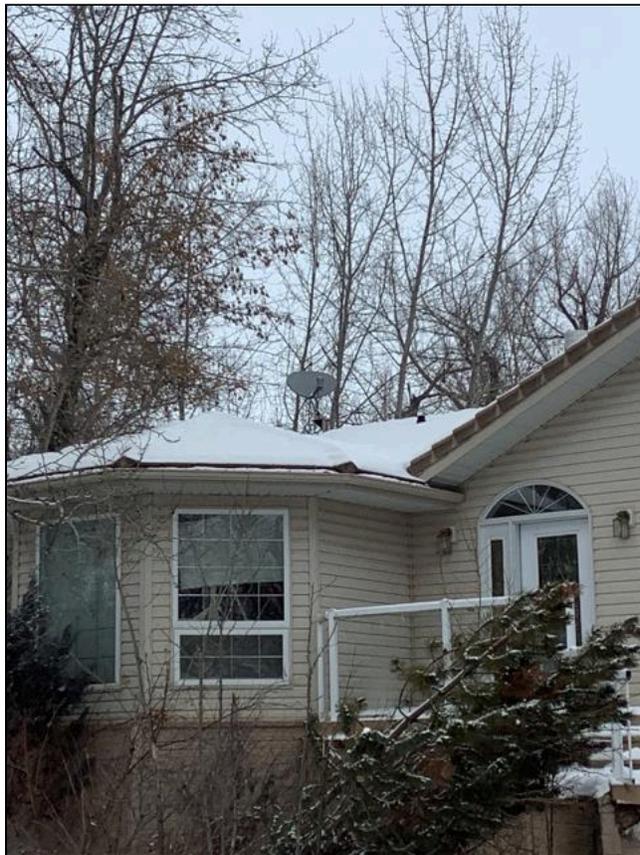
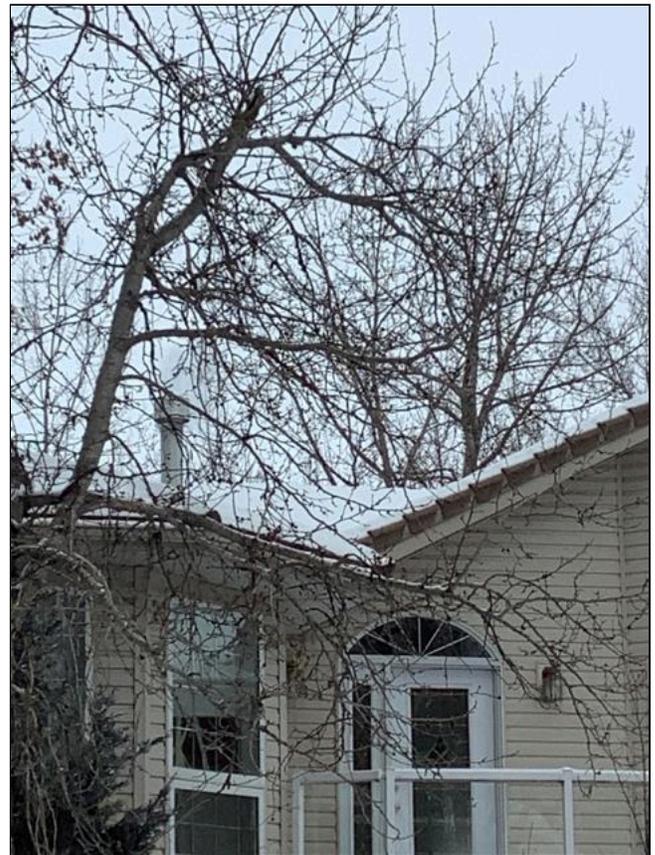
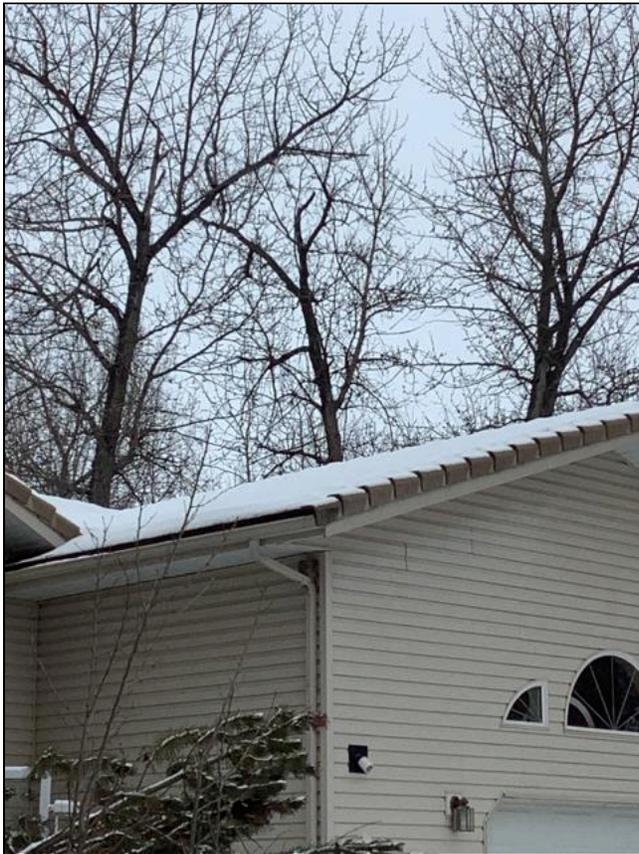
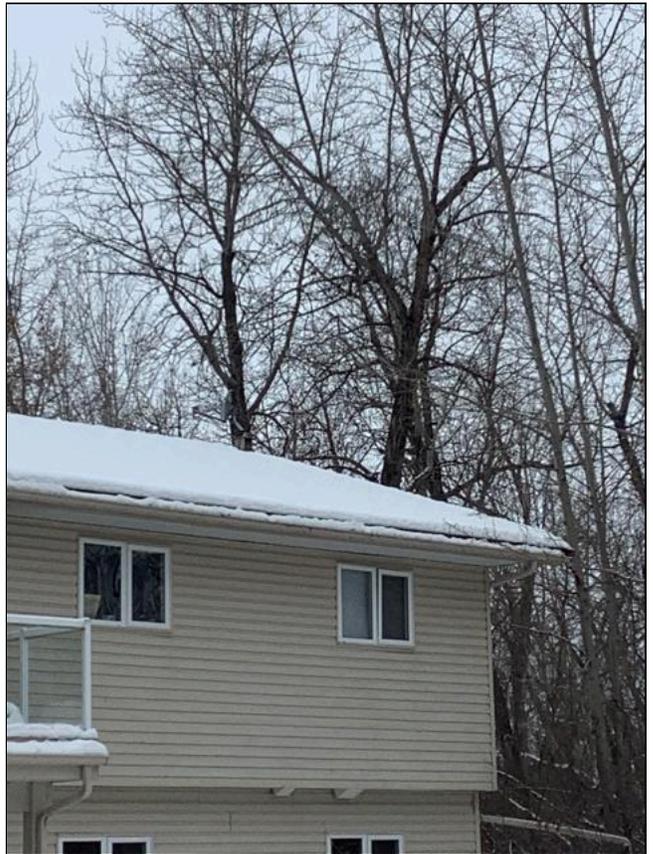
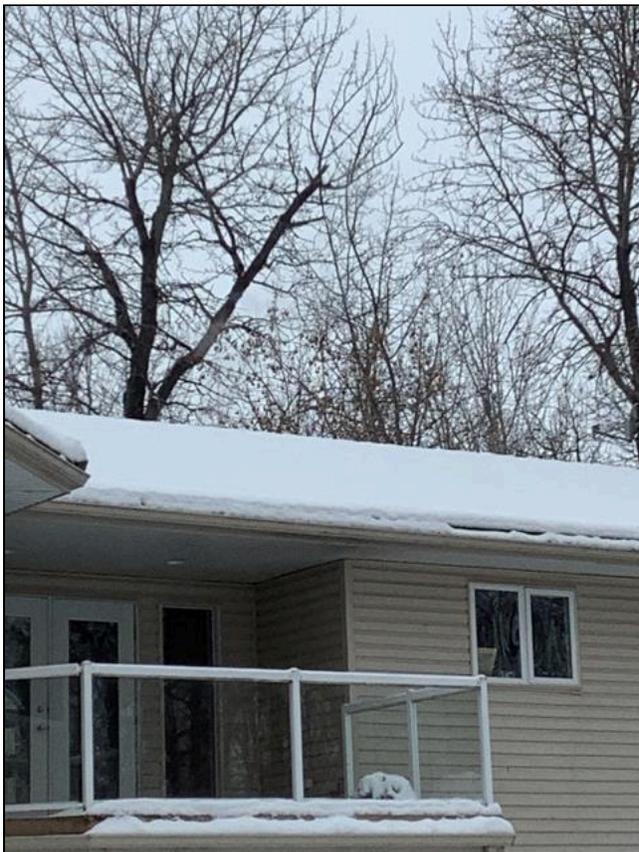
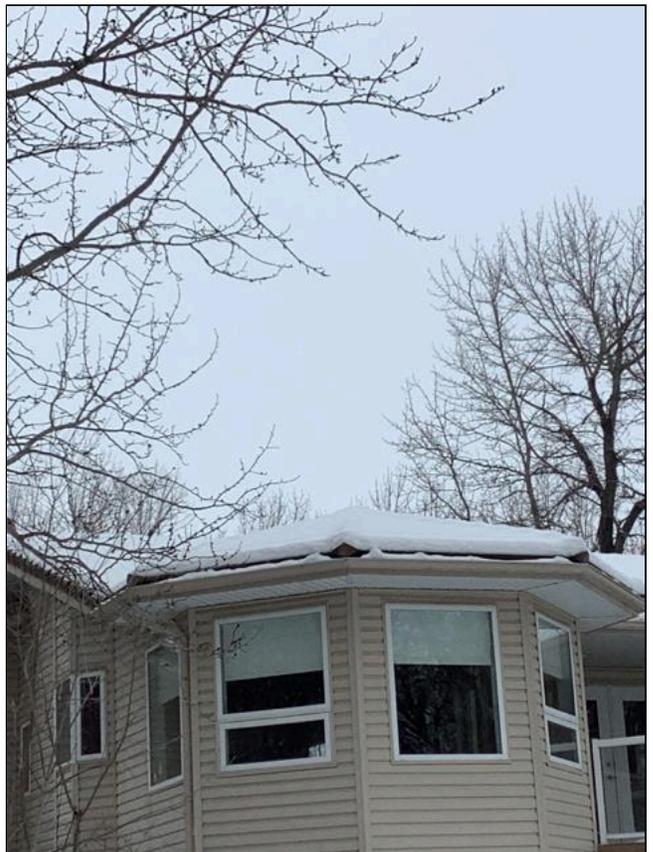
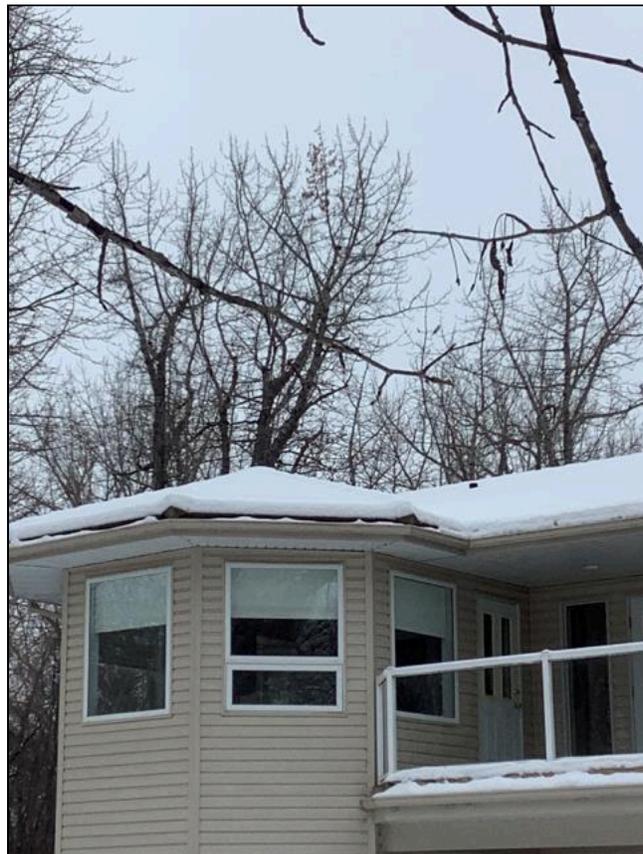
Roof was limited to a visual inspection with the use of binoculars as it was covered in snow, no issues to report from what was seen.

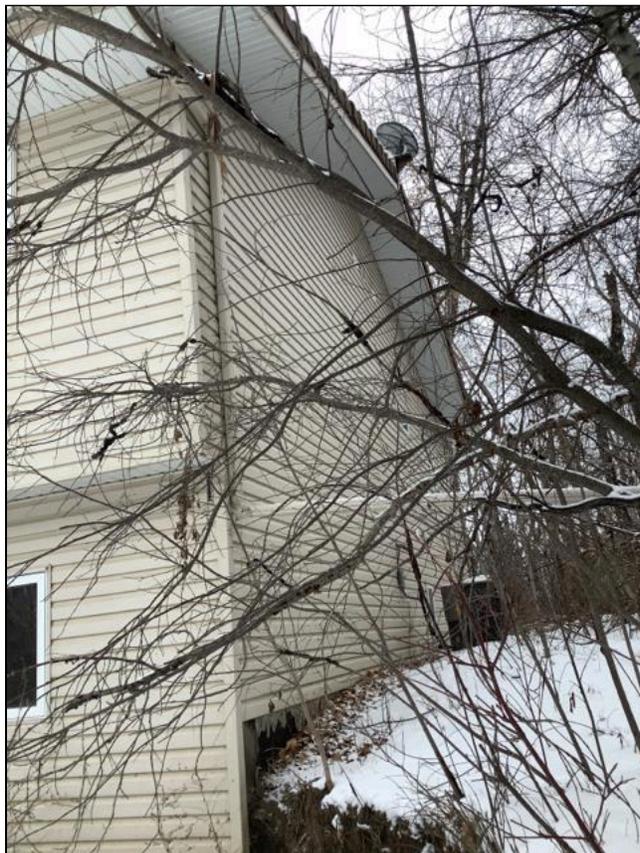
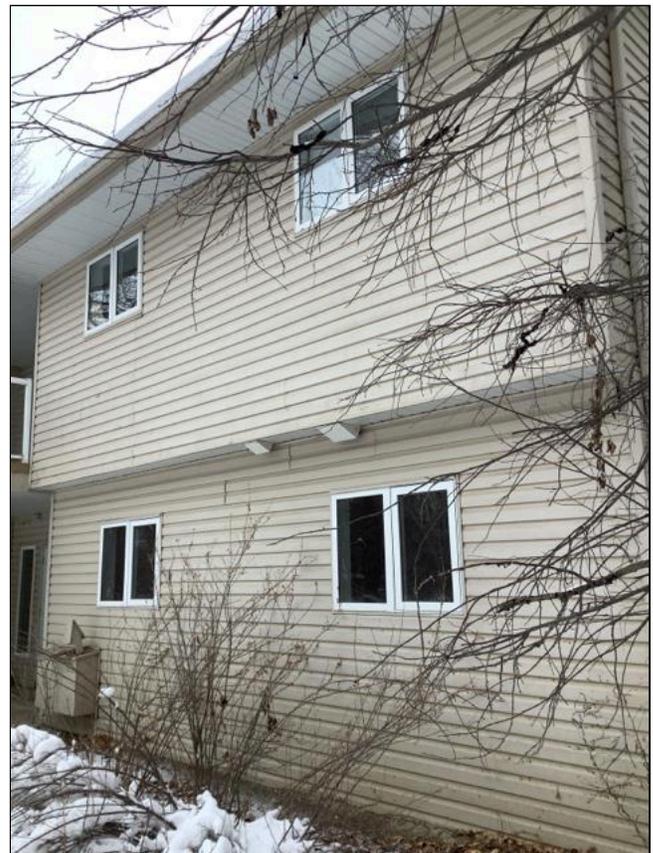
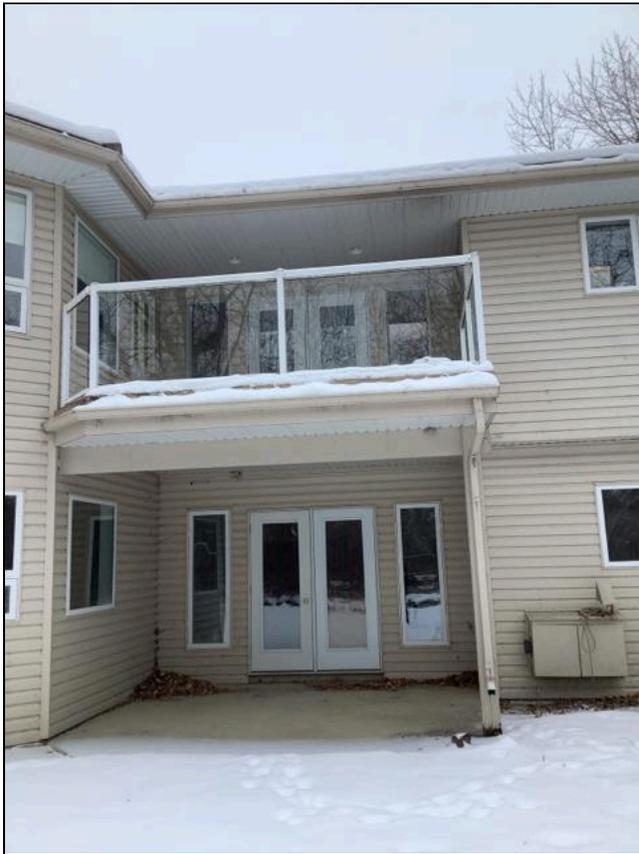
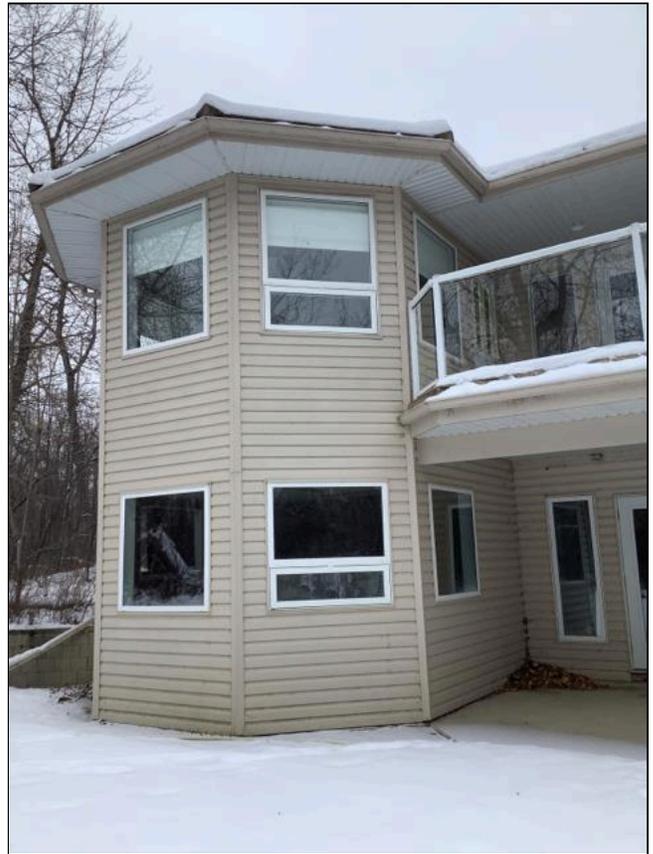
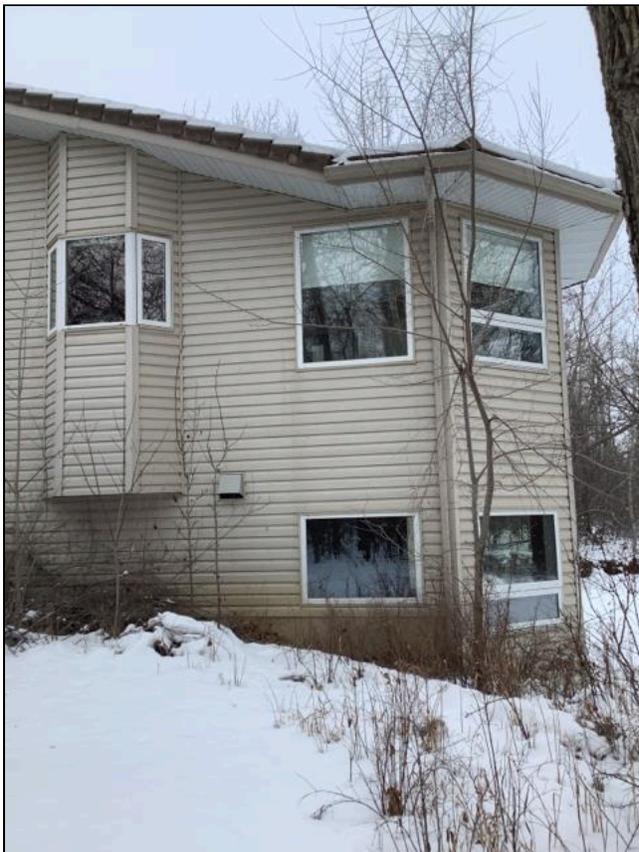
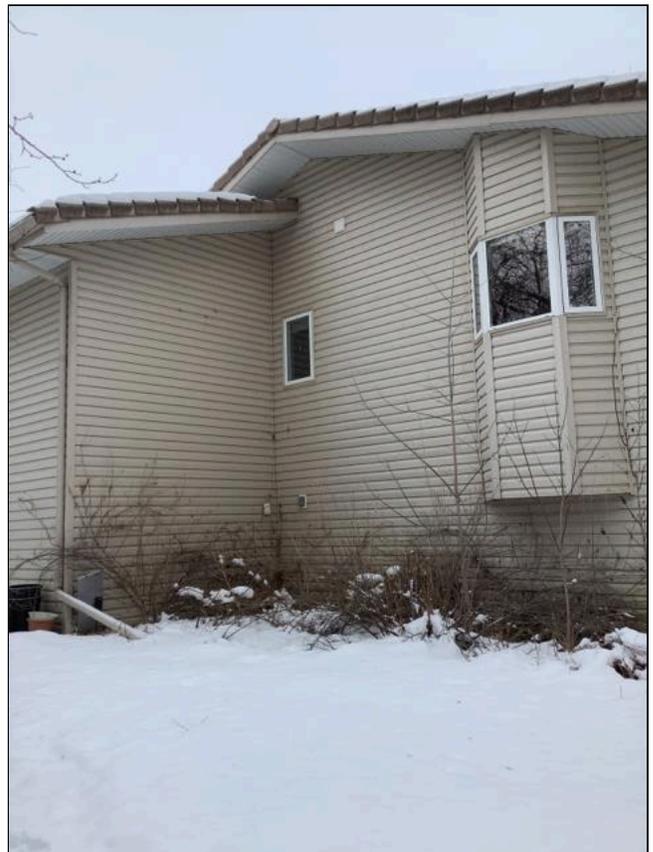
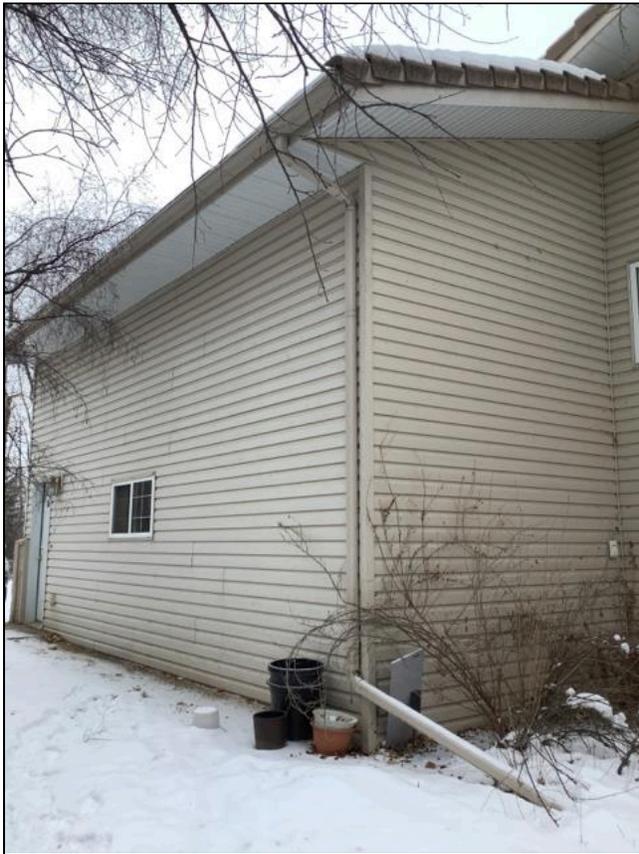
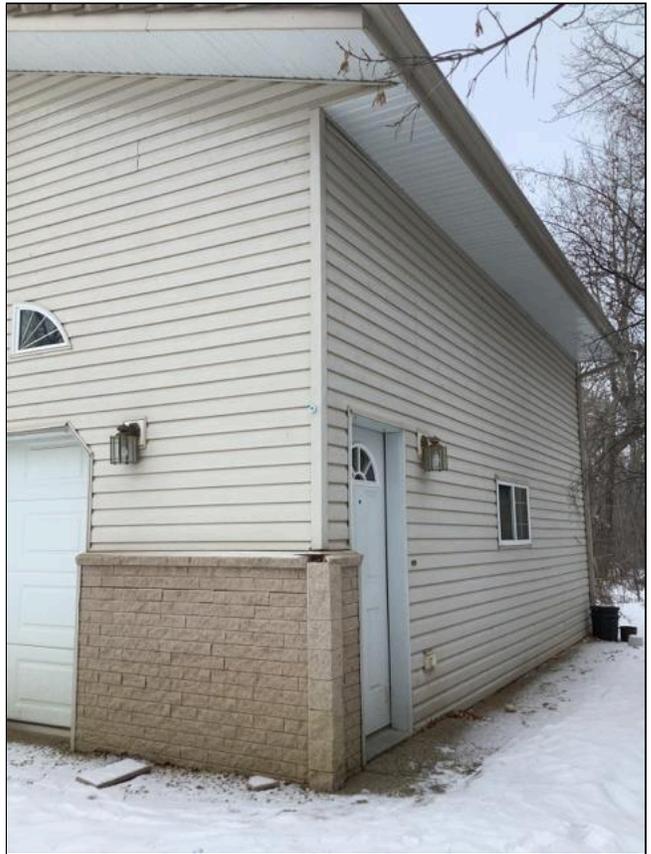
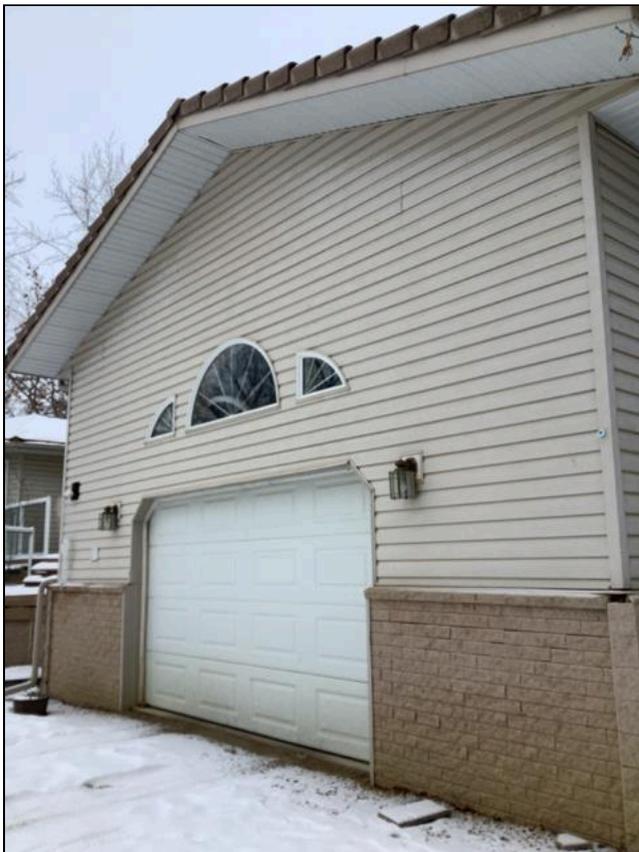
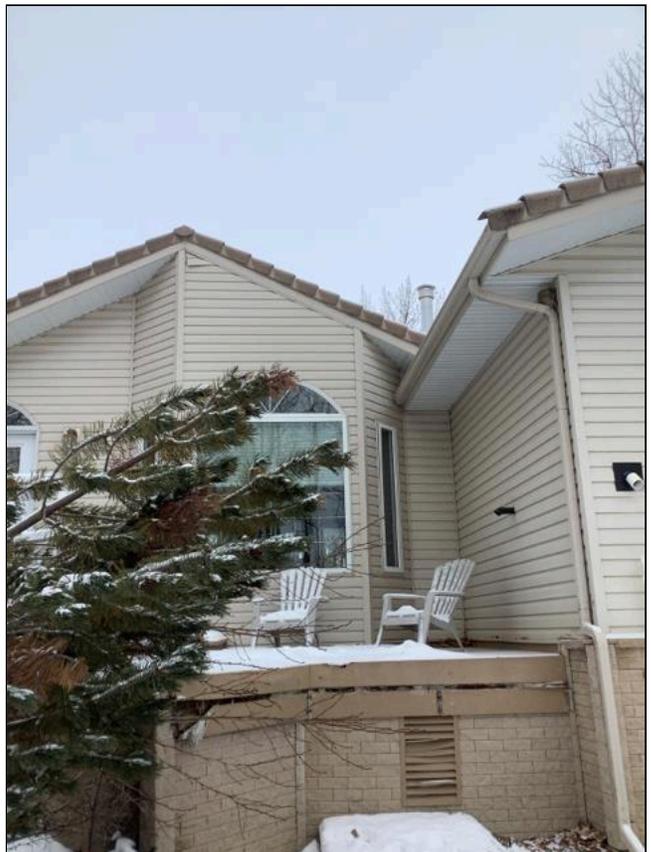
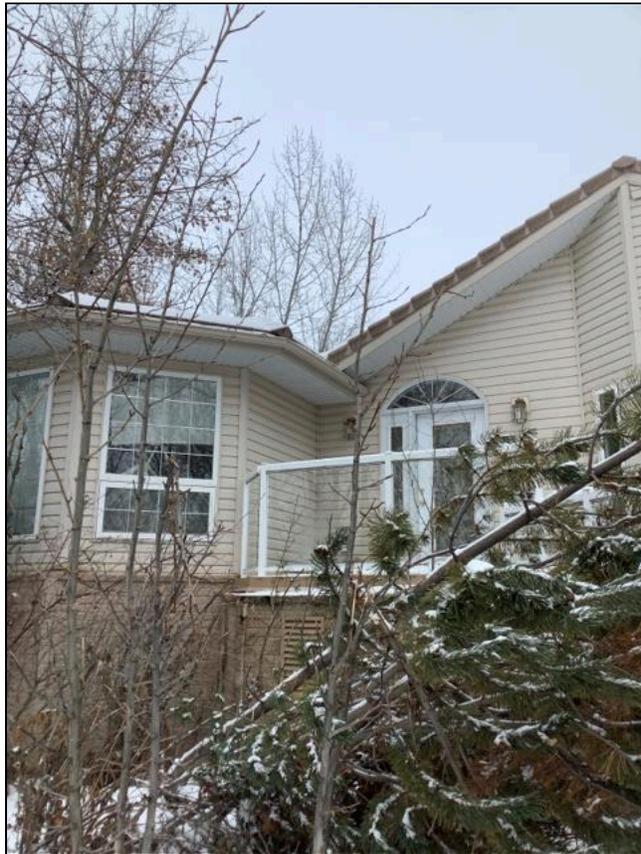
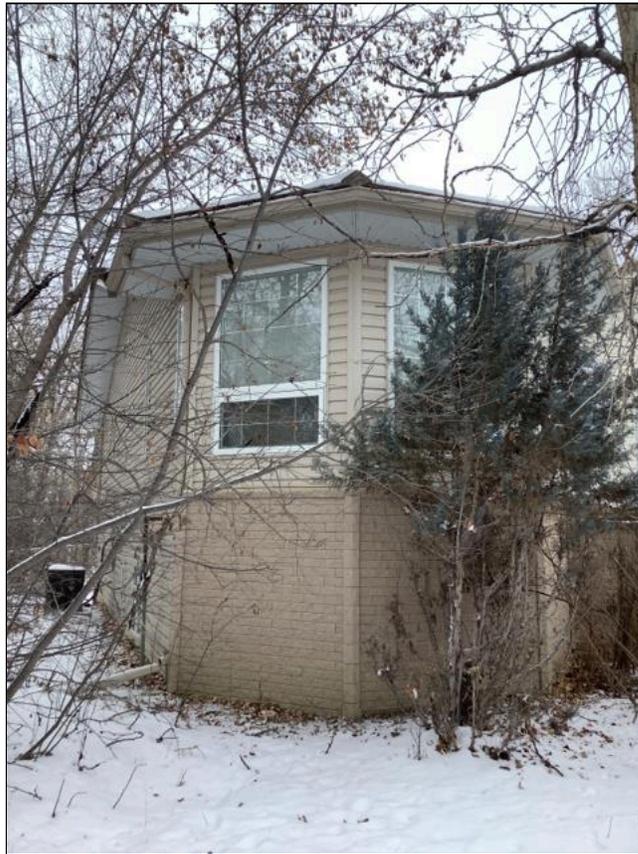
Higher levels of wall clad around the home are only visually inspected from the ground level. No major concerns to report.

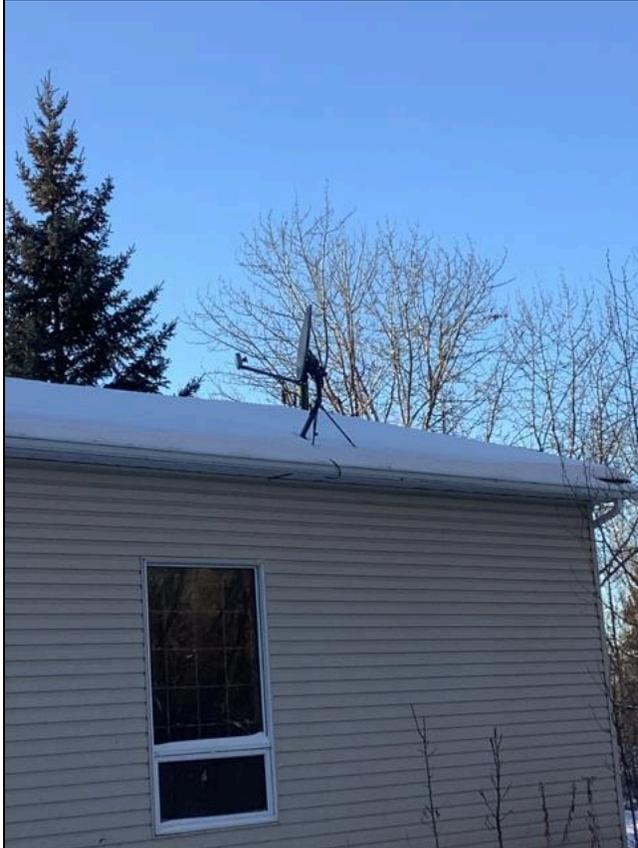
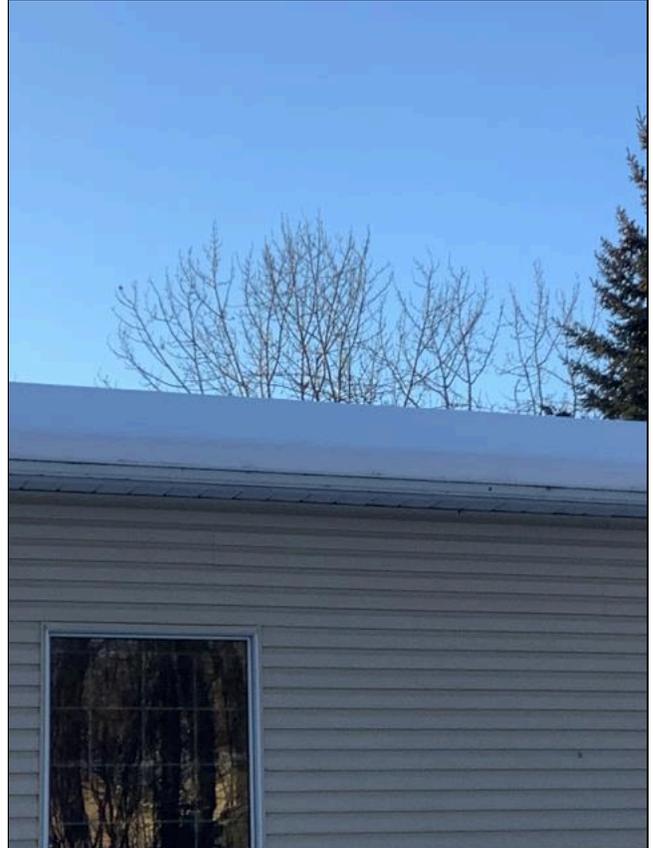
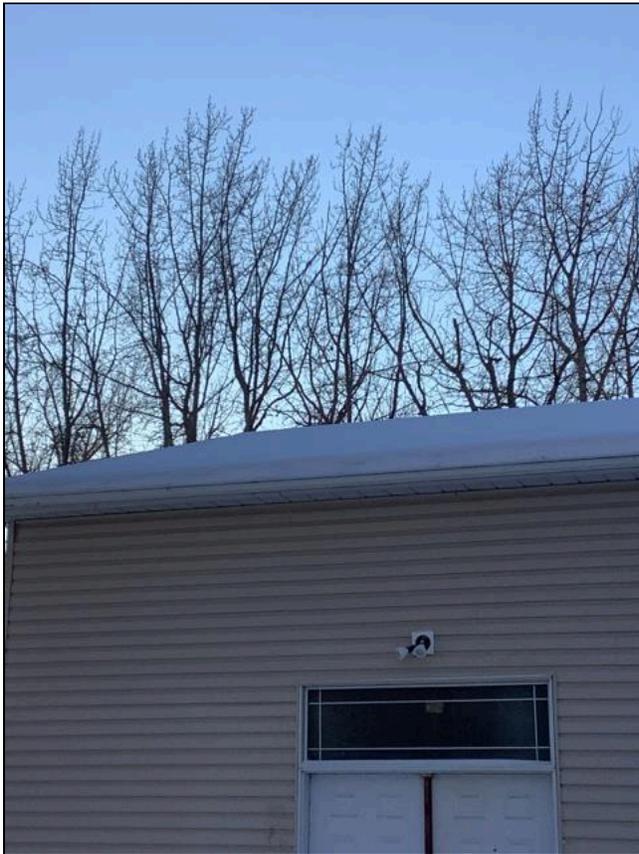
Roof was limited to a visual inspection with the use of binoculars as it was covered in snow, no issues to report from what was seen.

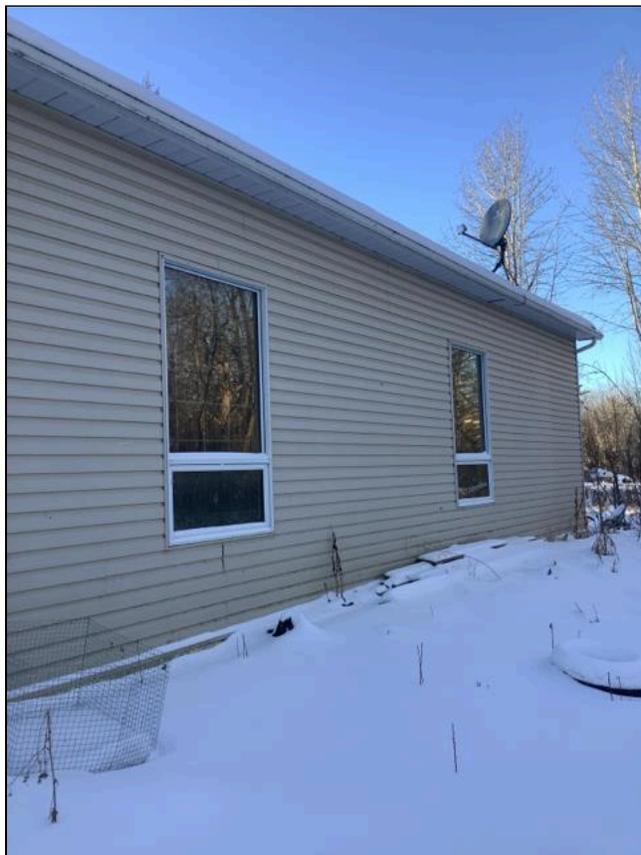
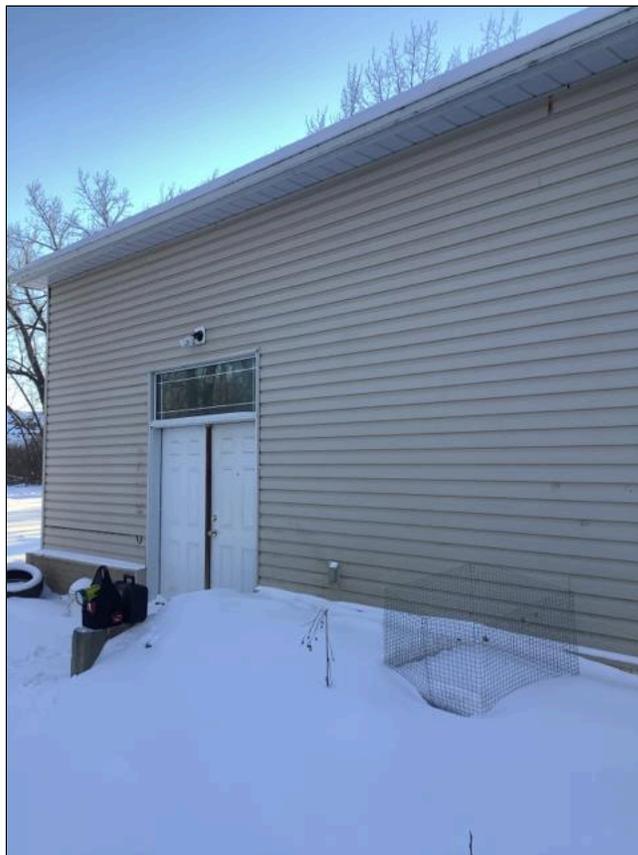
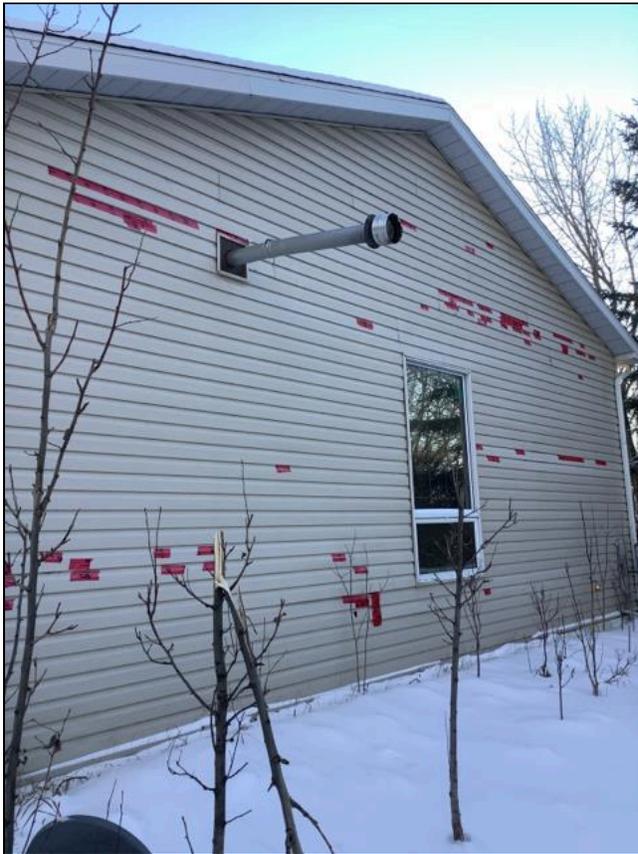
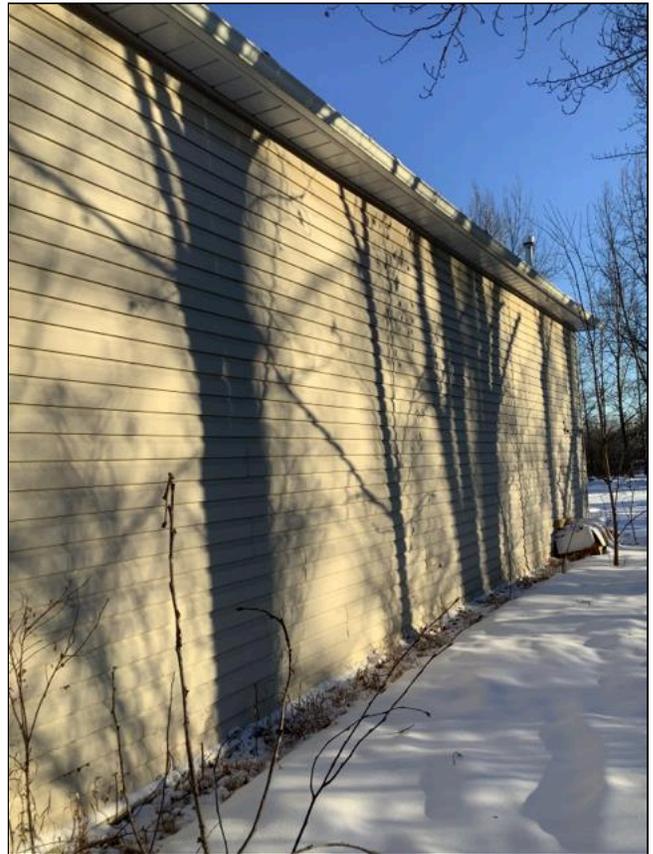
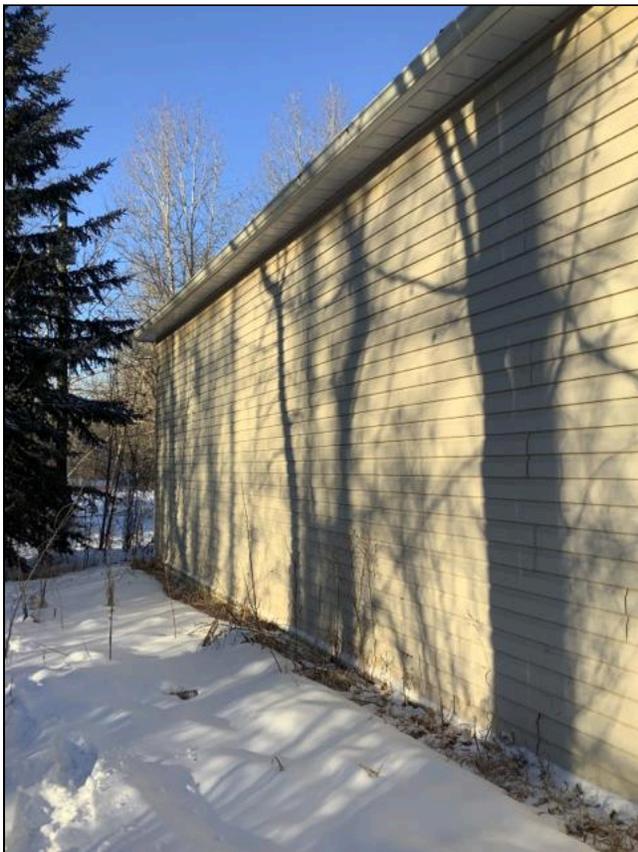
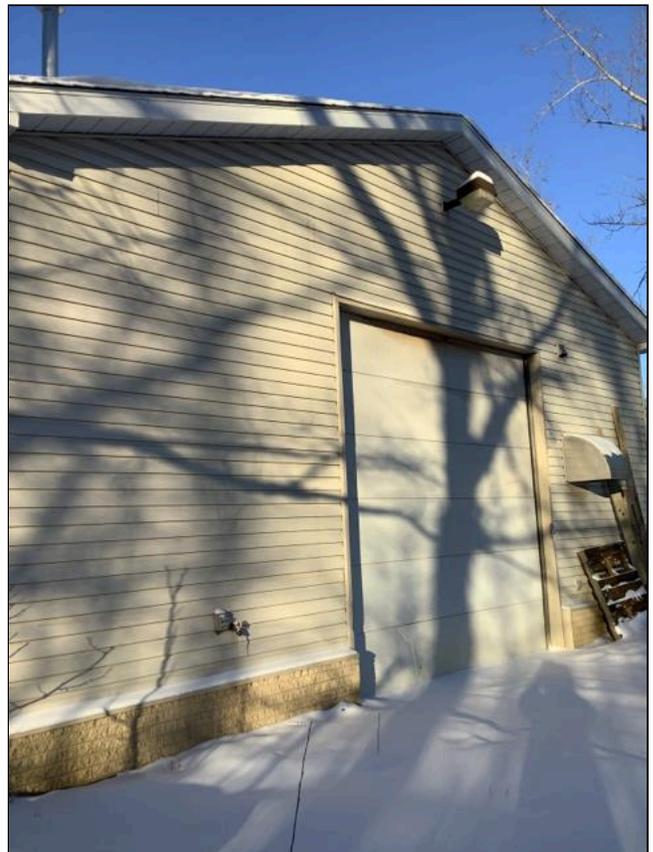
Higher levels of wall clad around the home are only visually inspected from the ground level. No major concerns to report.

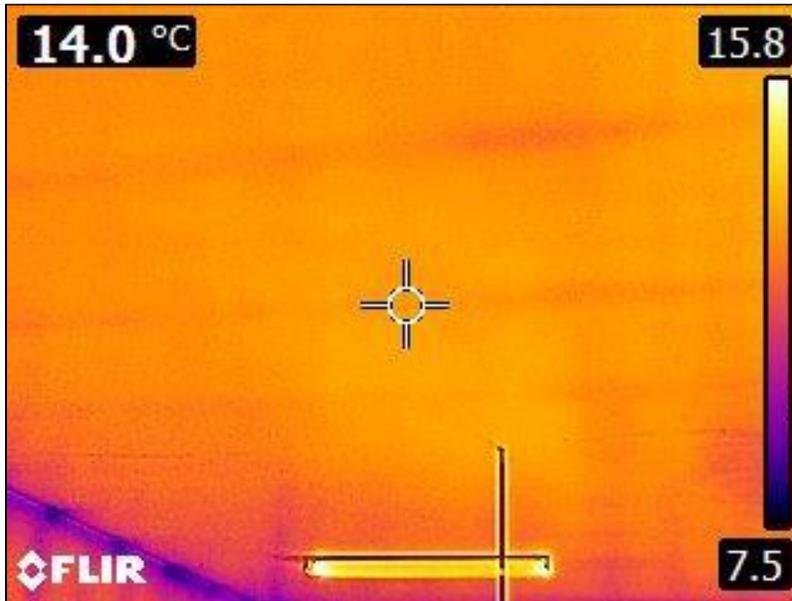
4.5 Item 1(Picture) Garage Ceiling

Dry at time of the inspection, in good shape and condition.

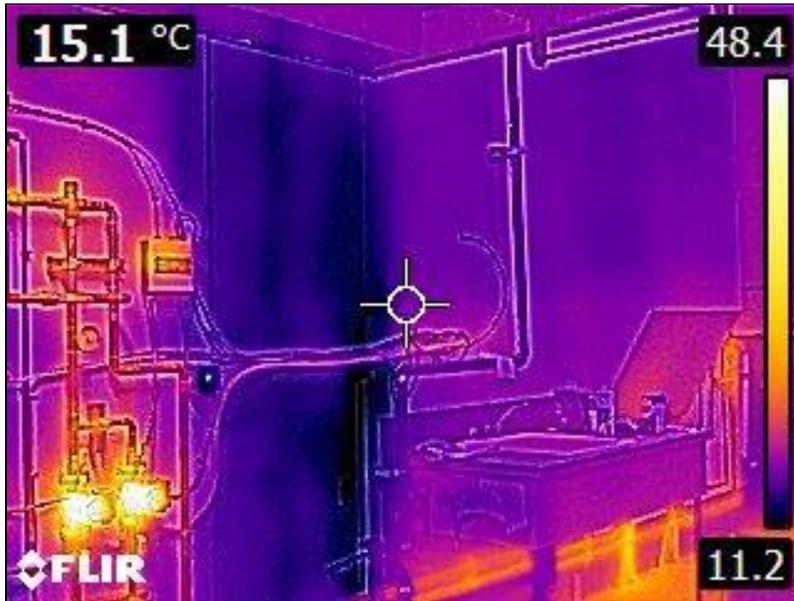
4.6 Item 1(Picture) Garage Firewall

Firewall in good condition- found to be dry, with no holes or damage of note at time of inspection. If damage occurs in the future, repair to maintain the fire rating.
