EXPRESSION OF INTEREST #2022-04-05

PROPOSAL: [Flood Mitigation – House Relocation]

3084 Riverview Drive - West Rosedale

3088 Riverview Drive - West Rosedale

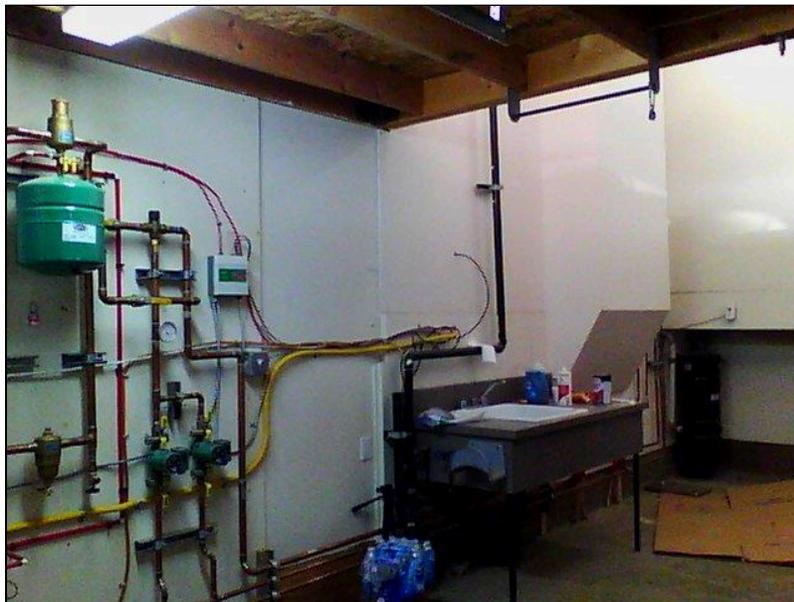
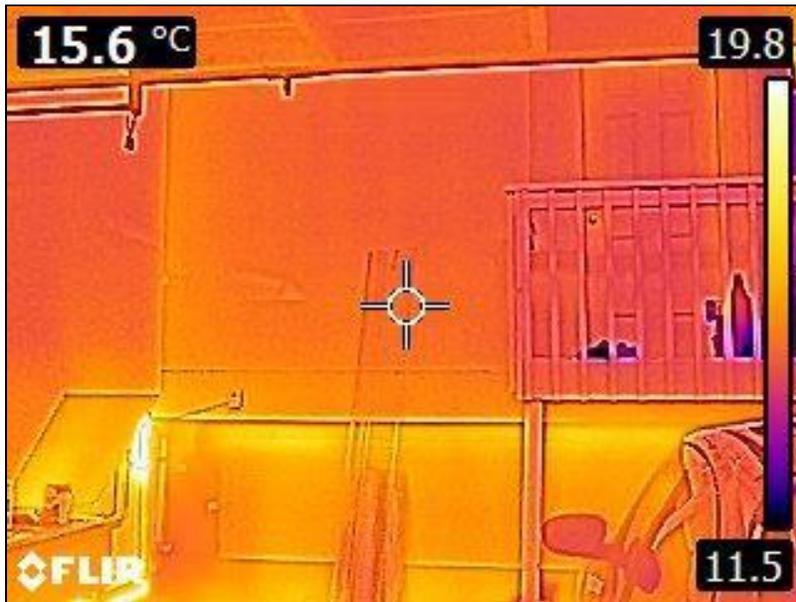
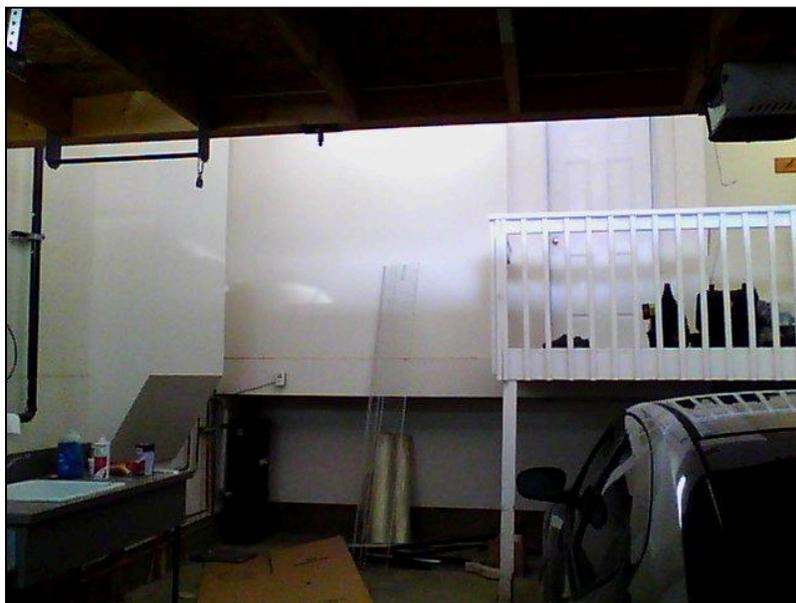
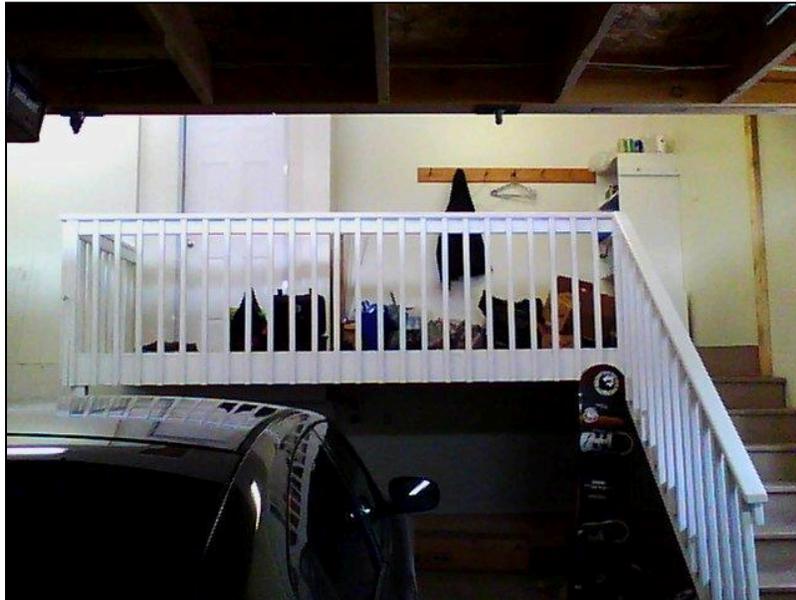
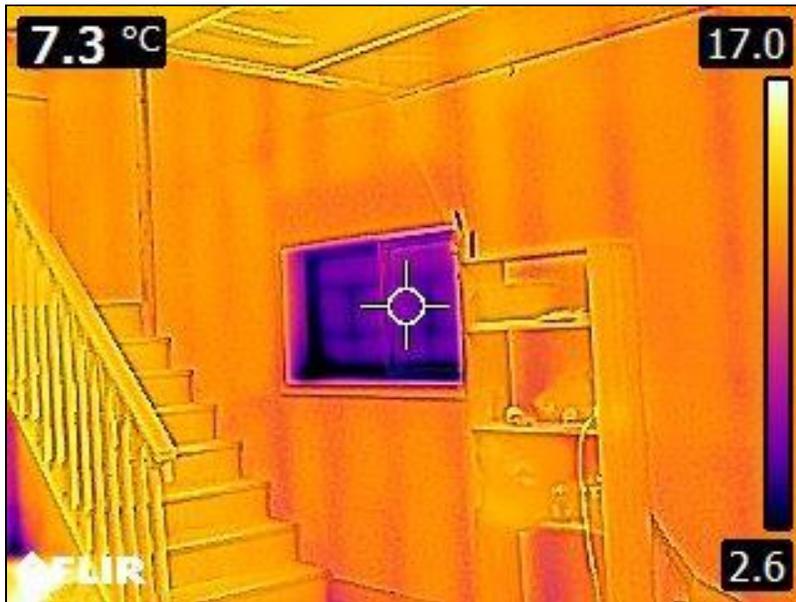
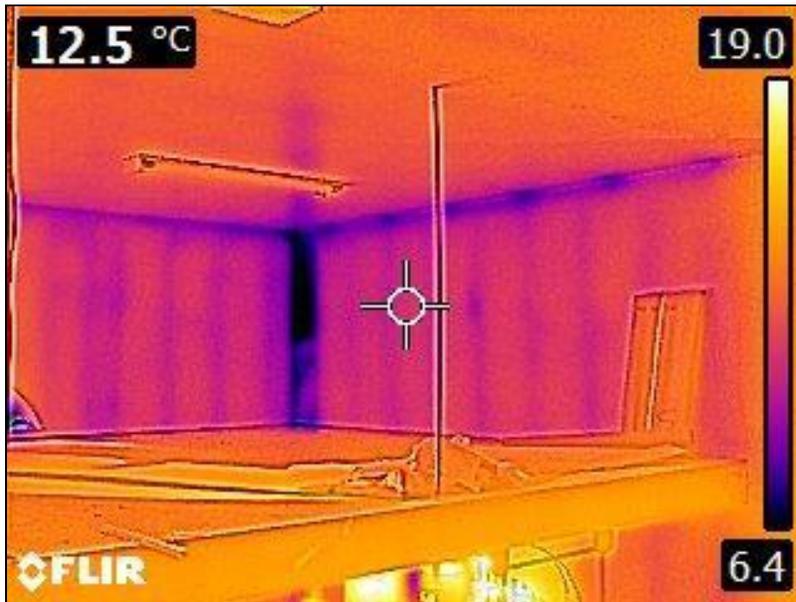
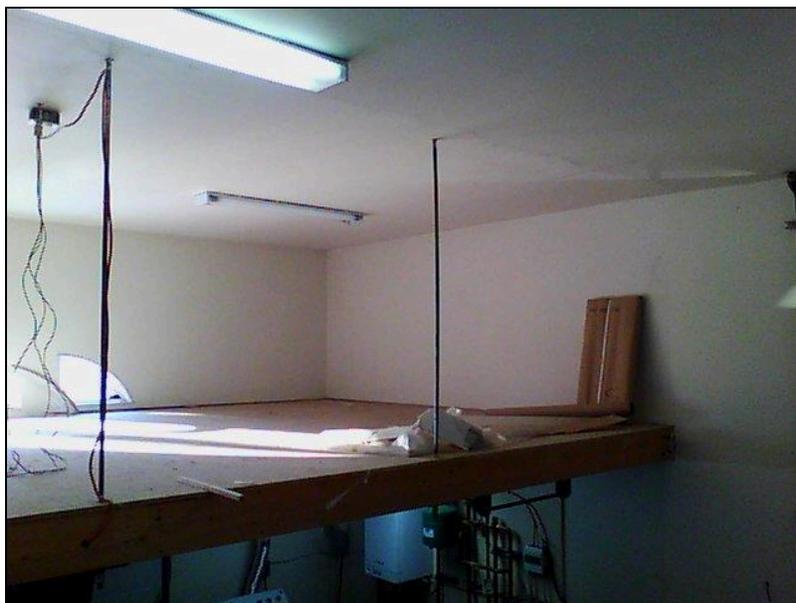
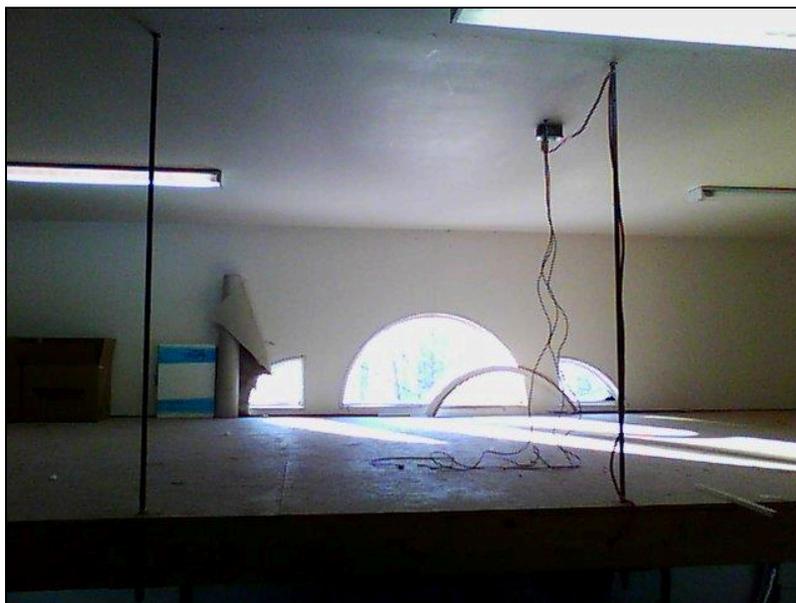
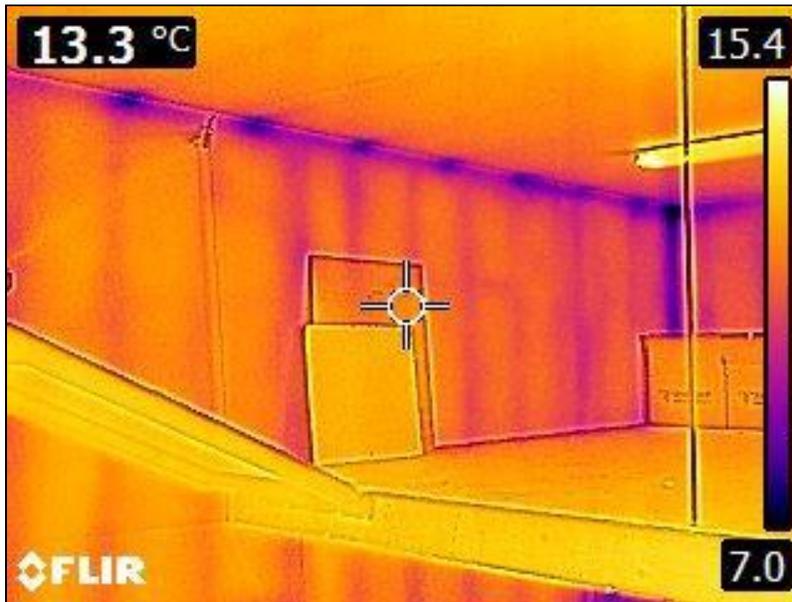
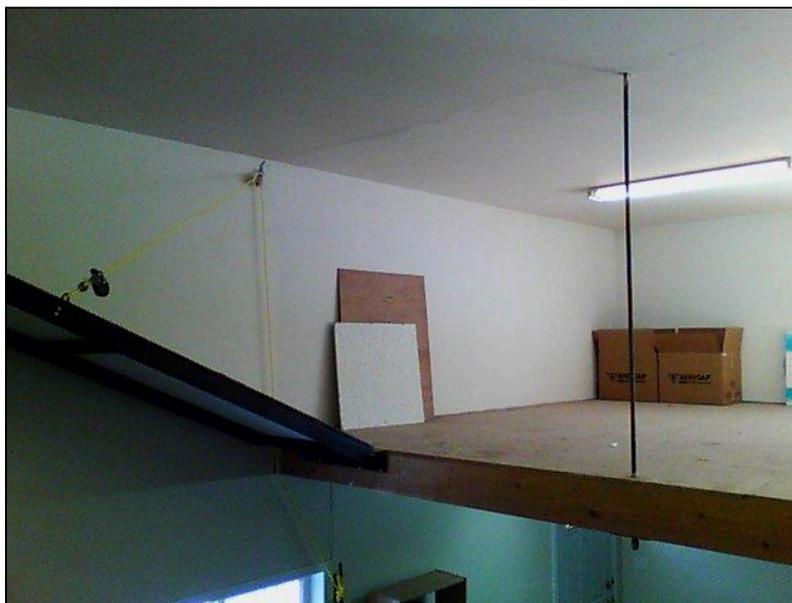
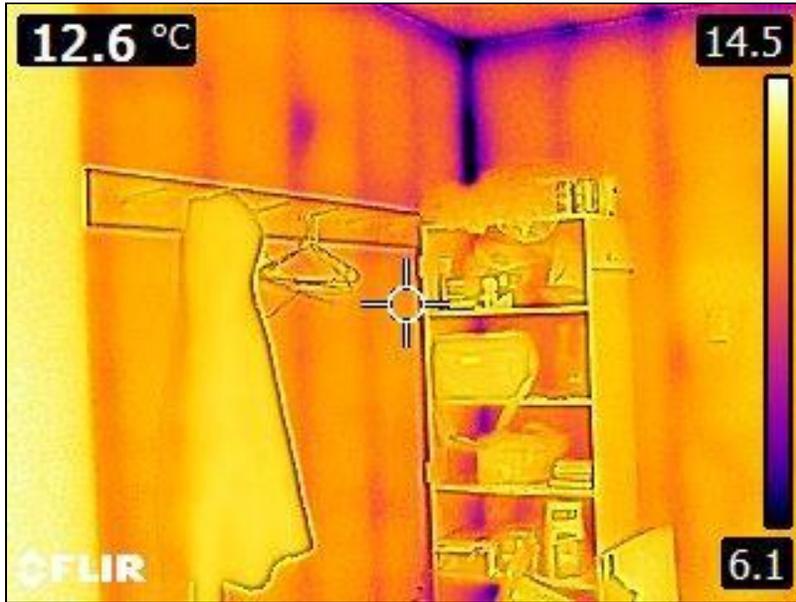
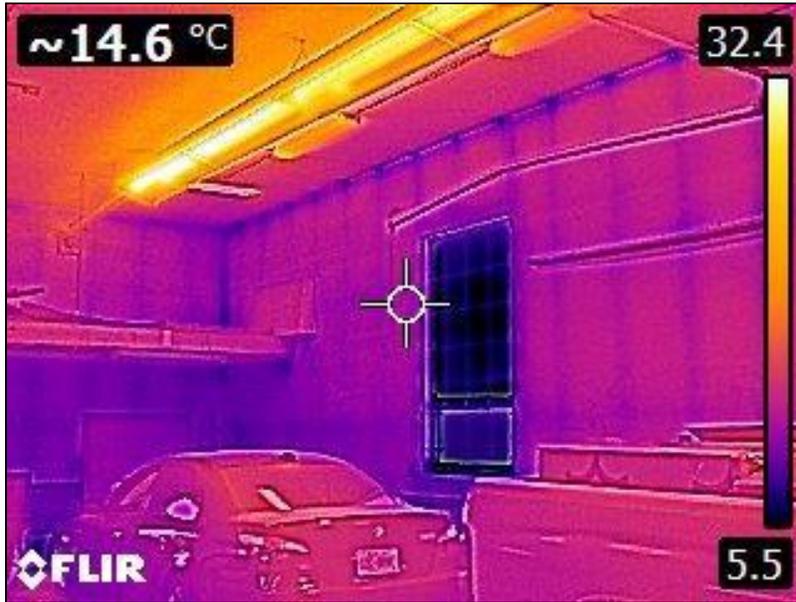
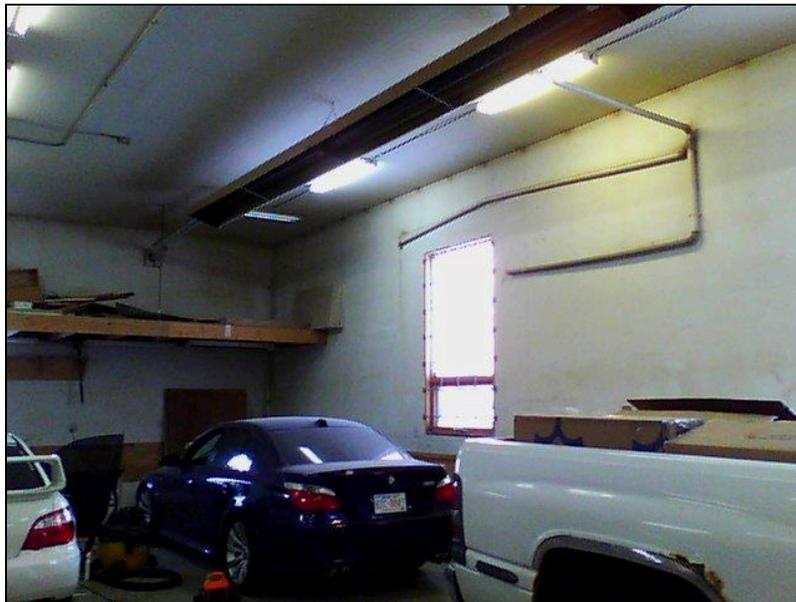
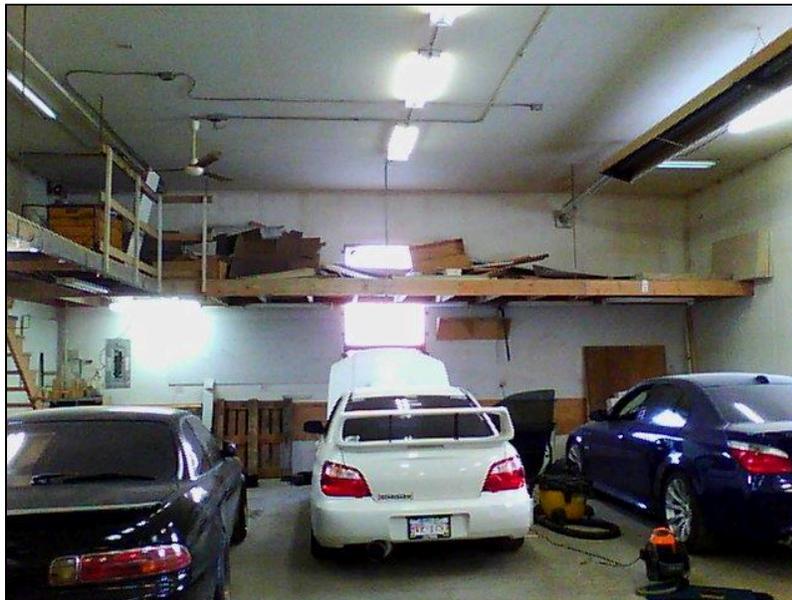
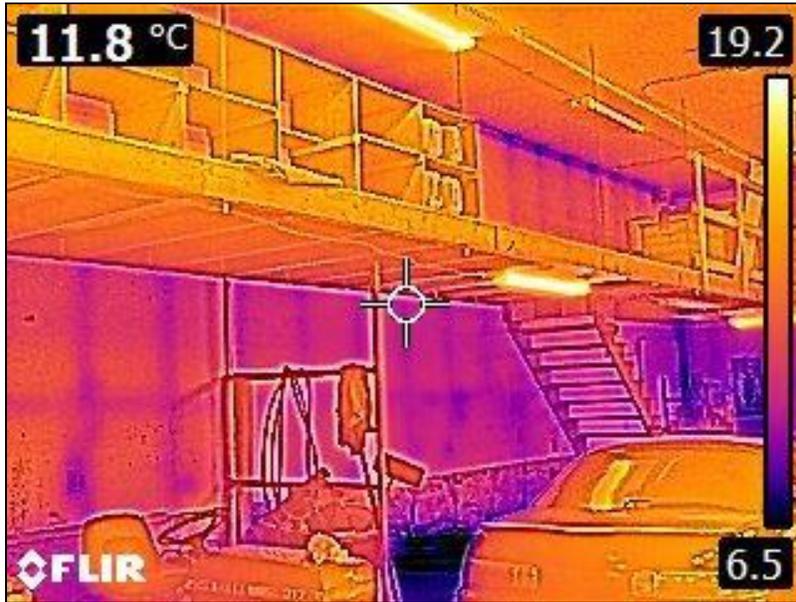
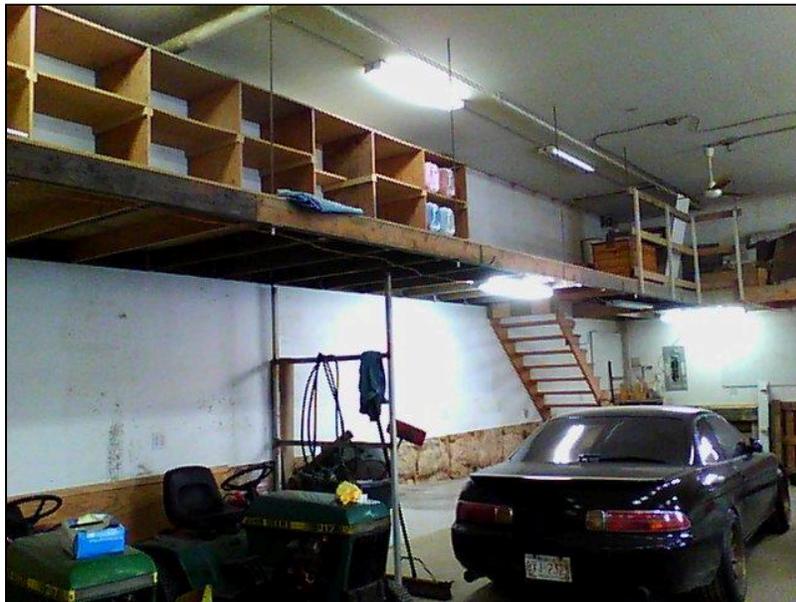
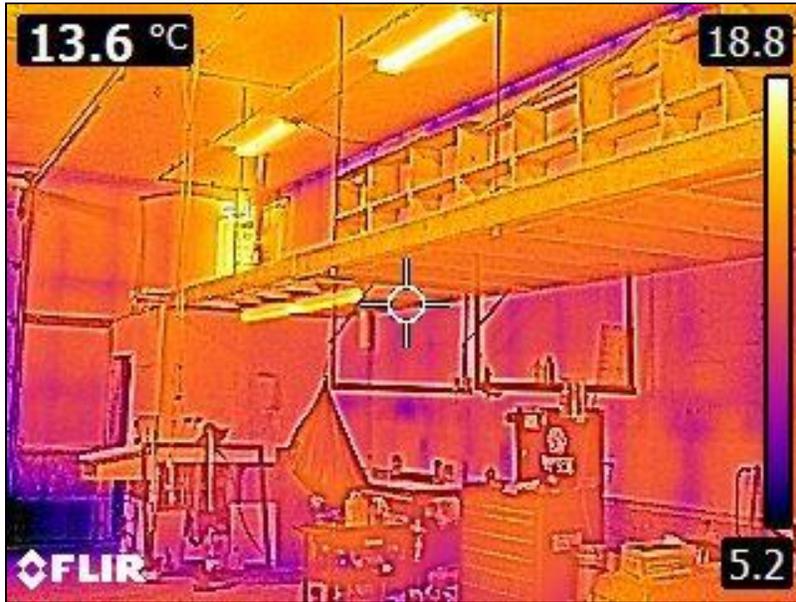
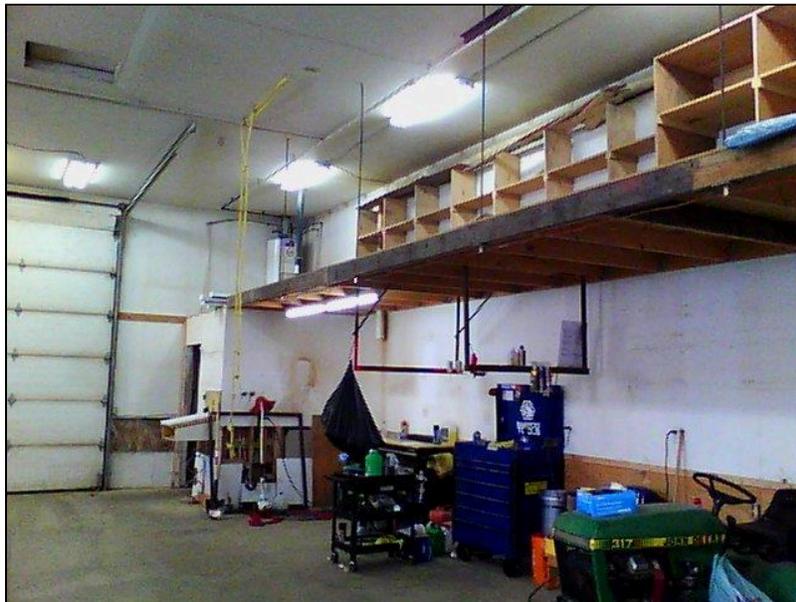
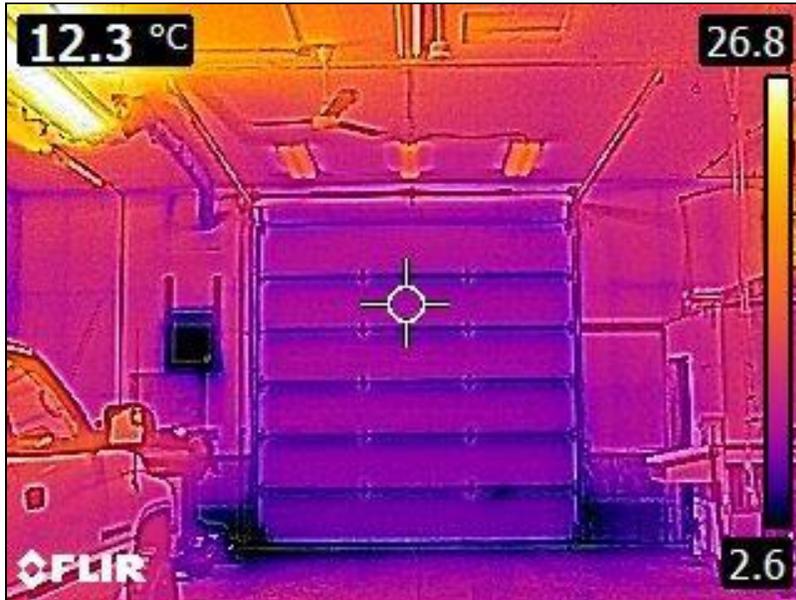
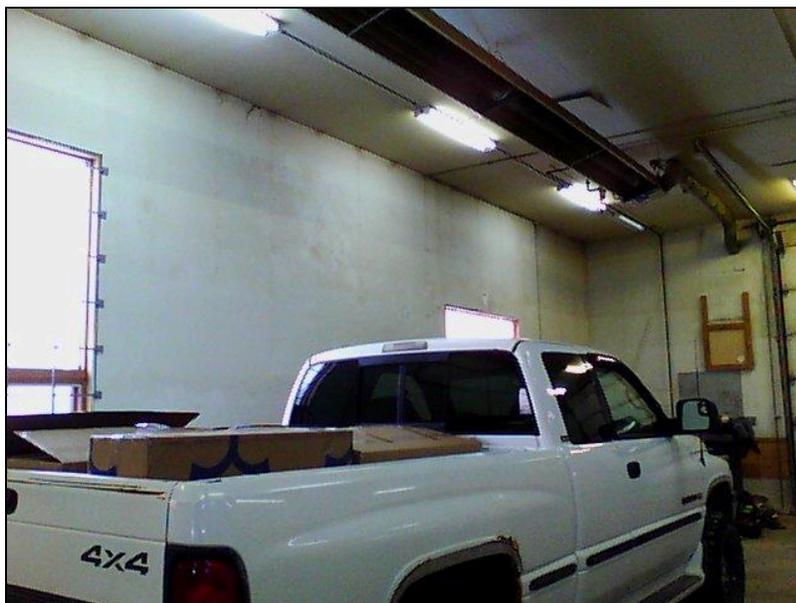
Firewall in good condition- found to be dry, with no holes or damage of note at time of inspection. If damage occurs in the future, repair to maintain the fire rating.

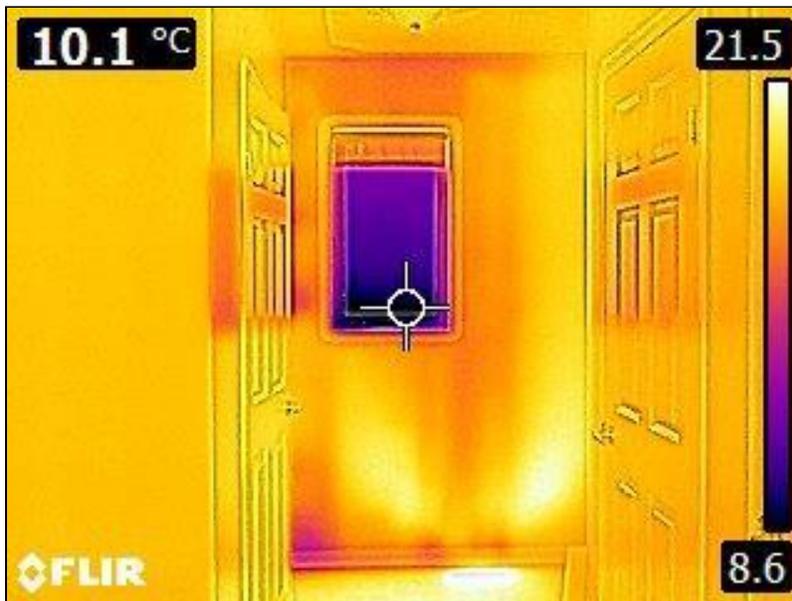
5.1 Item 1(Picture) Interior Walls

All walls were in good condition and dry at the time of inspection. (Cosmetic issues are not part of the inspection.)

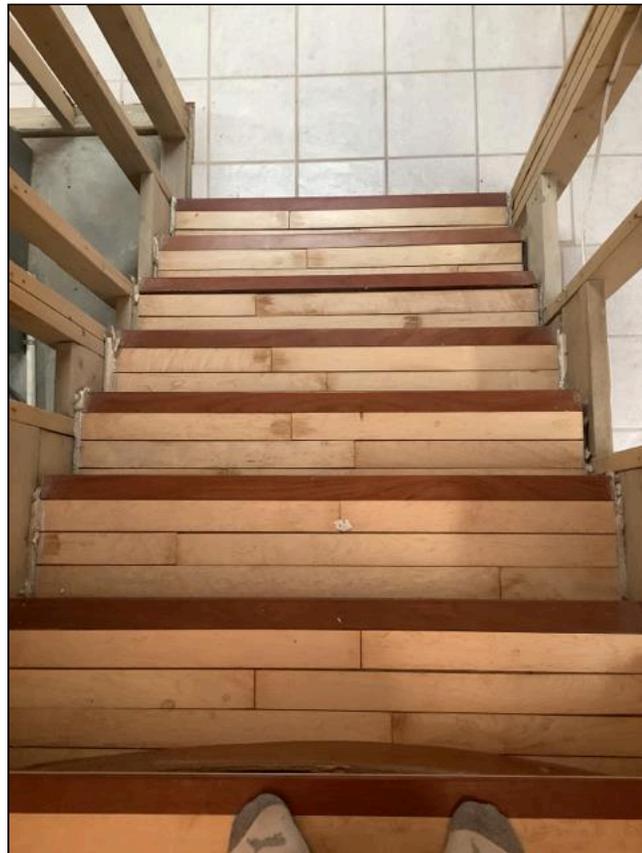
The steps leading to the basement are damaged and warped from moisture from the flood, these areas are hazardous and should be repaired as required.

5.3 Item 1(Picture) Steps to Basement - damaged and warped

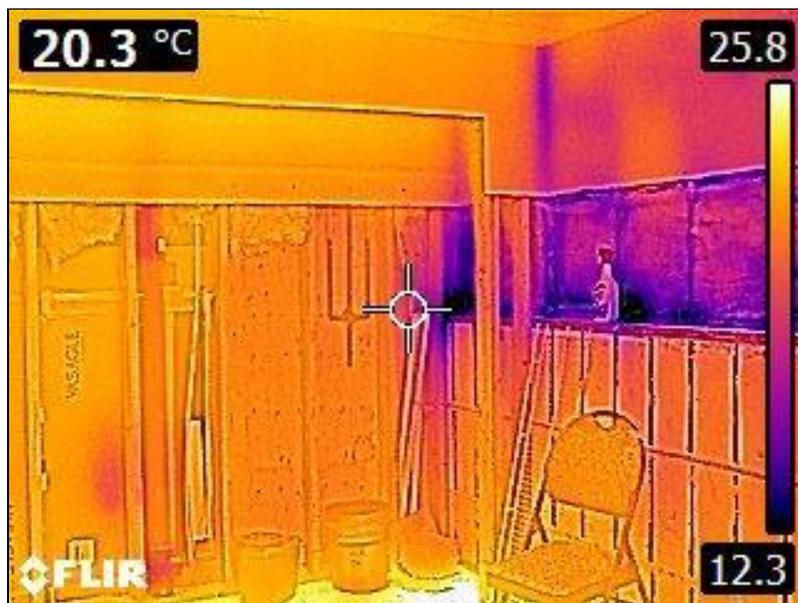
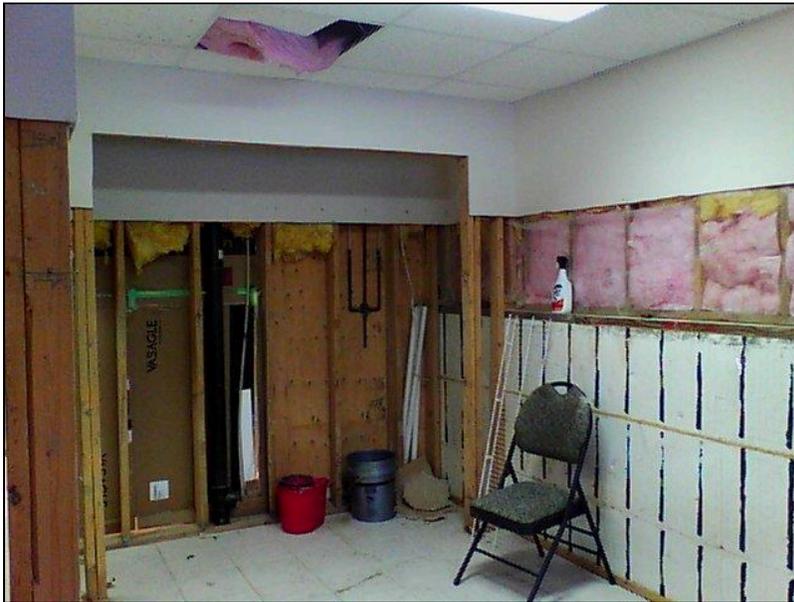
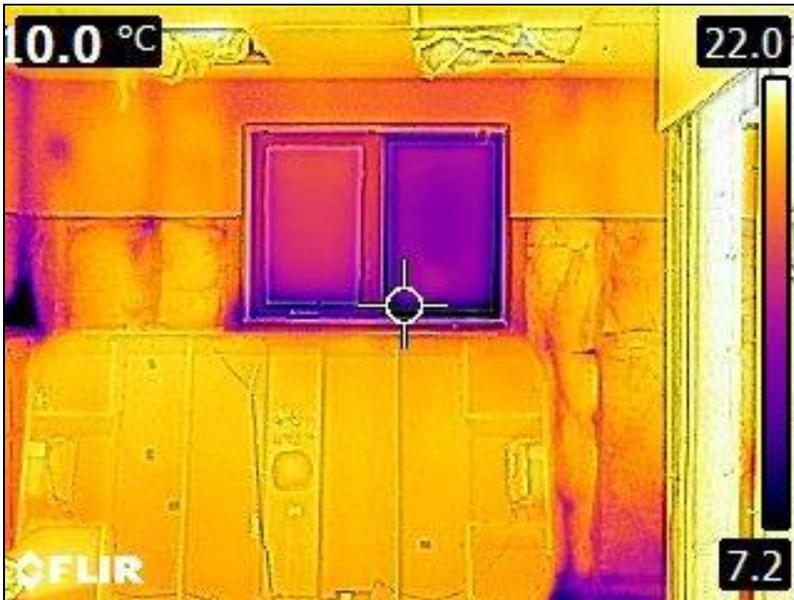
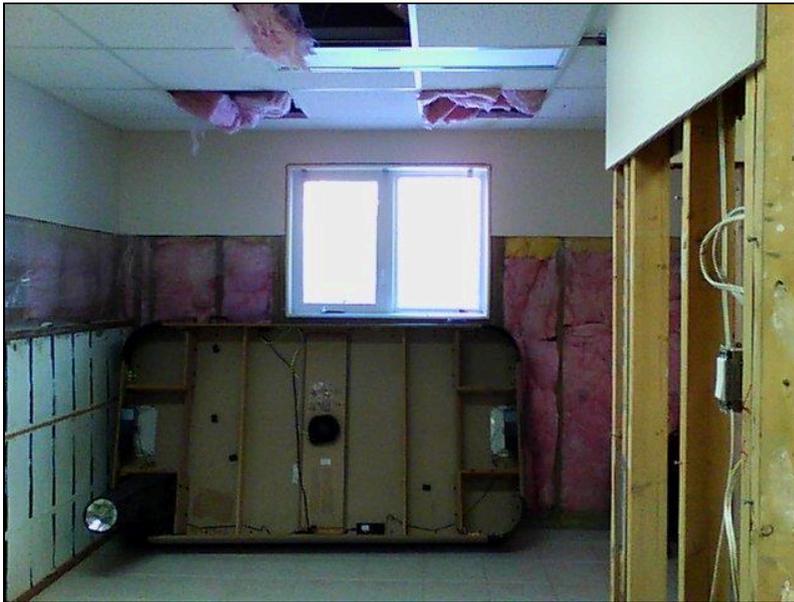
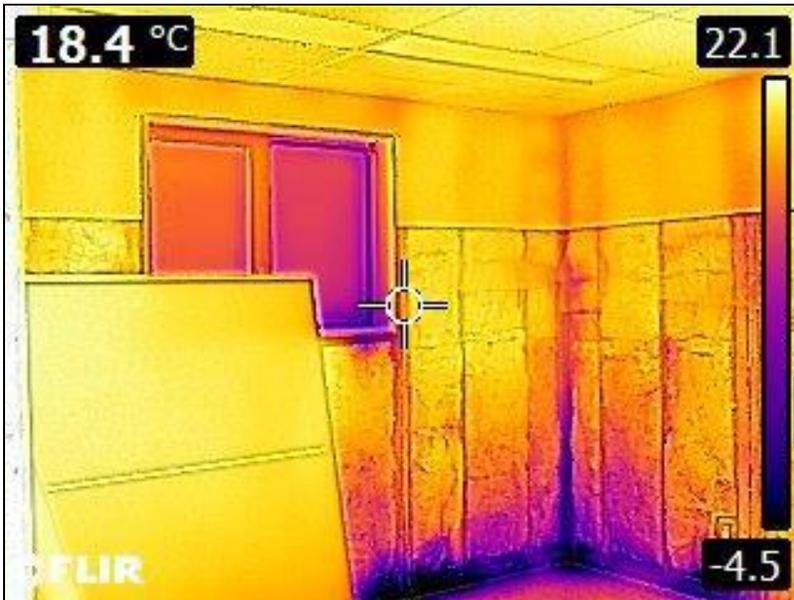
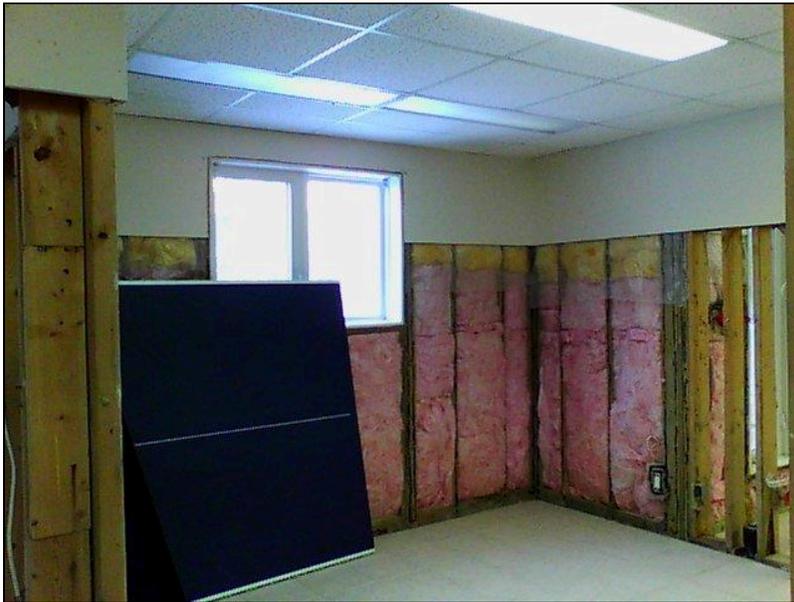
7.0 Item 1(Picture) Basement Foundation

The basement area was dry on day of the inspection. Future conditions cannot be determined as these are changeable with the weather conditions. Recommend obtaining information from seller on any past water/moisture penetration. Basement has been flooded and half the drywall removed, no issues to report.

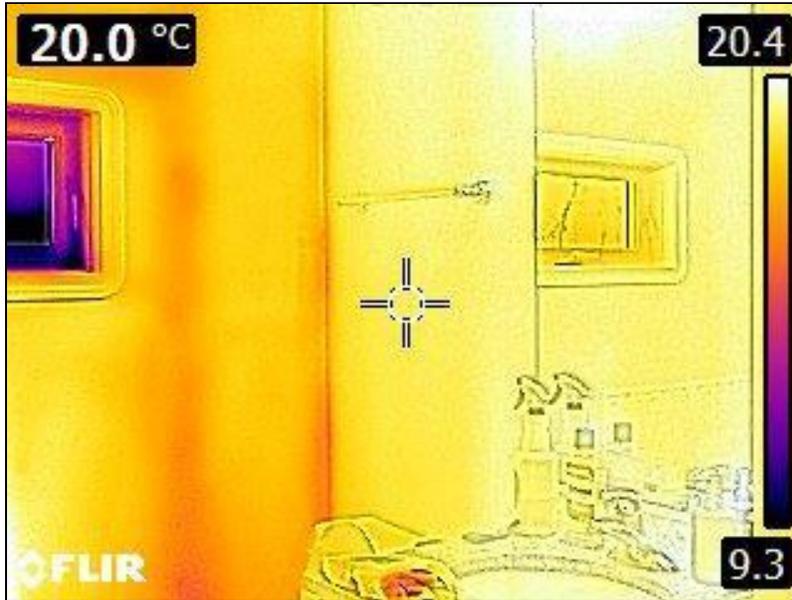
9.0 Item 1(Picture) Bathroom Walls

All bathroom walls and ceiling were in good condition and dry at time of inspection. (Cosmetic issues are not part of the inspection.)

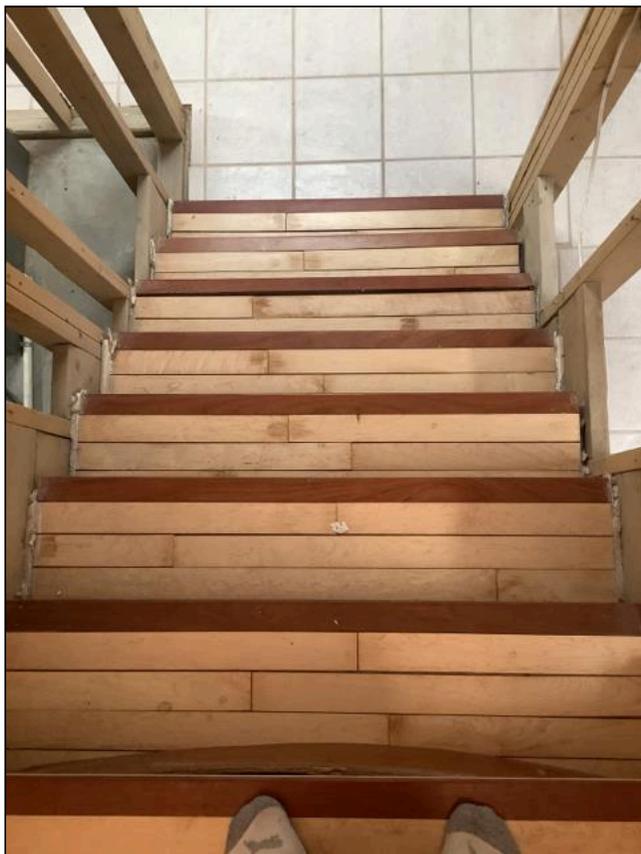
The steps leading to the basement are damaged and warped from moisture from the flood, these areas are hazardous and should be repaired as required.

5.3 Item 1(Picture) Steps to Basement - damaged and warped
